# Via Mare Condominium Association, Inc.

June 19, 2024 • Atlantic Beach, FL

**STRUCTURAL INTEGRITY  
RESERVE STUDY**

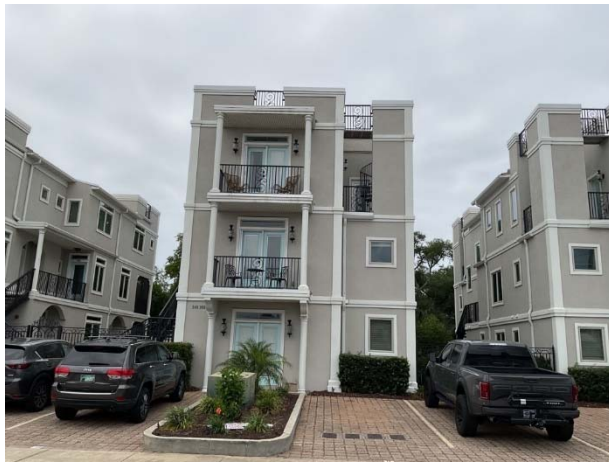
Building front elevation

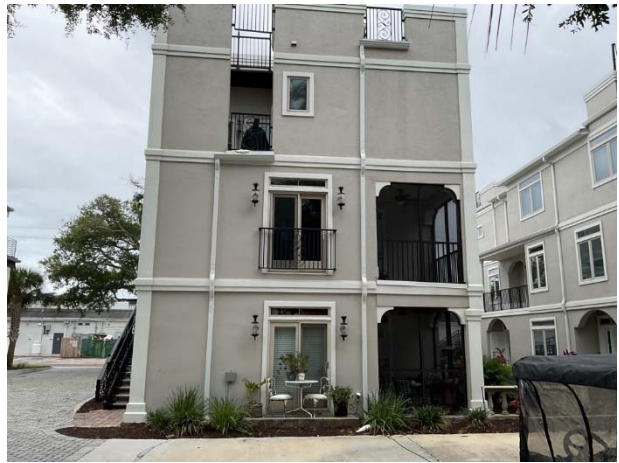
Building rear elevation

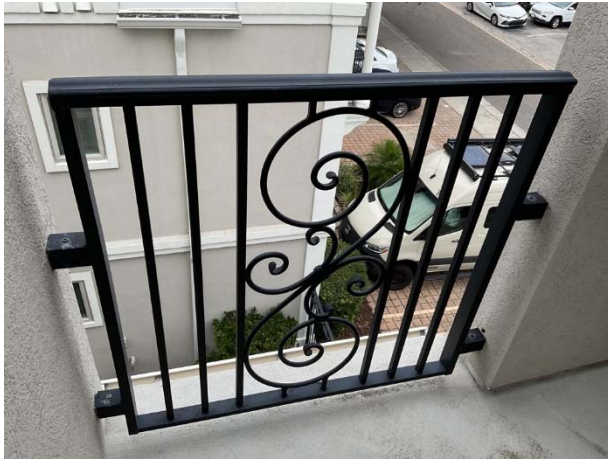
Decorative aluminum railing

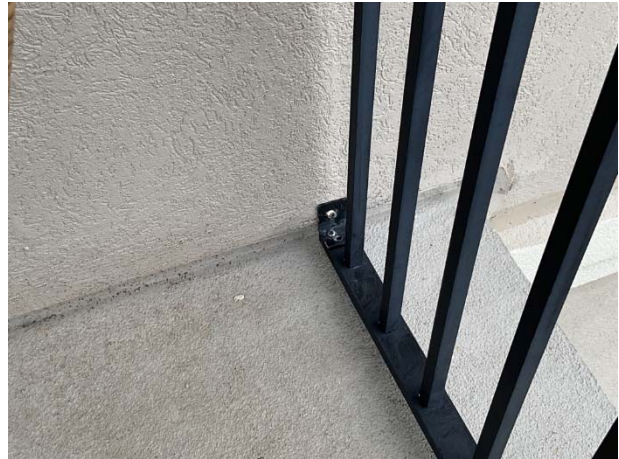
Mechanically attached railing

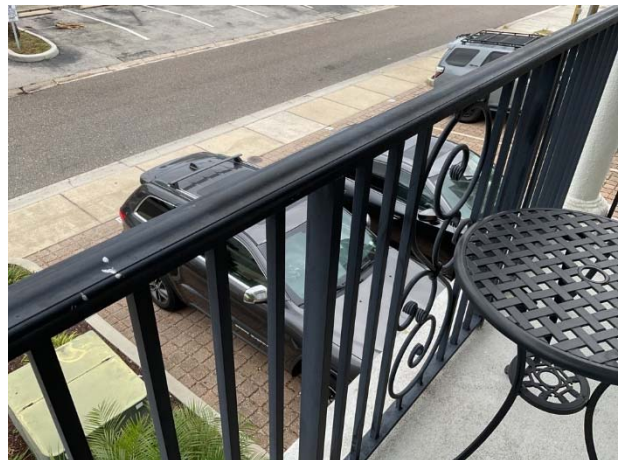
Aluminum railings

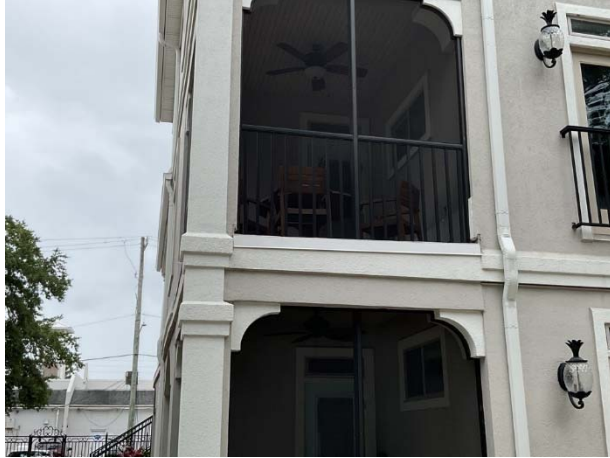
**Balcony surfaces sloped away from structure**

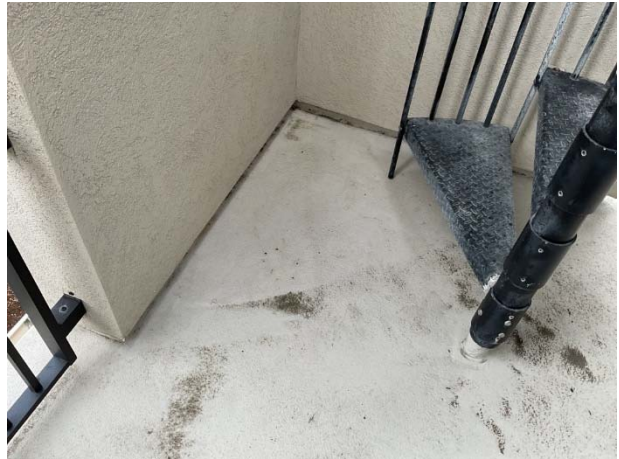
**Condition:** Good to fair overall with isolated water stains evident. We note minor cracks at the rooftop terraces

**Evidence of standing water**

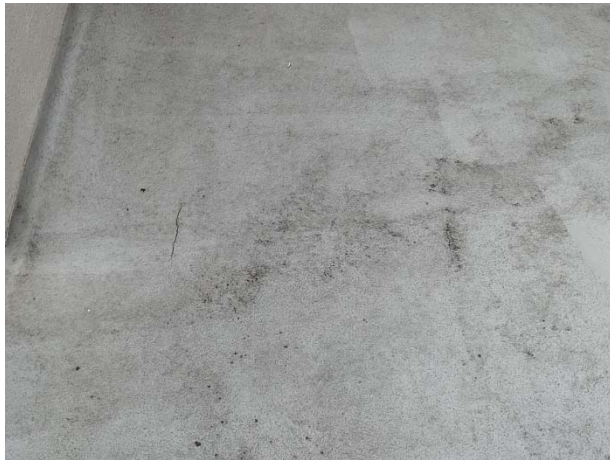
**Cracks in rooftop terrace concrete surface**

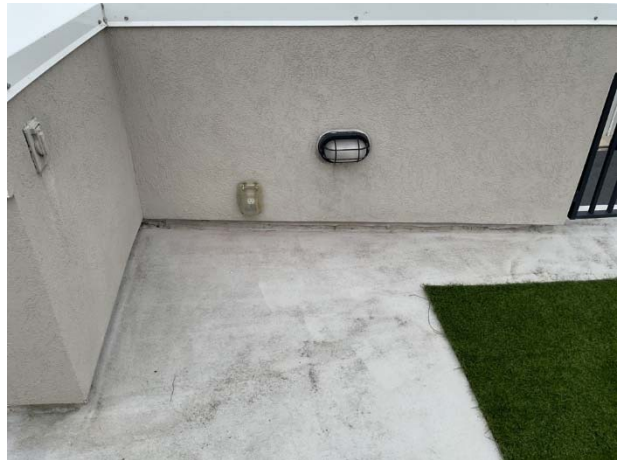
**Perimeter flashing at rooftop terrace**

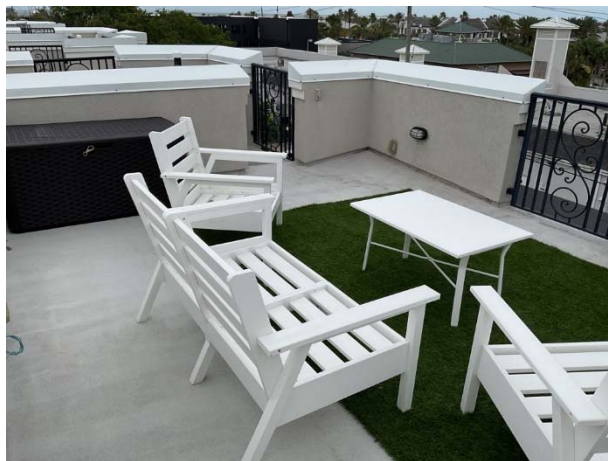
**Rooftop terrace overview**

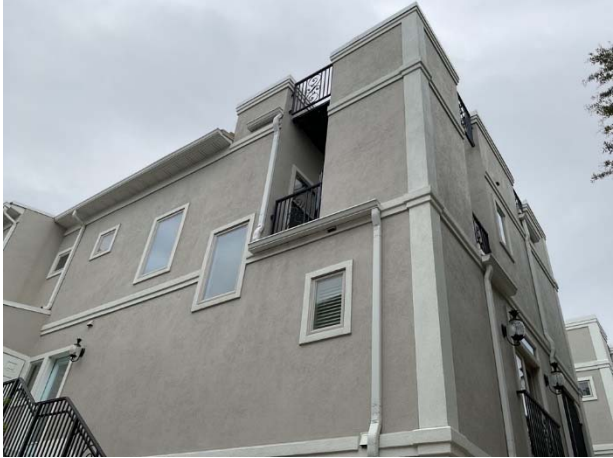
**Aluminum gutters and downspouts**

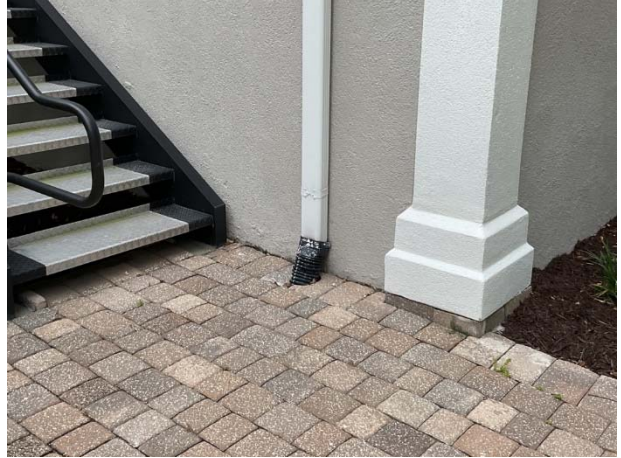
**Downspout directed into drain**

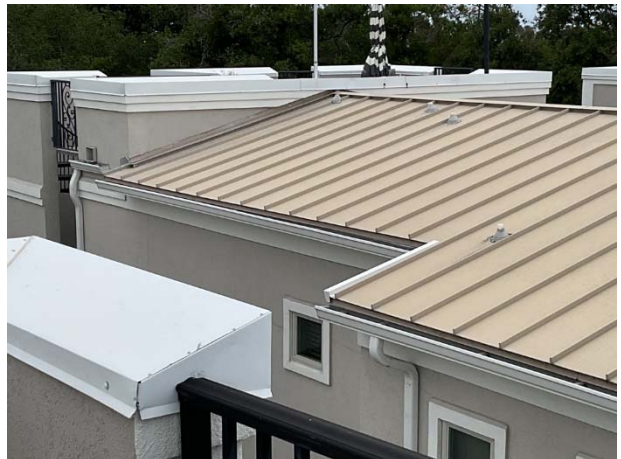
**Condition:** Good to fair overall with dented sections and gutter deflection evident.

**Gutter deflection**

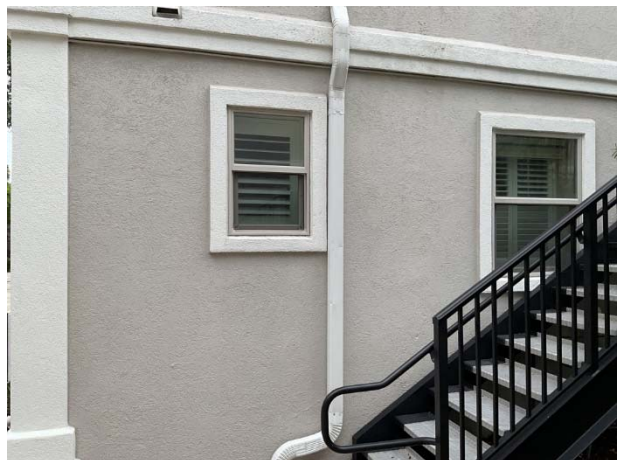
**Dented section**

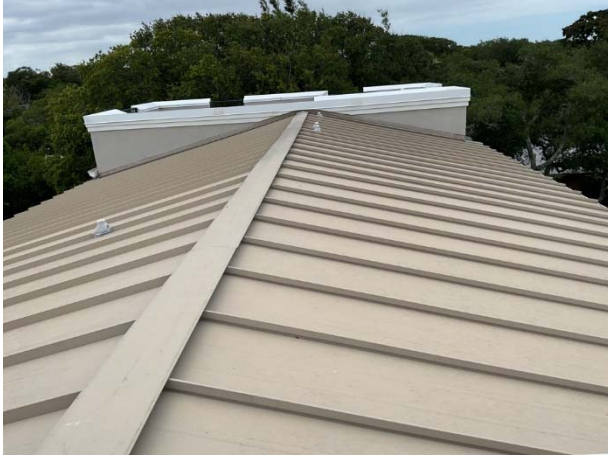
**Metal roof**

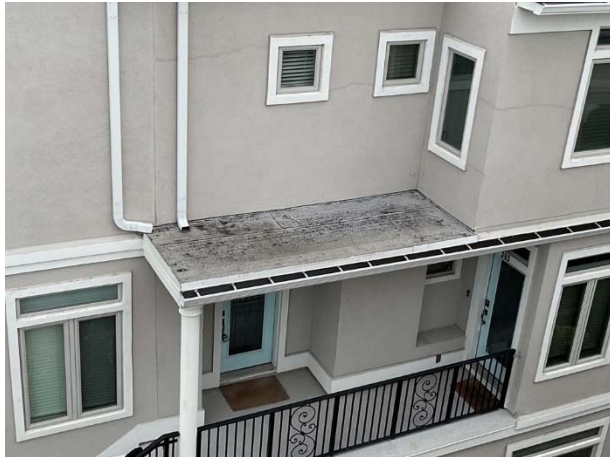
**Condition:** Fair overall with evidence of standing water where downspouts discharge directly onto lower roof sections. The Association does not report history of leaks.

Modified bitumen roof section with evidence of standing water

**History:** Reportedly replaced in 2018. We note evidence of varied age based on visual condition. We recommend the Association should conduct inspections of the roofs semiannually and fund these inspections through the operating budget.

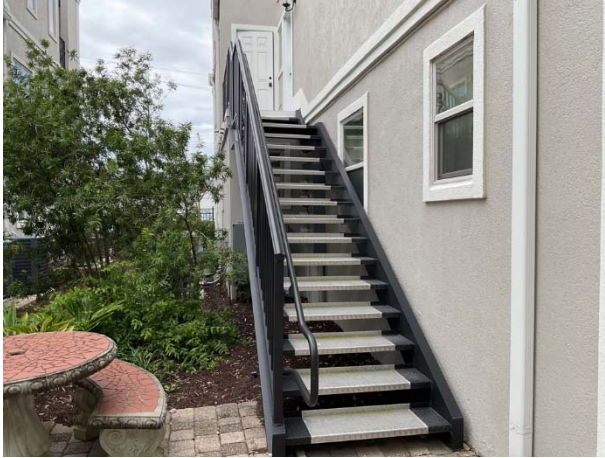
**Staircase overview**

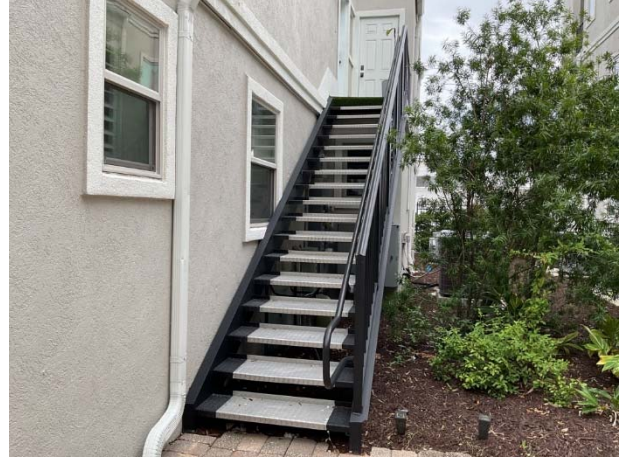
**Staircase overview**

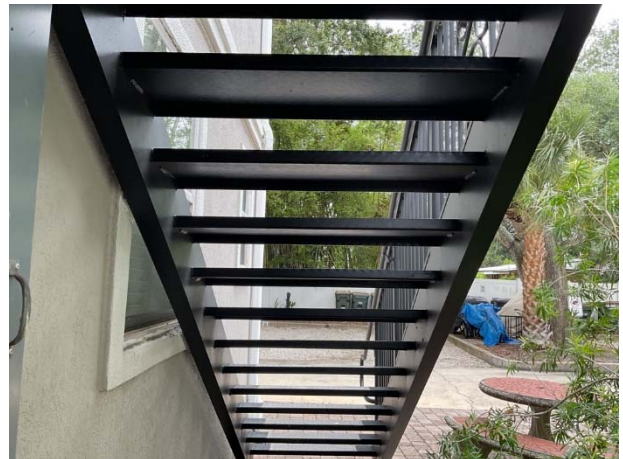
**Metal staircase structure**

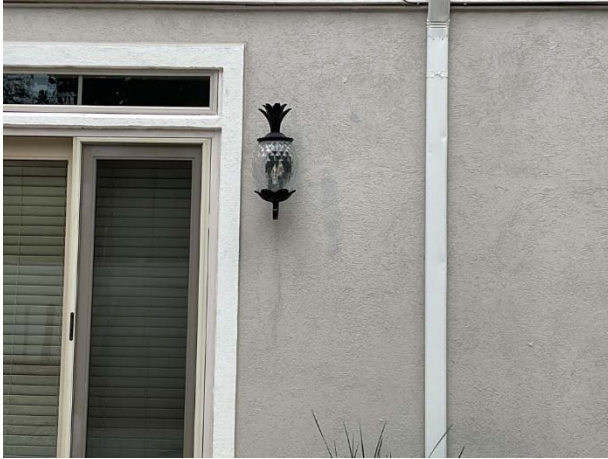
**Finish deterioration**

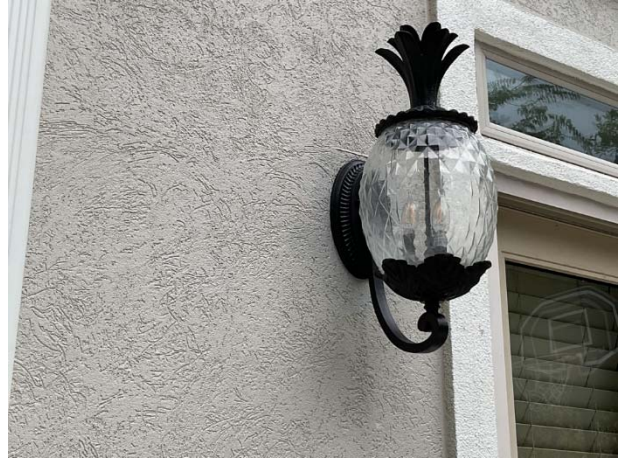
**Inconsistent finishes behind light fixture**

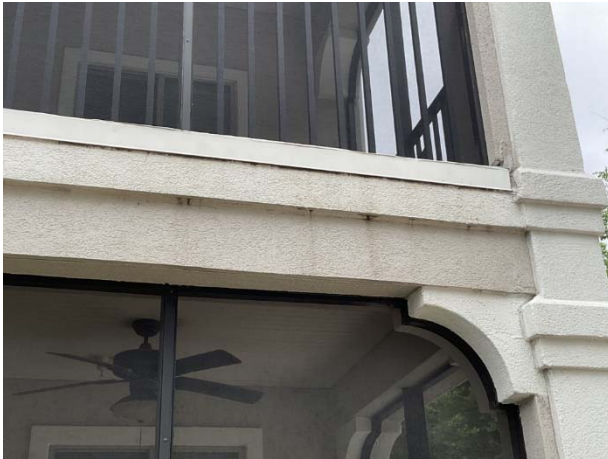
**Stains**

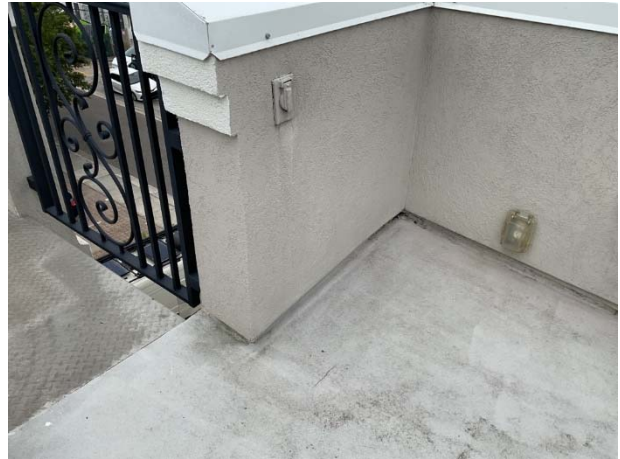
**Stucco terminates above terraces**

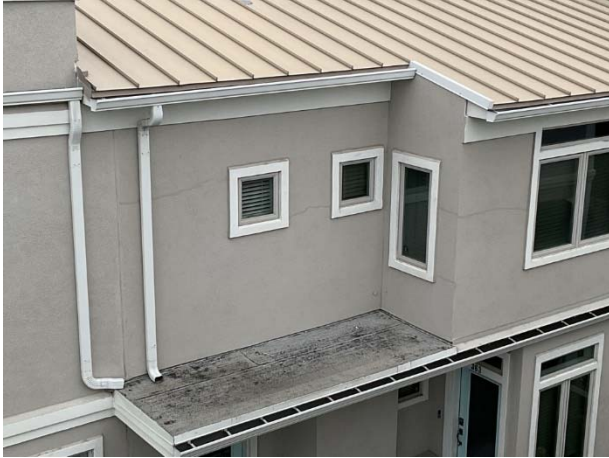
**Evidence of previous crack repair**

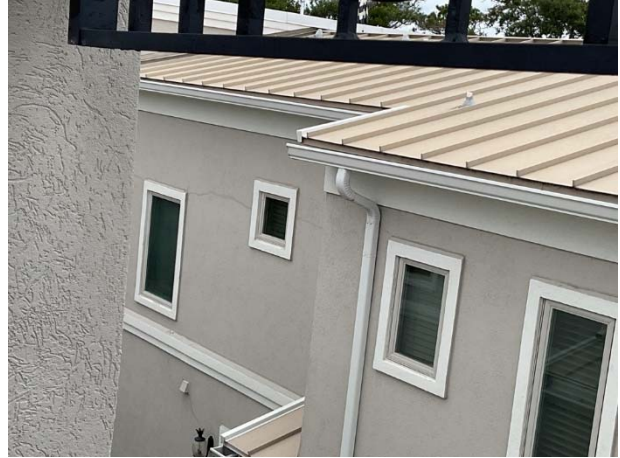
- Minor cracks are evident
- Isolated damaged stucco is evident

**Stucco cracks**

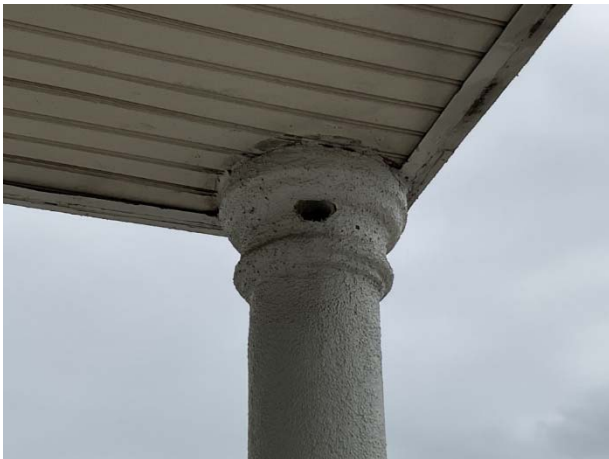
**Stucco damage**

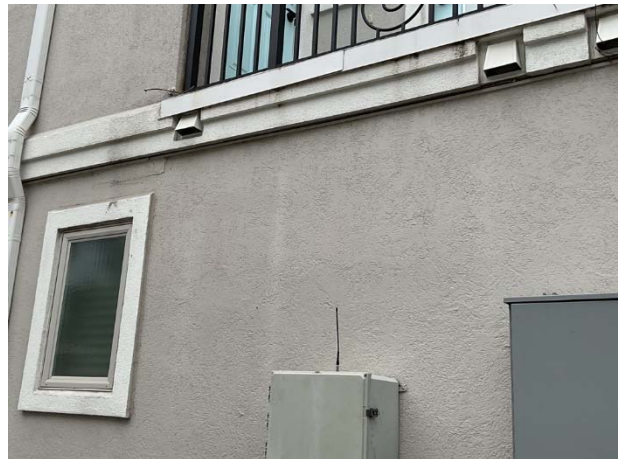
**Efflorescence**

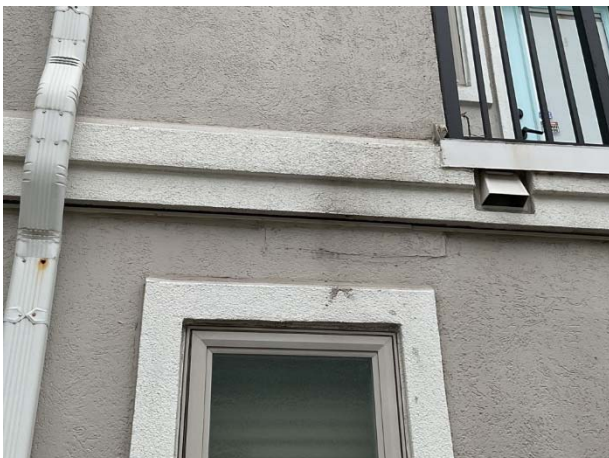
**Evidence of previous repair**

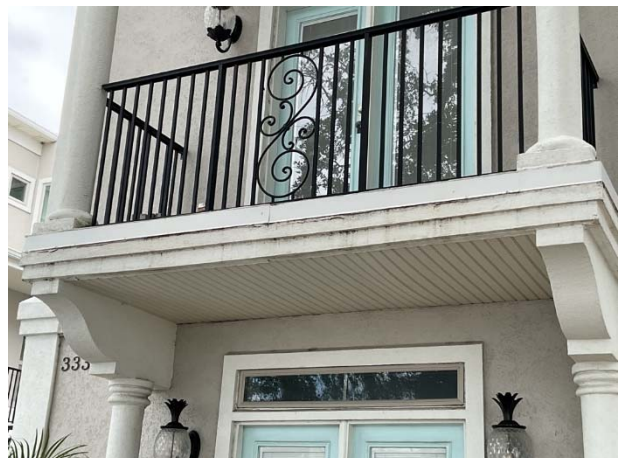
**Stucco damage at balcony edge**

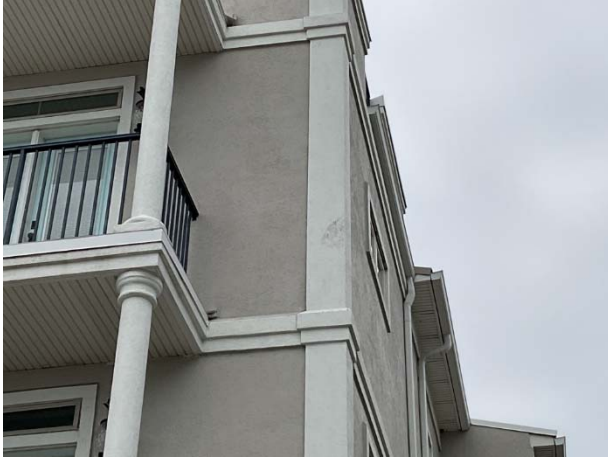
**Stucco damage**

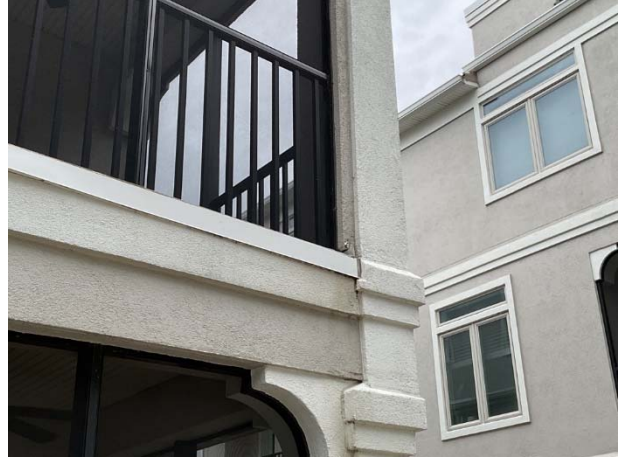
**Flashing and diverter at balcony**

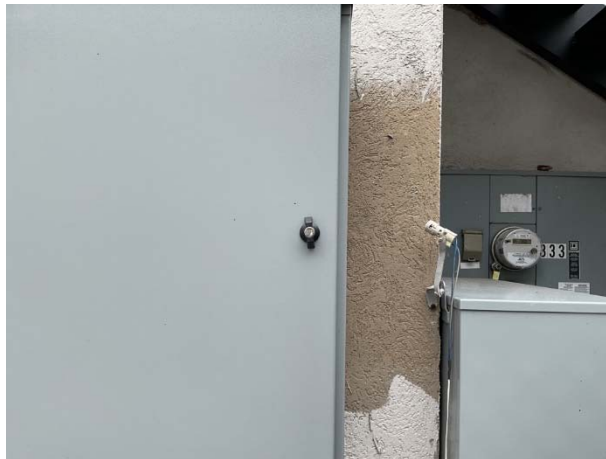
**Inconsistent finishes near life safety system control panel**

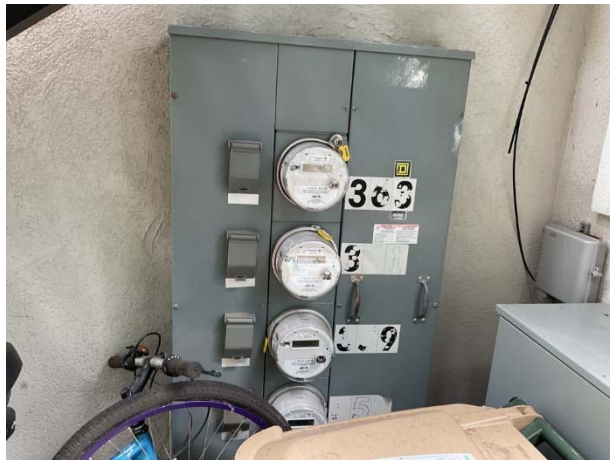
Electrical system main panels

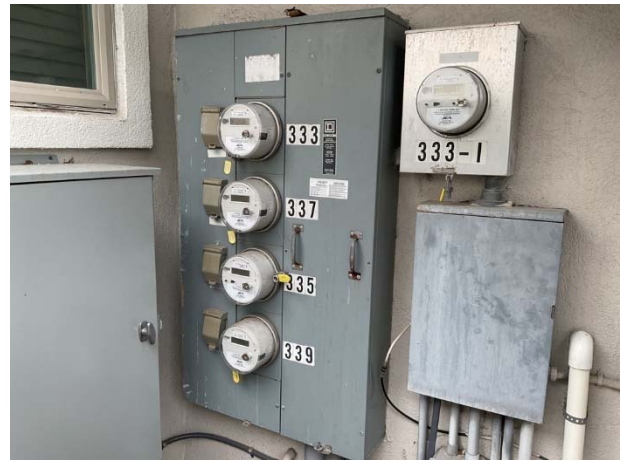
Electrical system main panels

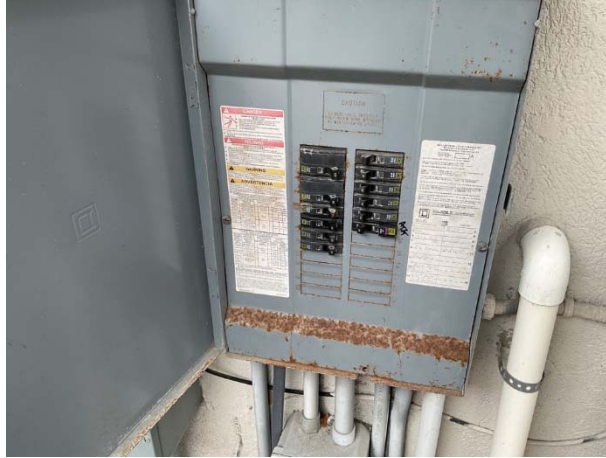
**Evidence of water infiltration at common circuit breaker panel**

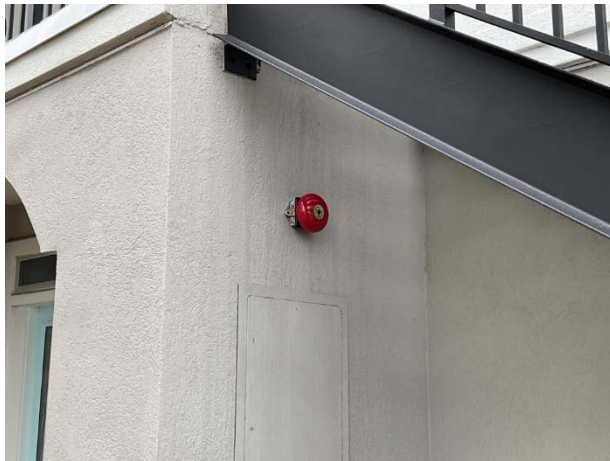
**Emergency device**

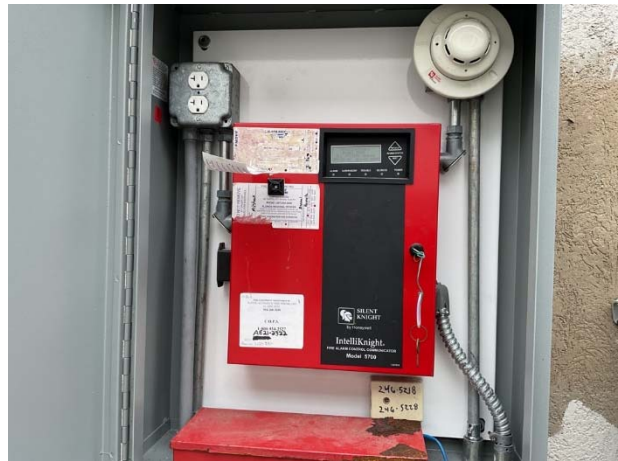
**Control panel**

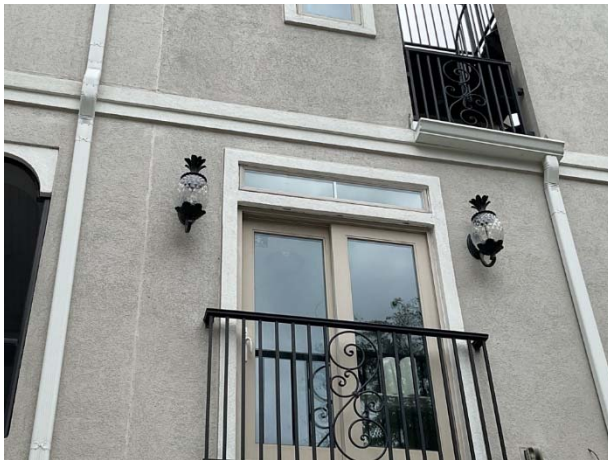
Wall mounted light fixtures

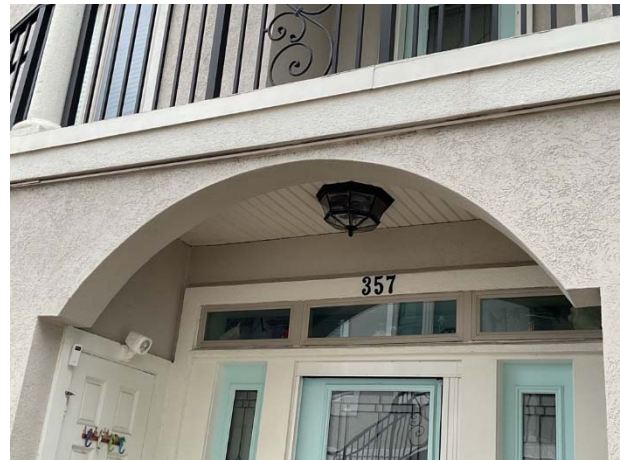
Ceiling mounted light fixture at unit entry

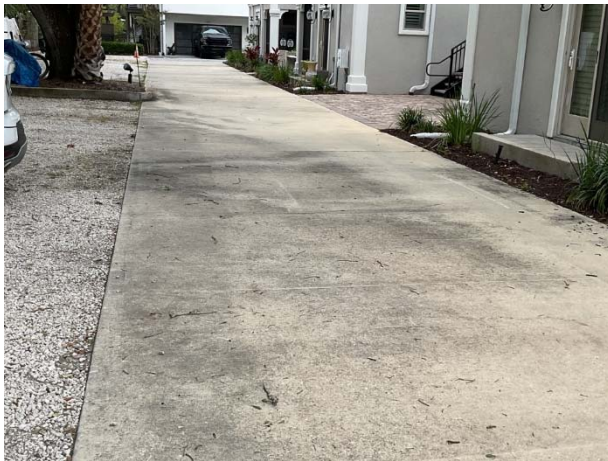
Concrete driveway

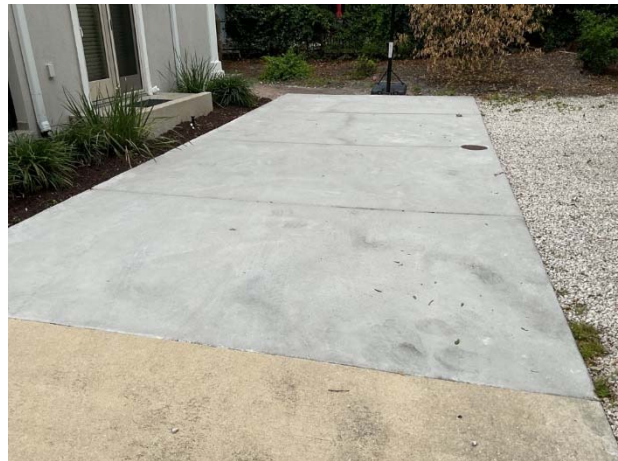
Recently replaced section

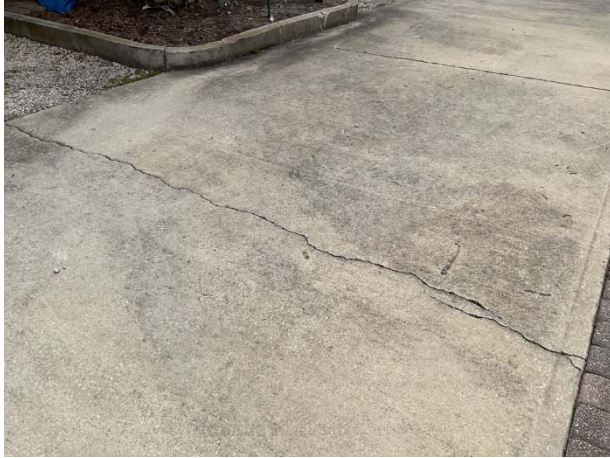
**Condition:** Good to fair overall. We note recent partial replacements, cracks and spalled concrete

**Driveway cracks**

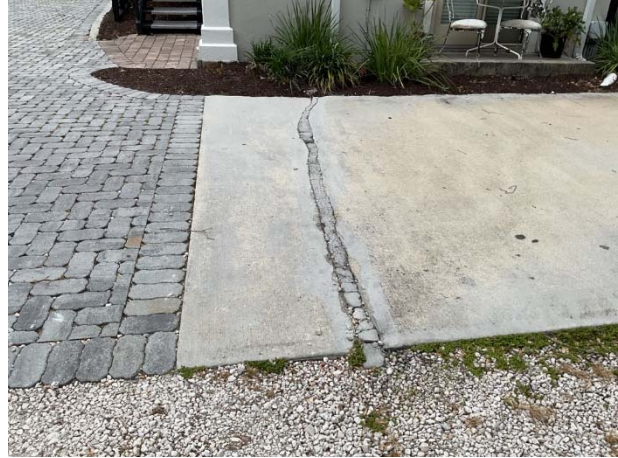
**Spalled concrete**

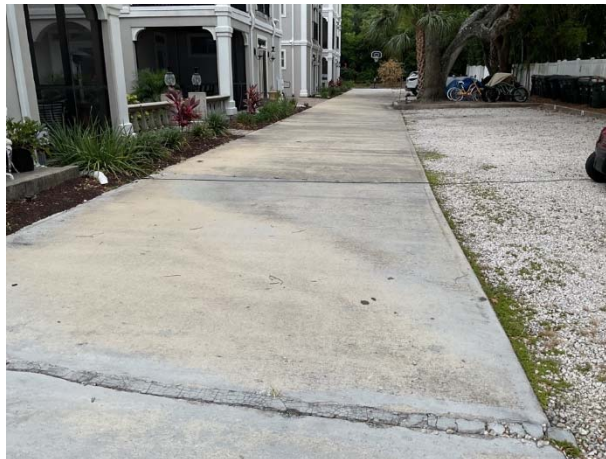
**Concrete driveway**

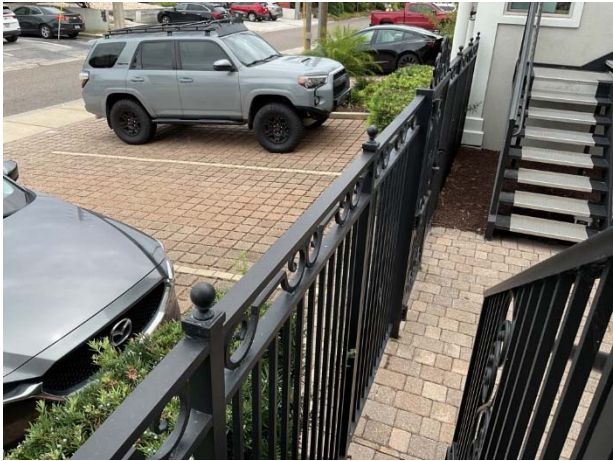
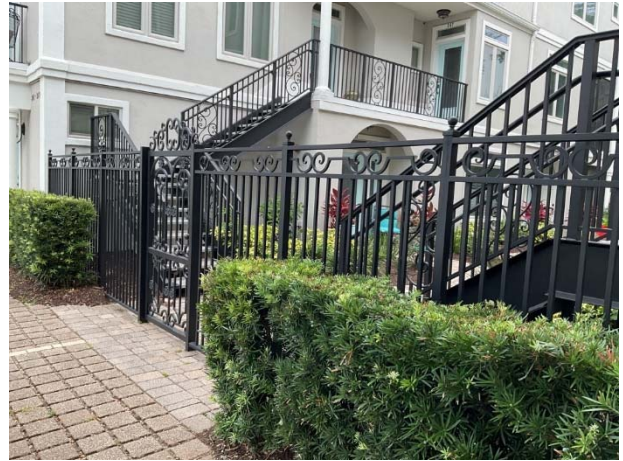
Aluminum fence at courtyard

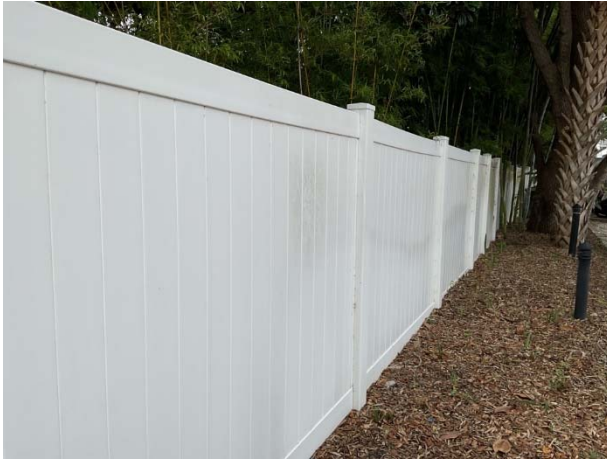
**Vinyl fence**

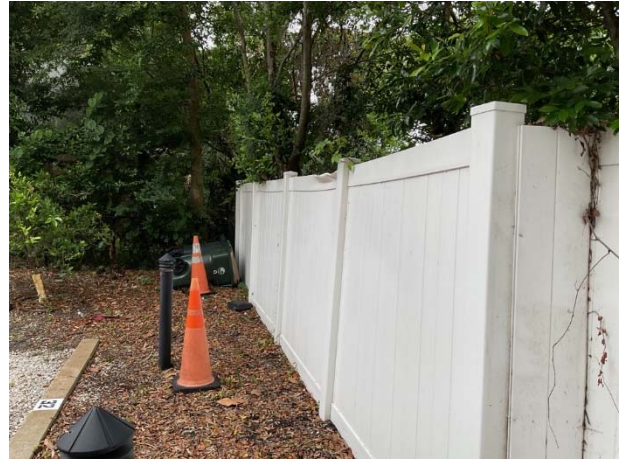
**Condition:** Fair overall with panel damage, mildew buildup and leaning sections evident

**Fence panel damage**

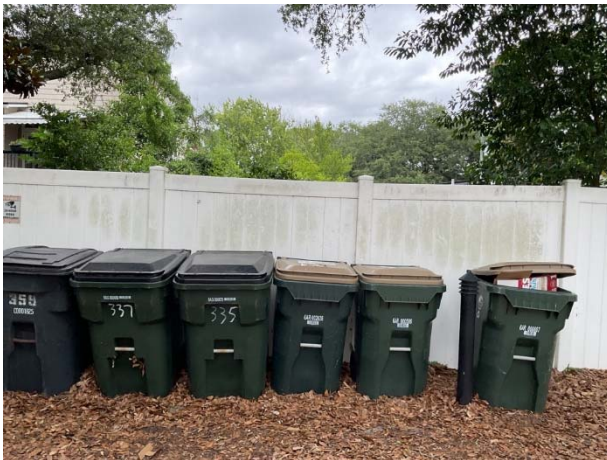
**Mildew buildup**

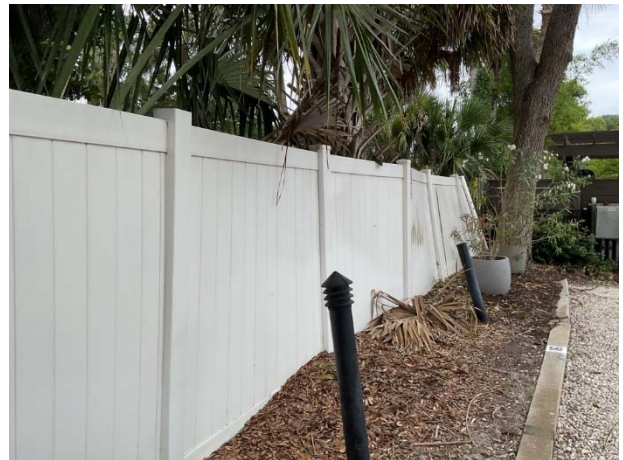
**Fence leaning section**

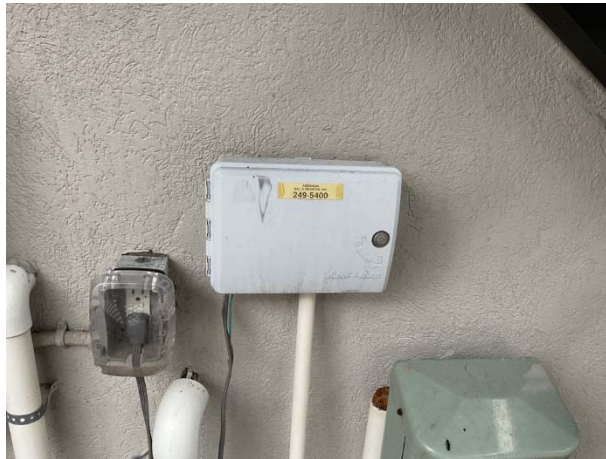
**Irrigation system controller**

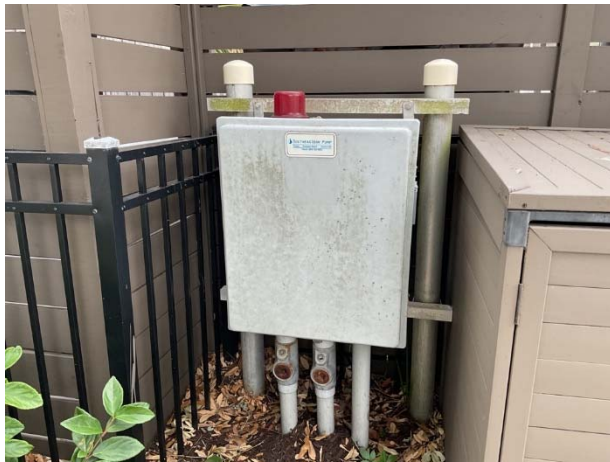
Lift station controls

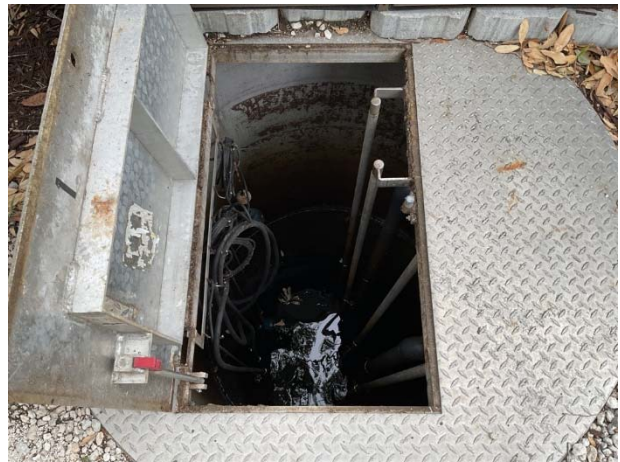
Lift station pit

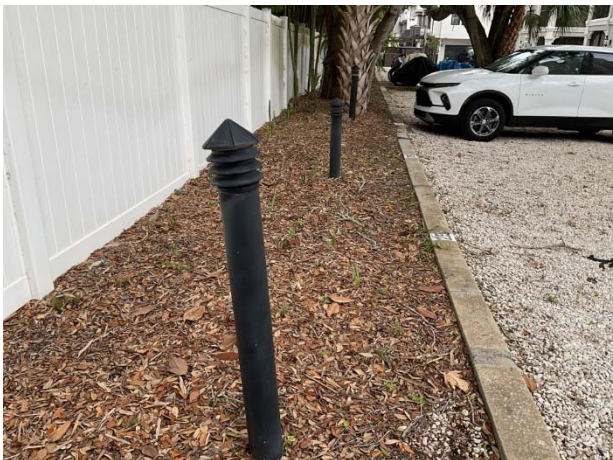
**Condition:** Fair overall. We note leaning and damaged fixtures

**Leaning bollard light fixture**

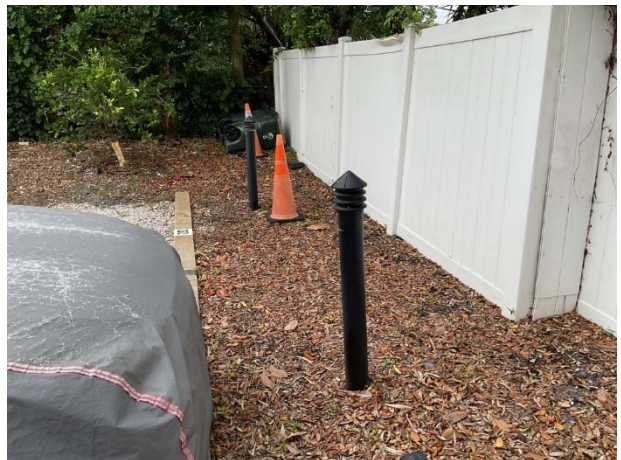
**Bollard light fixtures**

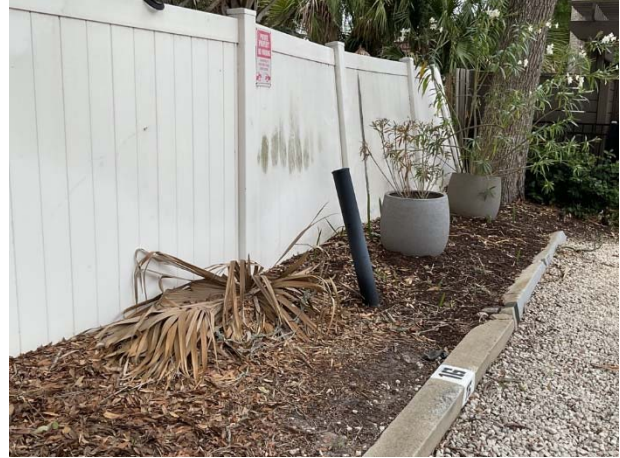
**Missing fixture**

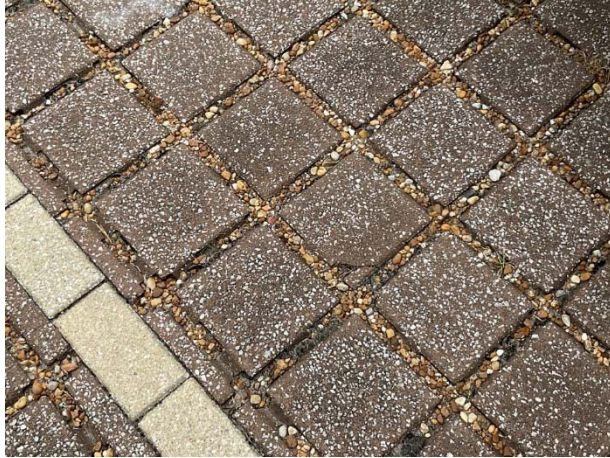
**Minor paver damage at parking area**

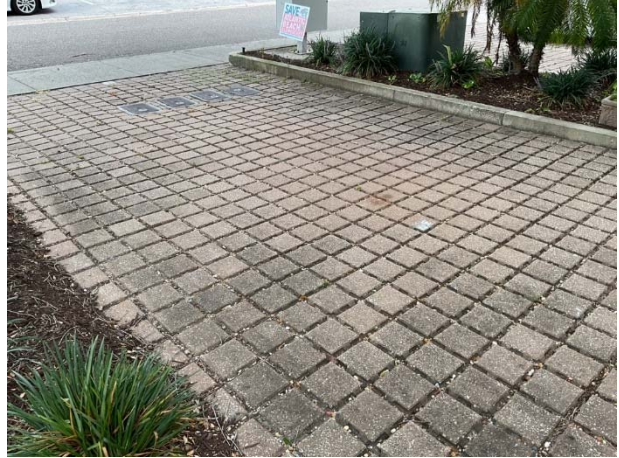
**Paver parking area**

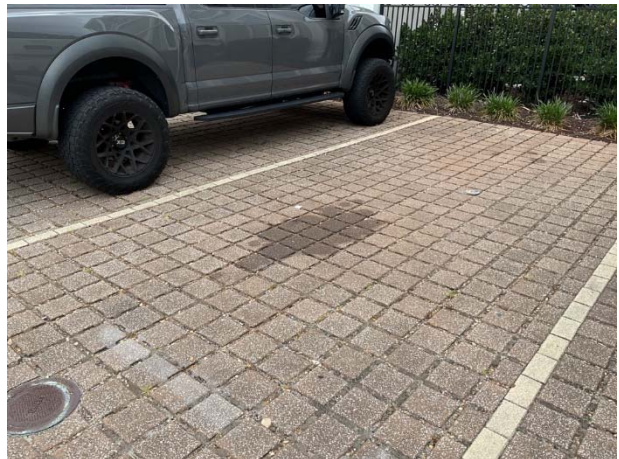
**Vehicle fluid stains at parking area**

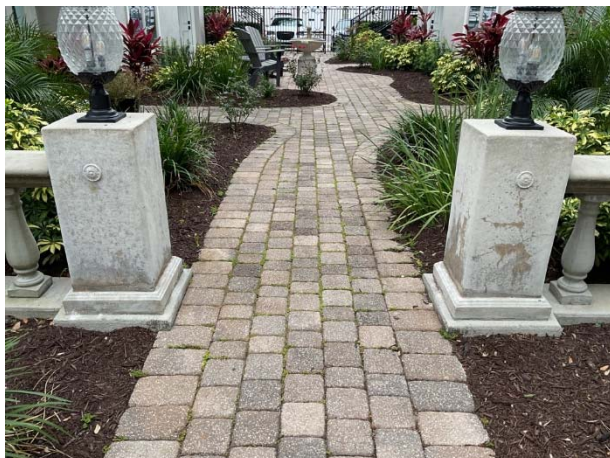
**Paver sidewalk at courtyard**
