CONSTRUCTION SOLUTIONS, INC
ENGINEERING • TESTING • PROJECT MANAGEMENT
www.constructionsolutions.cc

August 8, 2017

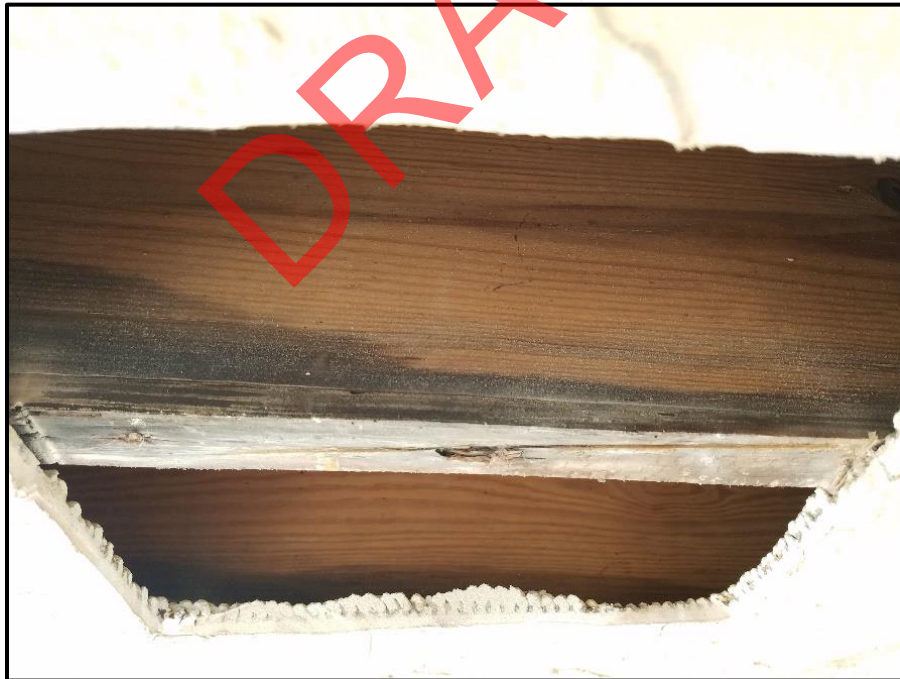
Photograph 2: Unit #203, Bottom edge of floor joist stained and rotting due to water intrusion.

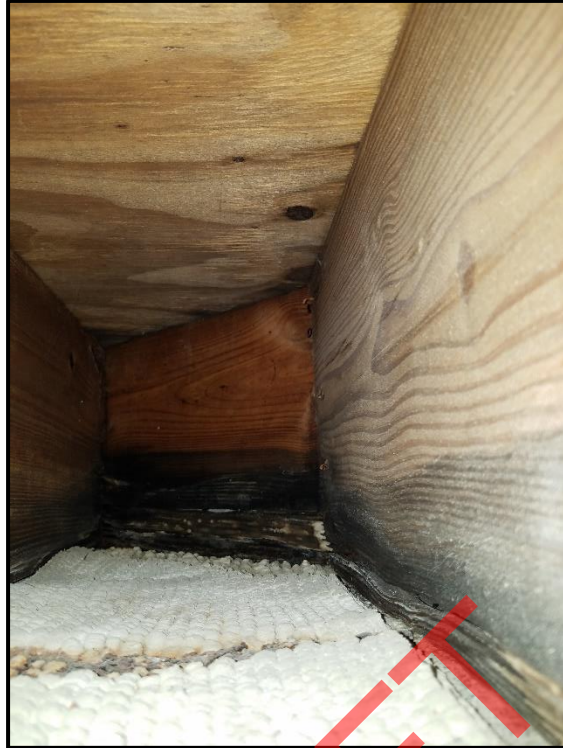
Photograph 3: Unit #203, Bottom edge of floor joists stained and rotting due to water intrusion.

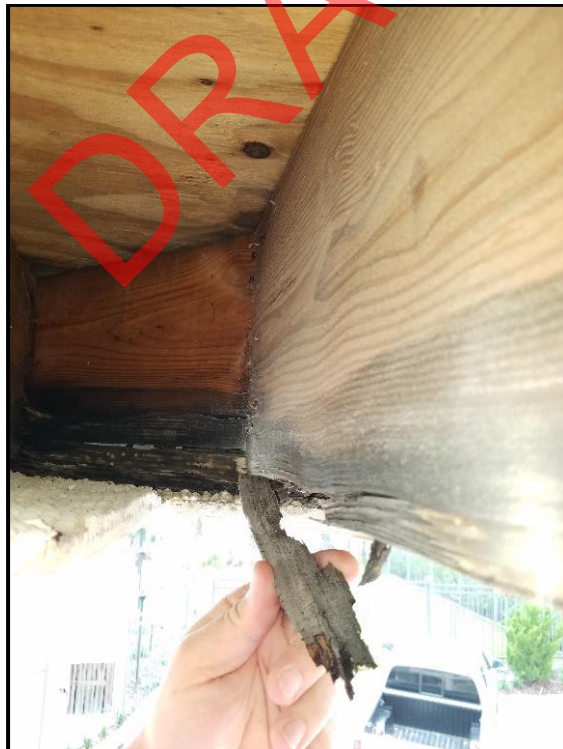
Photograph 4: Unit #203, Bottom edge of floor joist severely rotted.

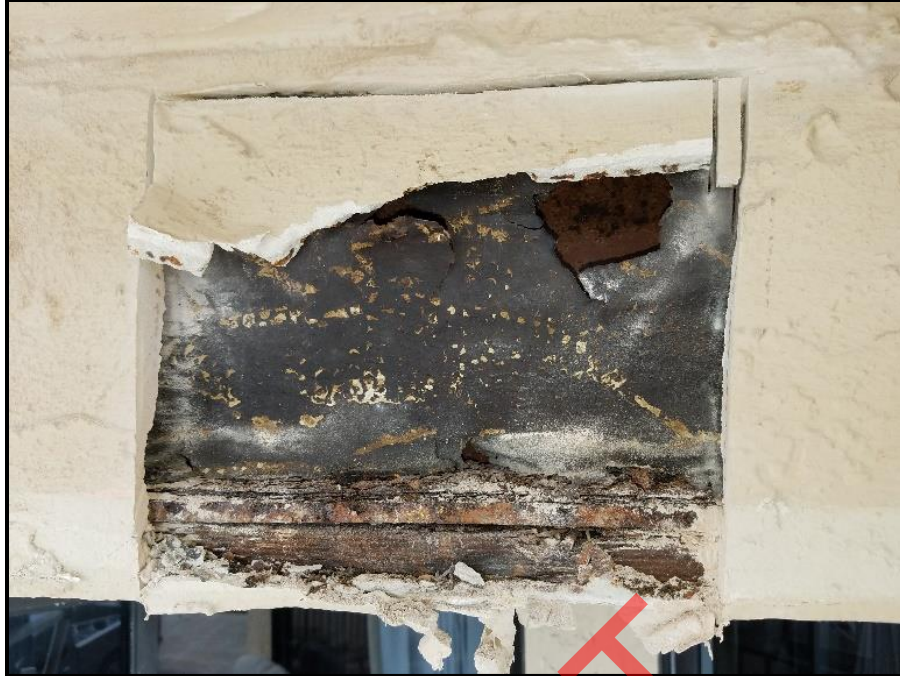
Photograph 5: Unit #203, Observation hole cut in stucco at structural I-beam. Felt paper stained due to water intrusion.

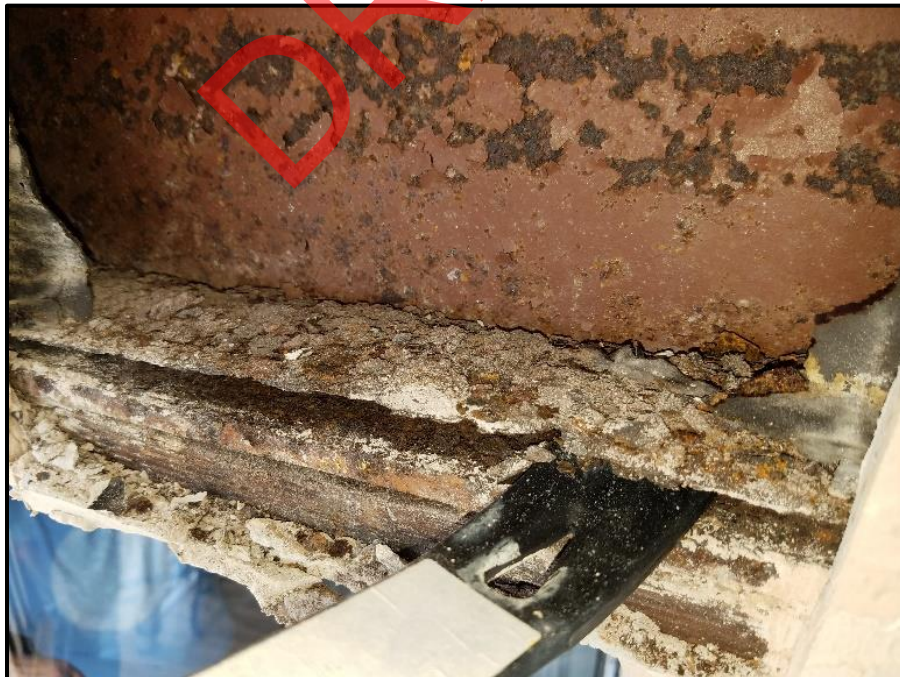
Photograph 6: Unit #203, I-beam delaminating in layers due to long term water intrusion.

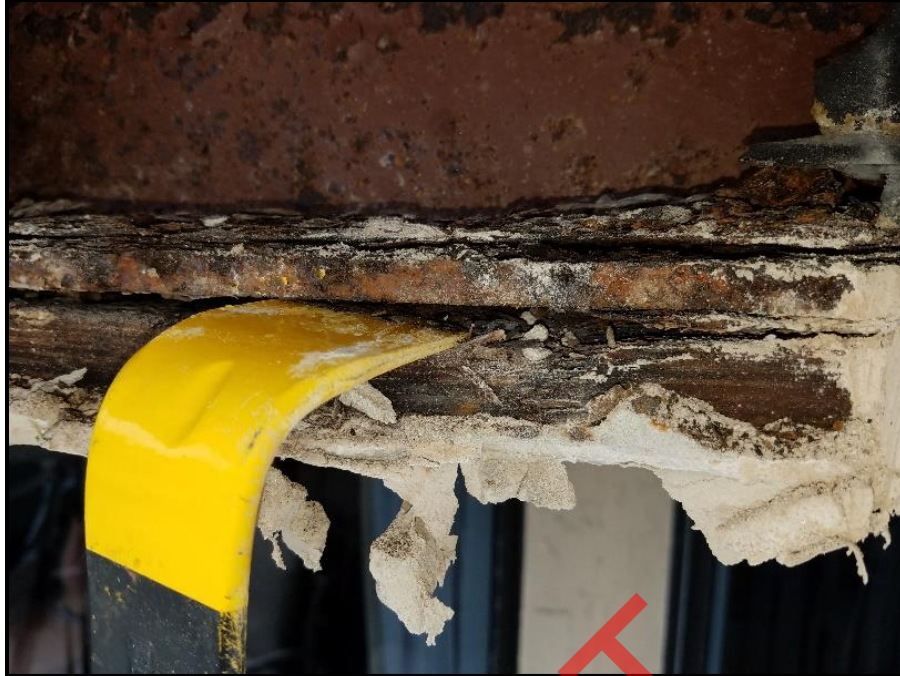
Photograph 7: Unit #203, Wooden buck at I-beam saturated with water and decayed.

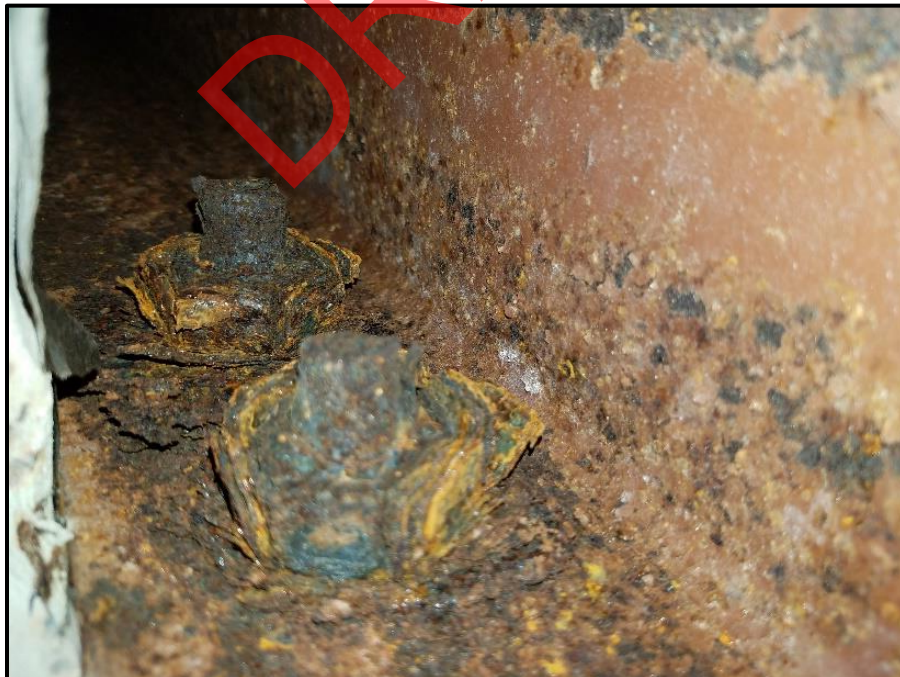
Photograph 8: Unit #203, I-beam fasteners severely corroded due to long term water intrusion.

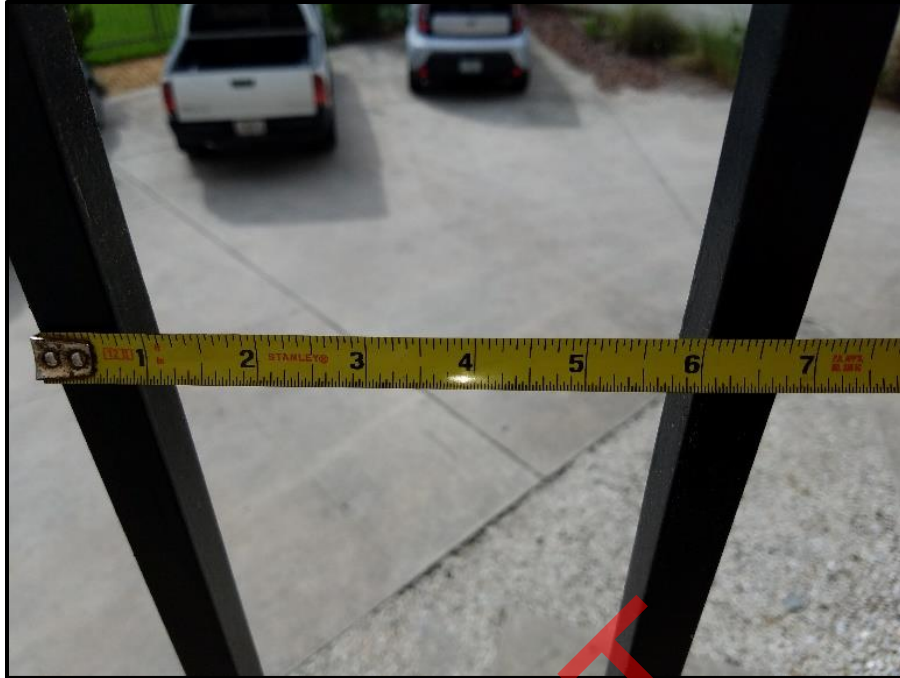
Photograph 9: Unit #203, Guardrail picket spacing exceeds code requirement of less than 4 inches.

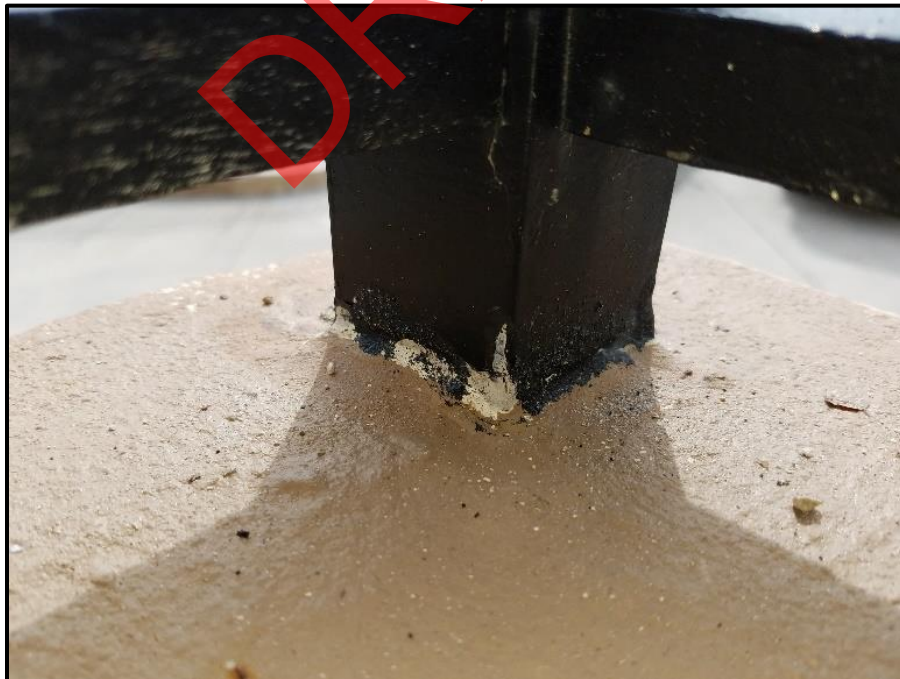
Photograph 10: Unit #203, Guardrail post corrosion (aluminum oxide).

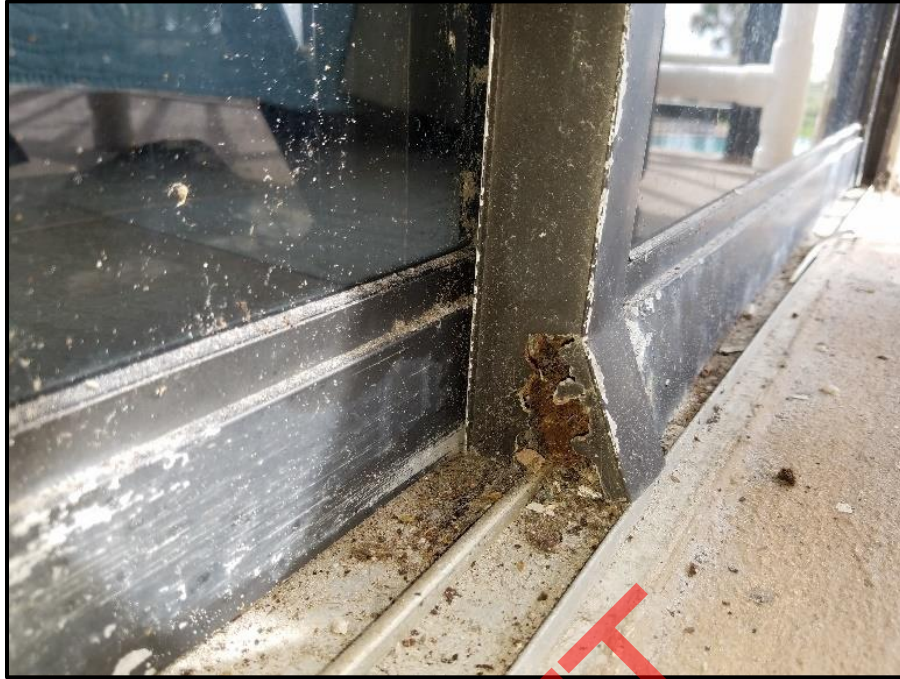
Photograph 11: Unit #203, Sliding glass doors heavily corroded due to long term salt exposure.

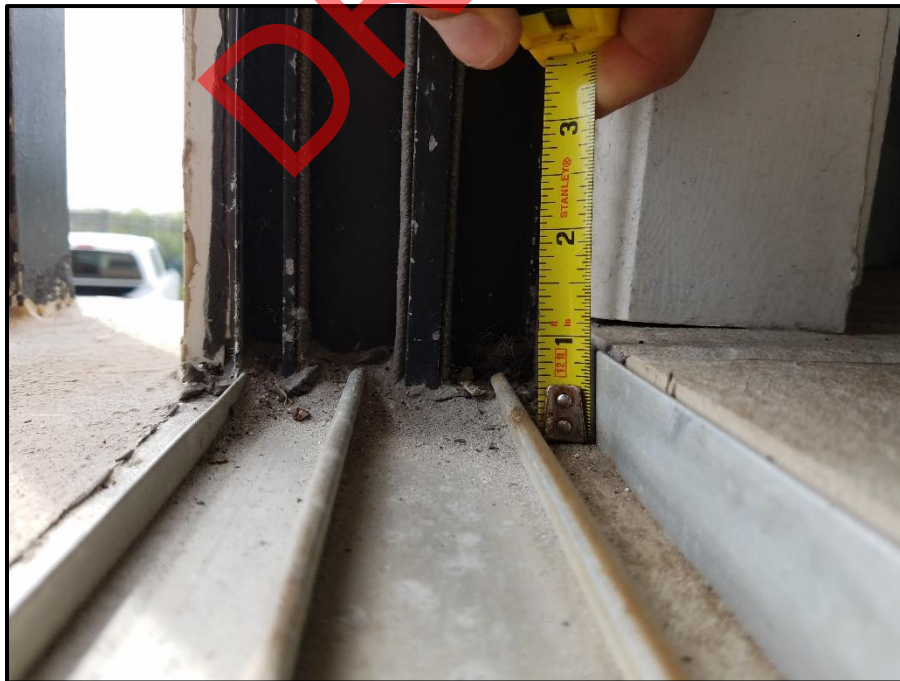
Photograph 12: Unit #203, Rear dam at sliding glass door threshold does not meet code requirement for water infiltration.

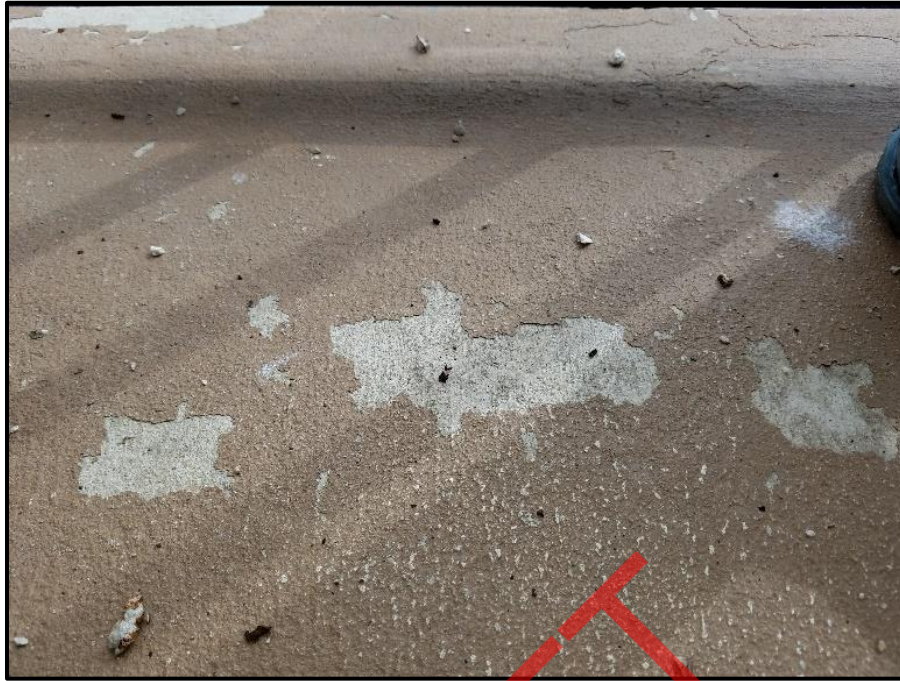
Photograph 13: Unit #203, Acrylic coating on balcony topping slab failing.

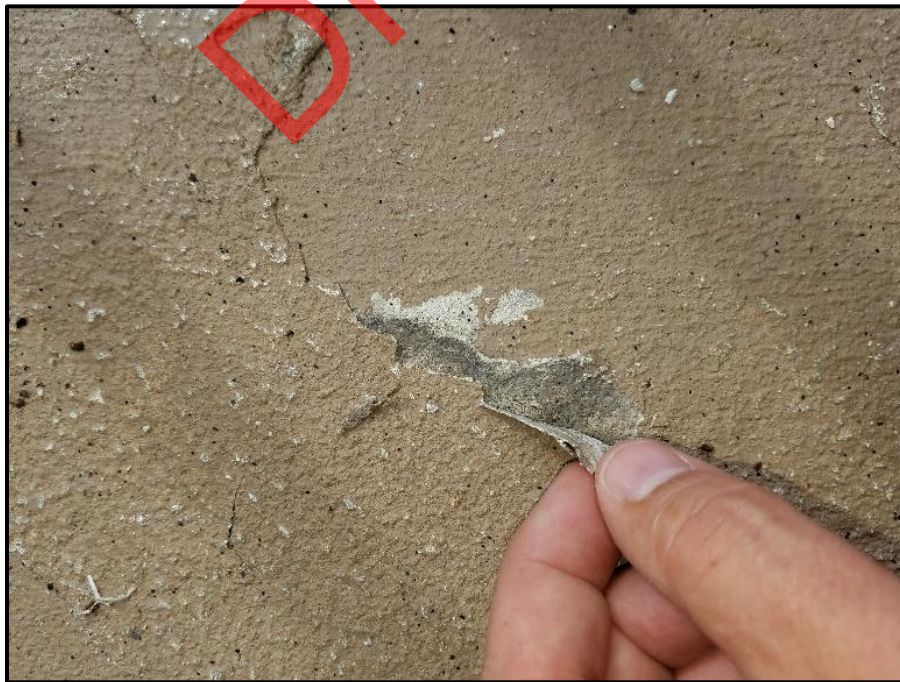
Photograph 14: Unit #203, Water intrusion under acrylic coating.

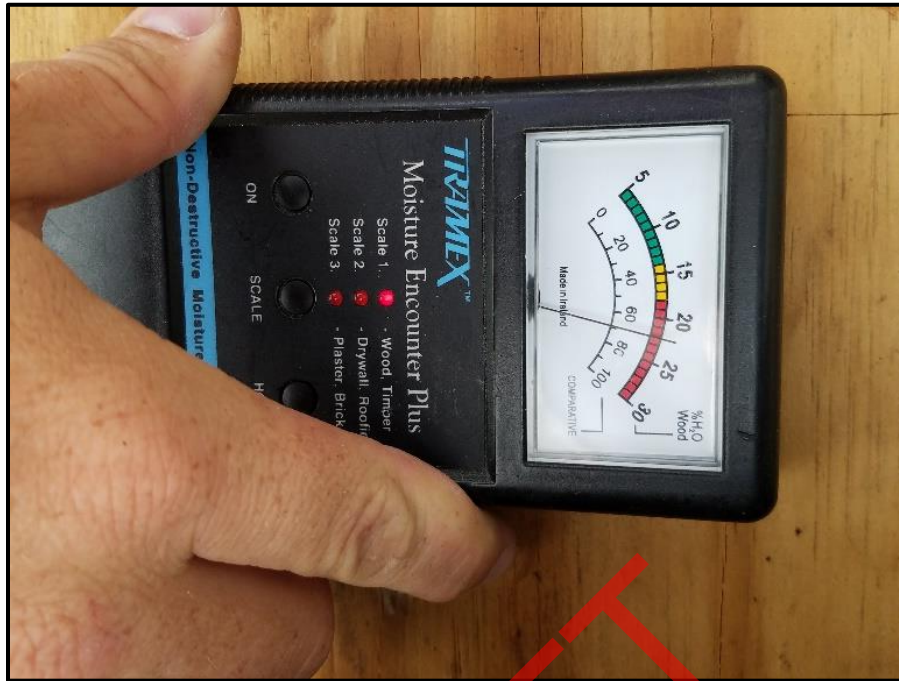
Photograph 17: Unit #204, Readings taken indicate high level of moisture contained in plywood sheathing.

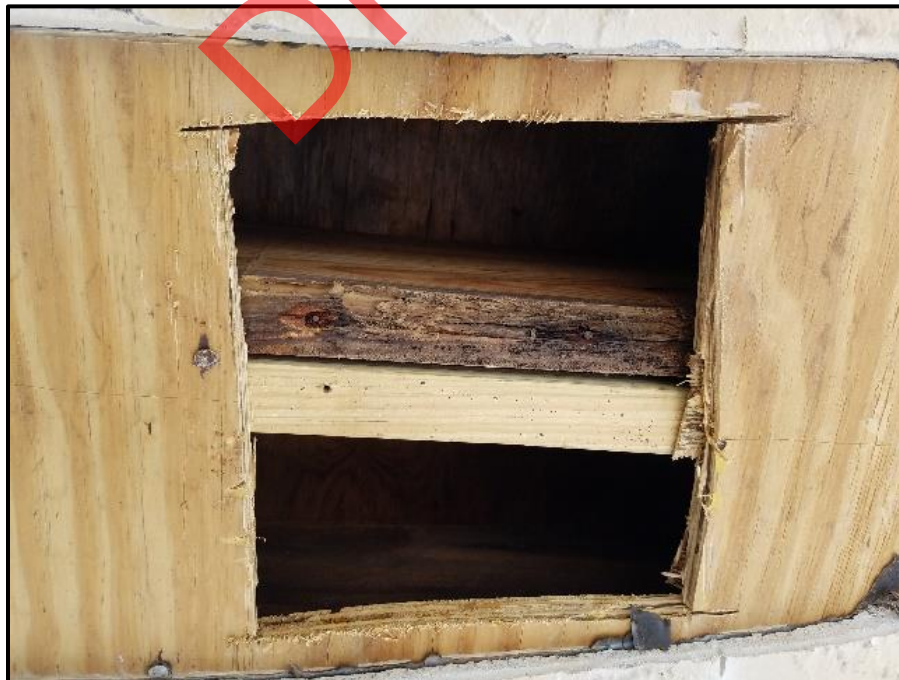
Photograph 18: Unit #204, New joist attached to old joist indicating previous repair attempt.

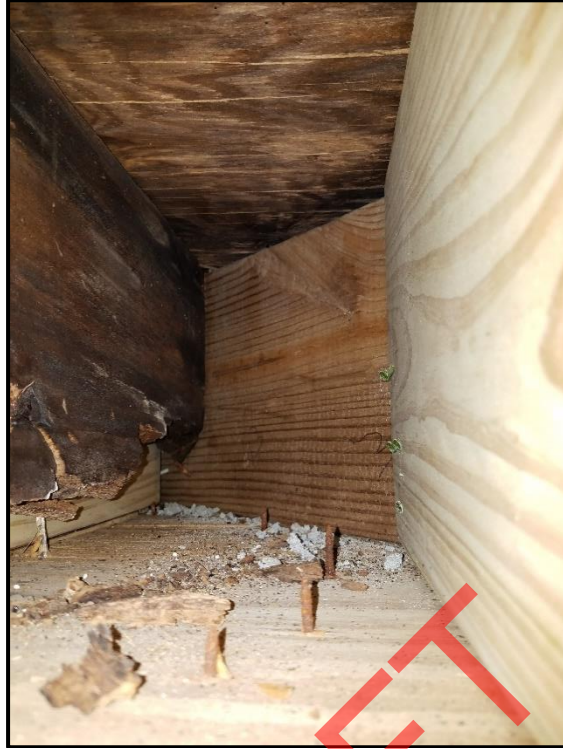
Photograph 19: Unit #204, Interior view of ceiling cavity. Decayed decking.

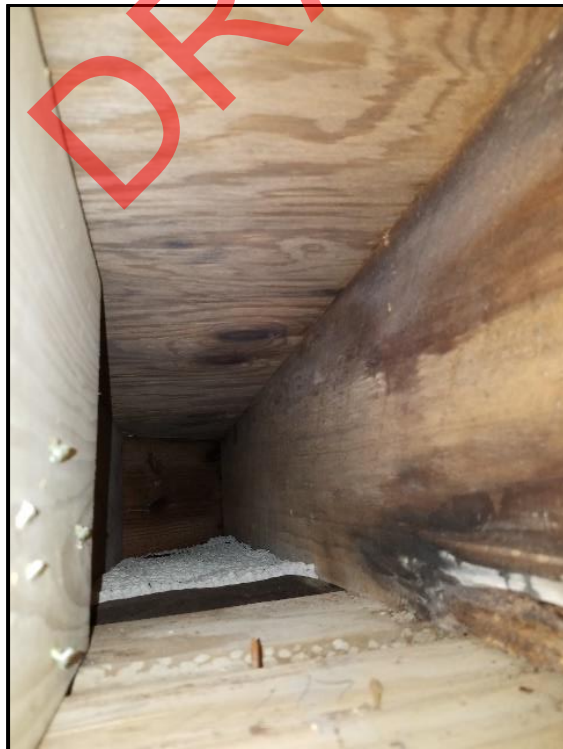
Photograph 20: Unit #204, Interior view of ceiling cavity. Water intrusion. Damaged and/or decayed wood framing.

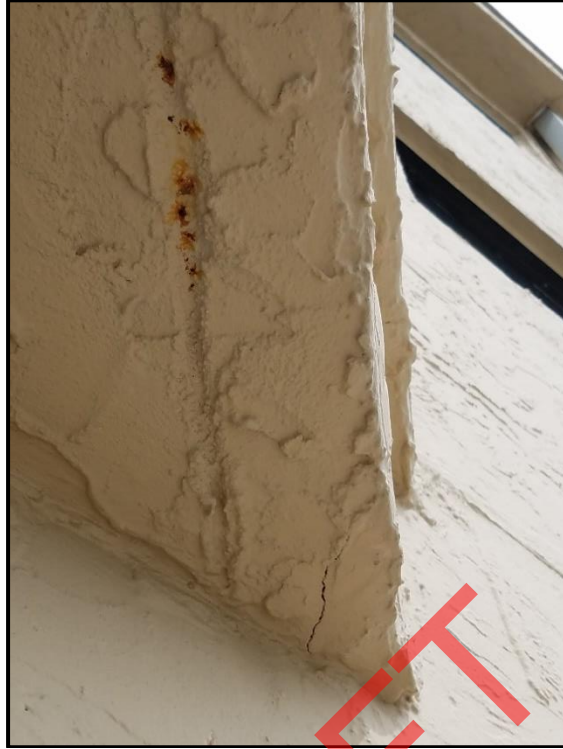
Photograph 21: Unit # 204, Rust stains at balcony edge indicating water intrusion.

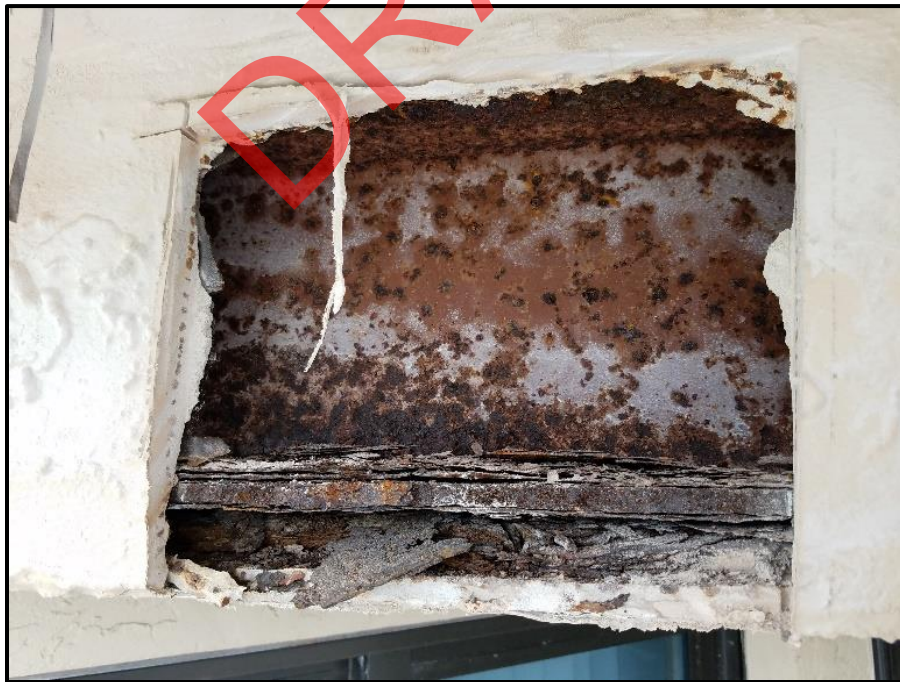
Photograph 22: Unit #204, Observation hole cut in stucco at structural I-beam.

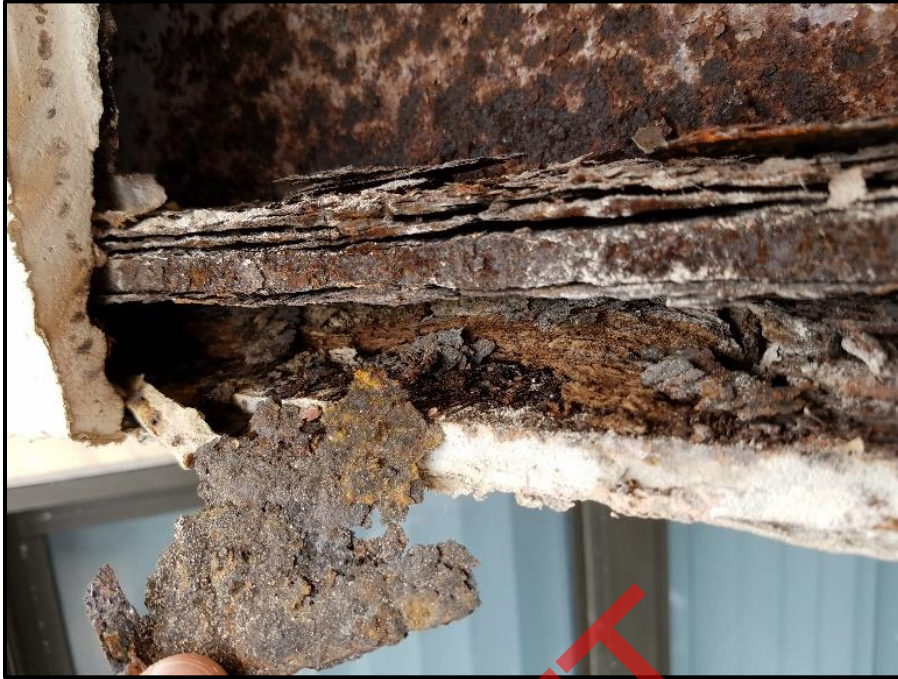
Photograph 23: Unit #204, I-beam and wooden buck heavily deteriorated due to long term water intrusion.

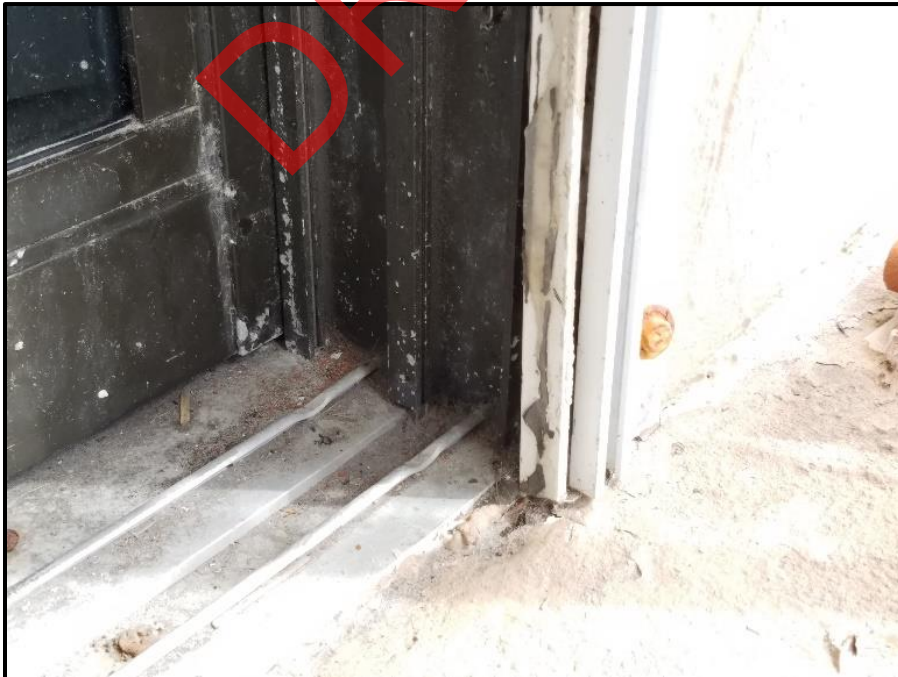
Photograph 24: Unit #204, No sealant at sliding glass door to stucco.

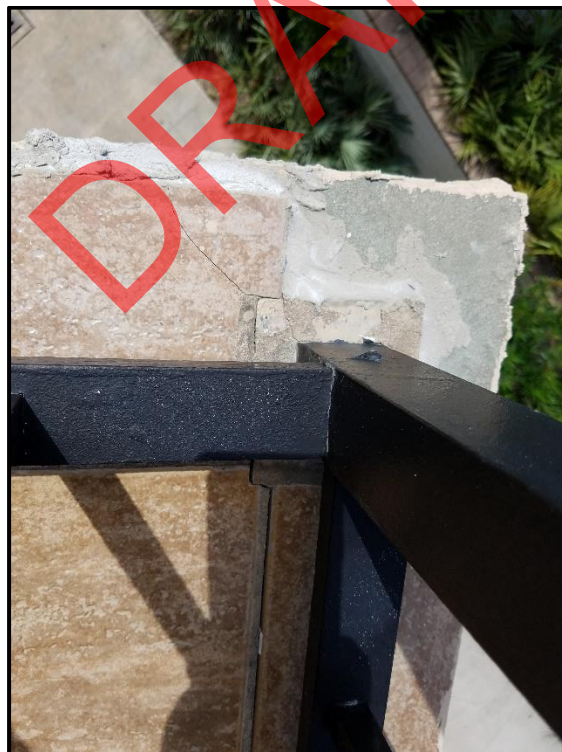
Photograph 28: Unit #402, Leading edge of balcony cracked and beginning to spall.

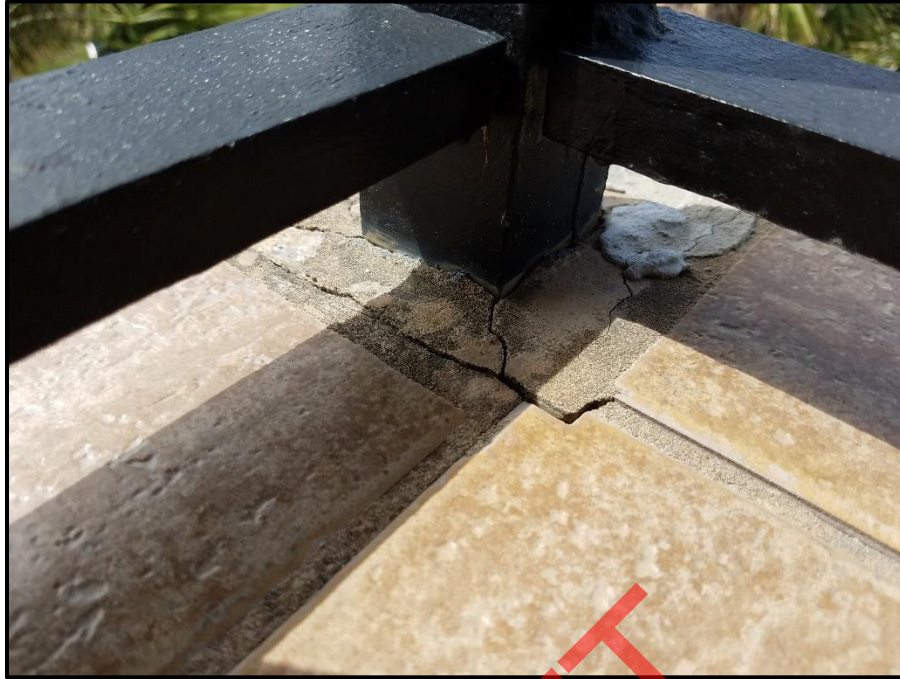
Photograph 29: Unit #402, Grout at guardrail post delaminating due to expansion, contraction and water intrusion.

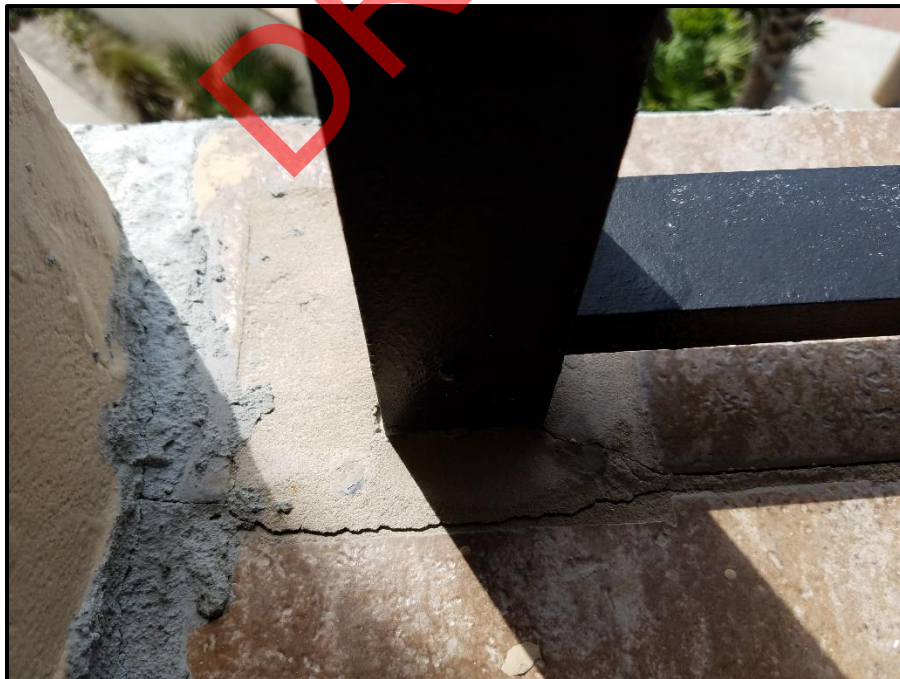
Photograph 30: Unit #402, Grout at guardrail post cracked, allowing water intrusion.

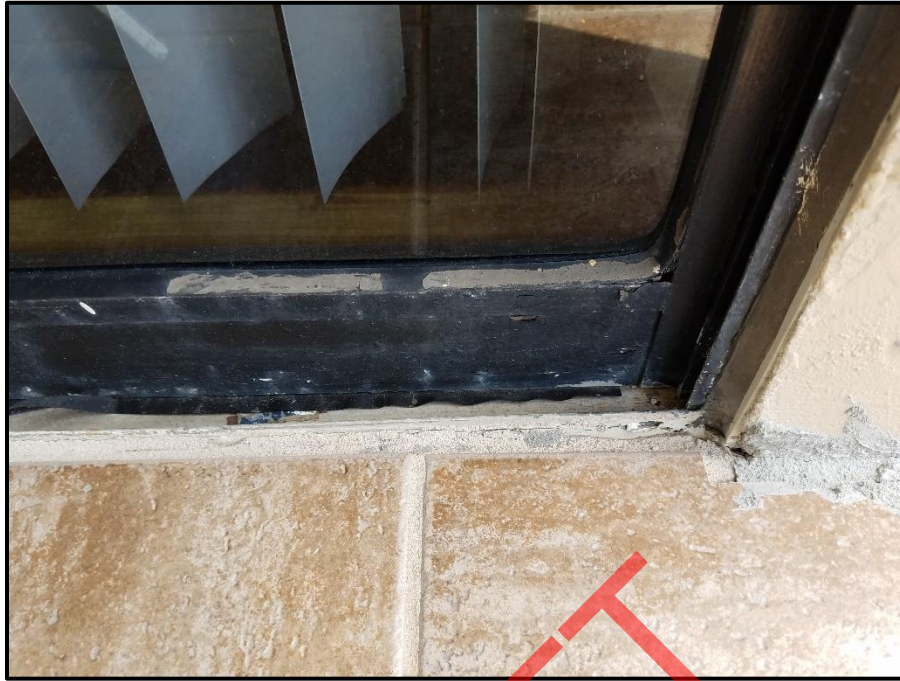
Photograph 31: Unit #402, Void in sealant at bottom right of sliding glass door noted as potential source of water intrusion.

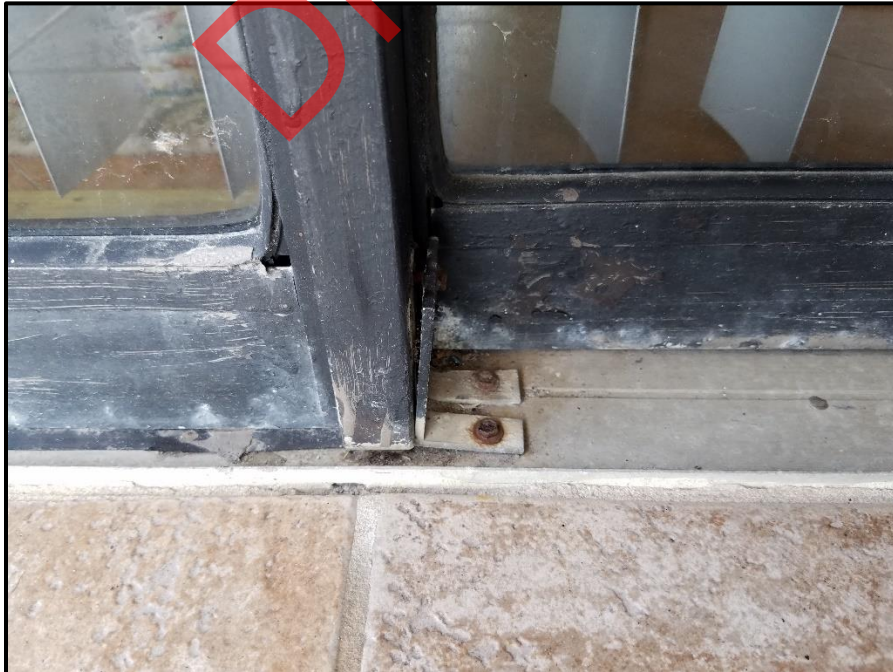
Photograph 32: Unit #402, Corroded fasteners observed at sliding glass door threshold.

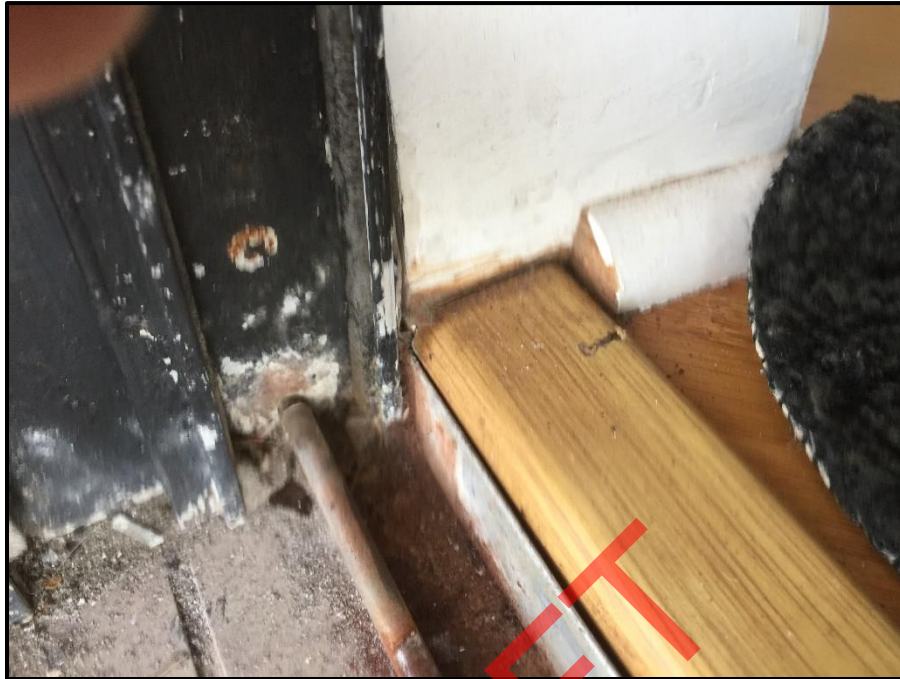
Photograph 33: Unit #402, Evidence of water intrusion noted at rear dam of sliding glass door.

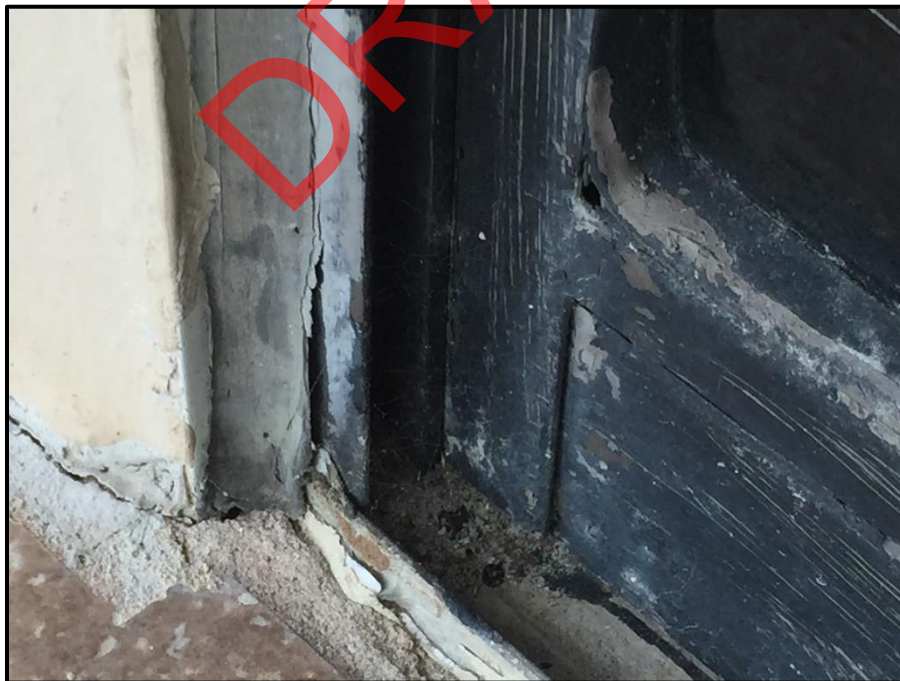
Photograph 34: Unit #402, Sealant failure at sliding glass door and unit wall.

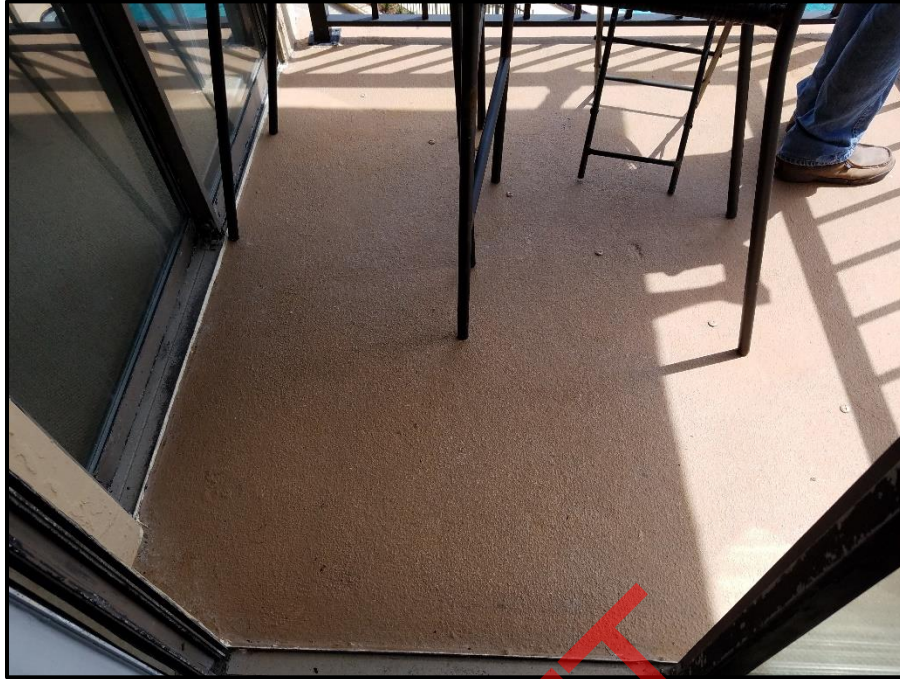
Photograph 35: Unit #403, Perspective view of balcony.

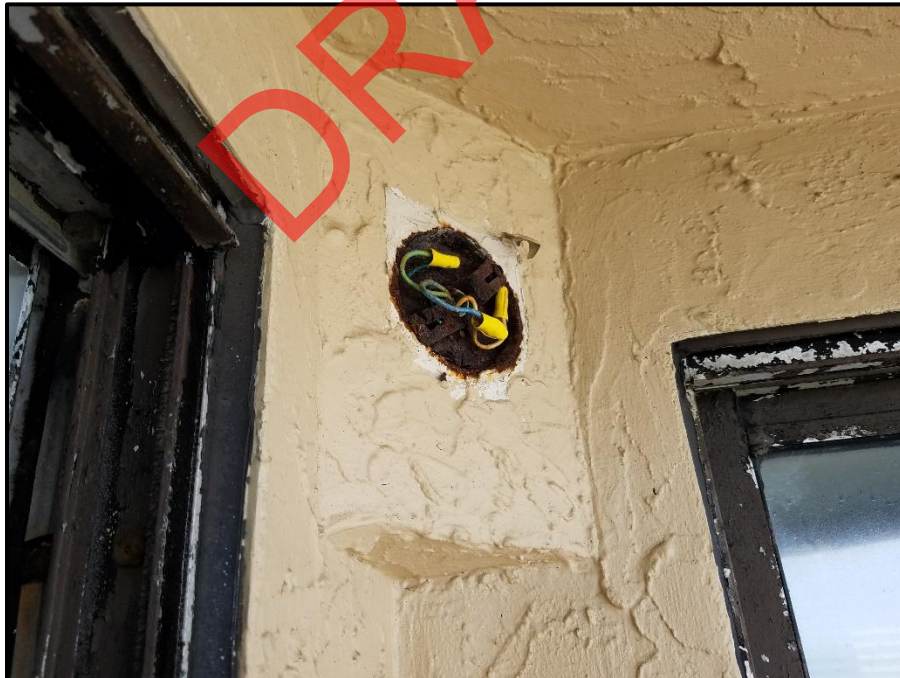
Photograph 36: Unit #403, Balcony light missing, leaving junction box exposed to potential water intrusion.

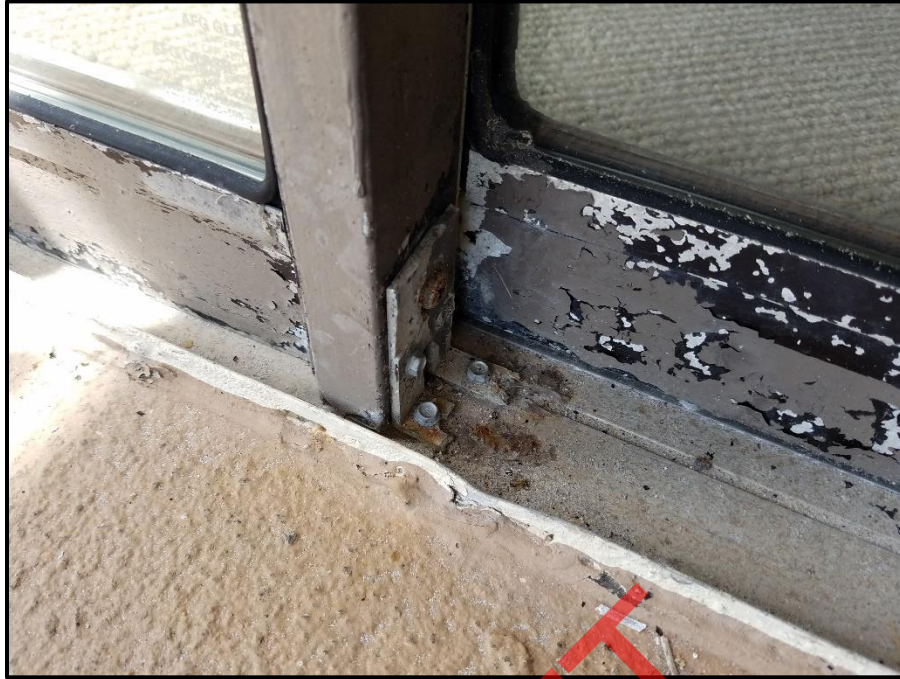
Photograph 37: Unit #403, Sliding glass doors heavily corroded.

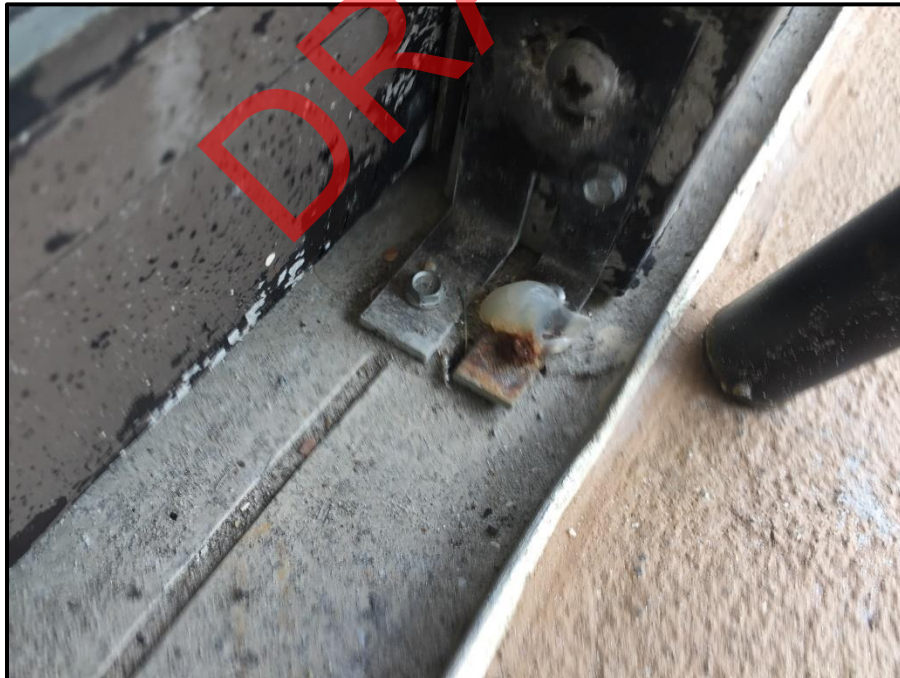
Photograph 38: Unit #403, Sliding glass door fasteners heavily corroded and a potential source of water intrusion.

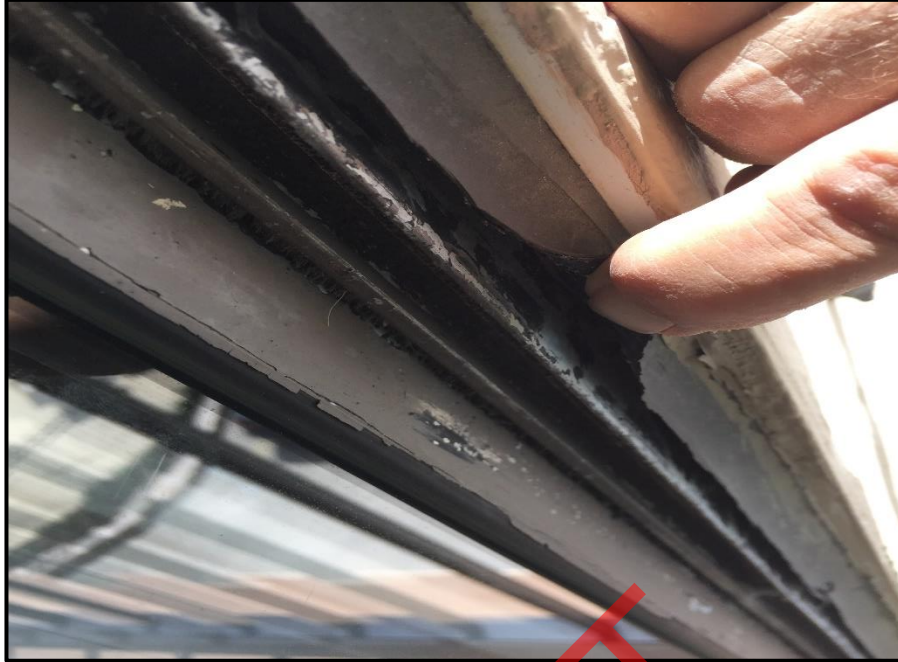
Photograph 39: Unit #403, Sliding glass door sealant failure.

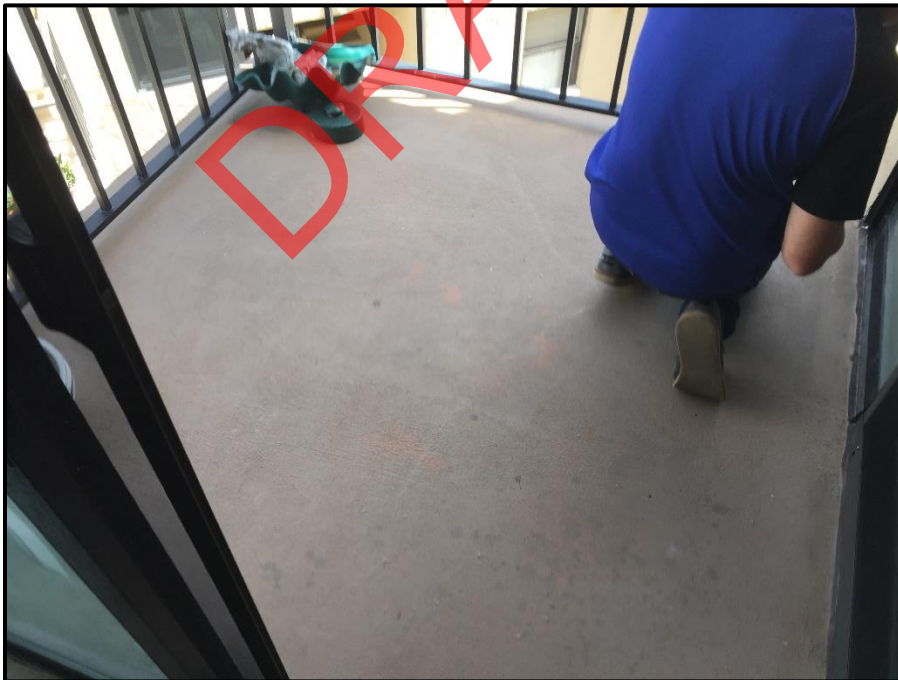
Photograph 40: Unit #401, Perspective view of balcony.

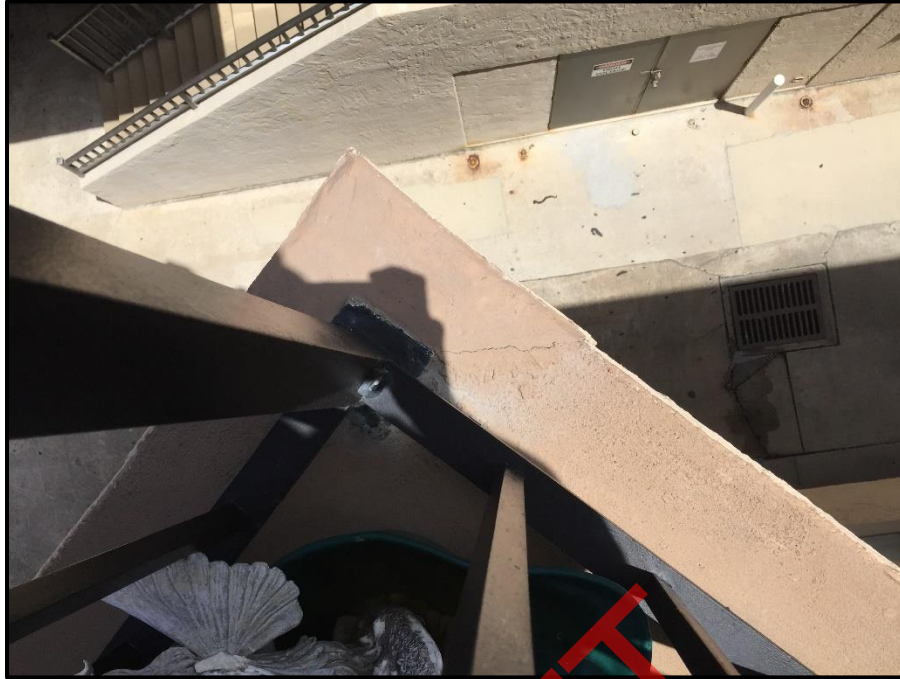
Photograph 41: Unit #401, Leading edge of balcony cracked and spalling.

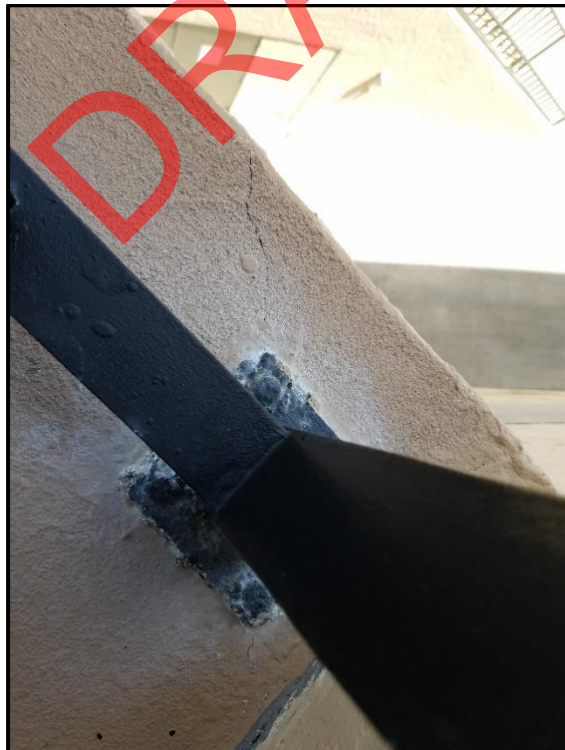
Photograph 42: Unit #401, Leading edge of balcony cracked and spalling at unit wall.

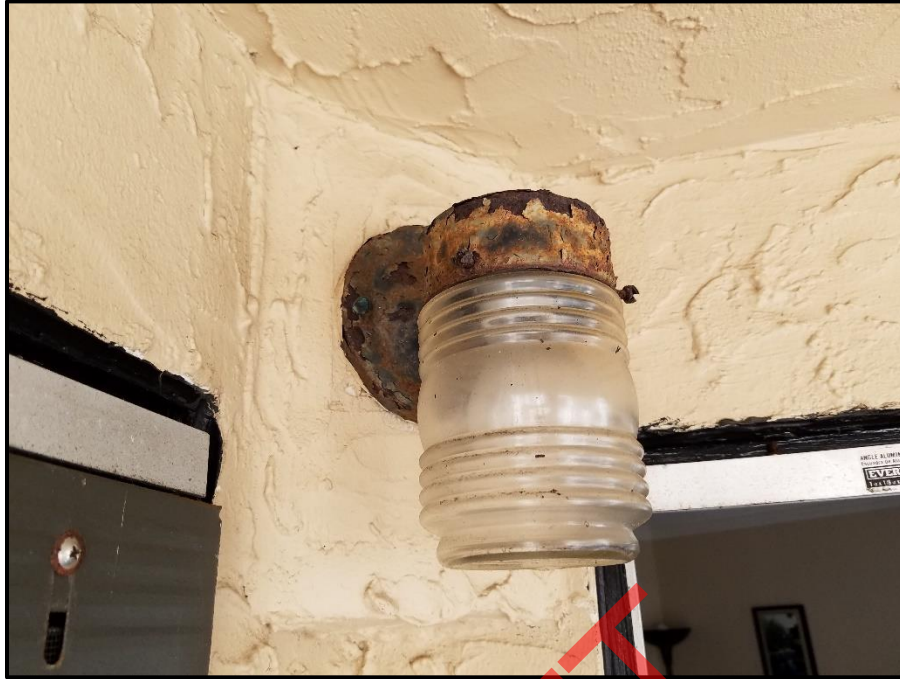
Photograph 43: Unit #401, Balcony light heavily corroded and is not sealed to the wall.

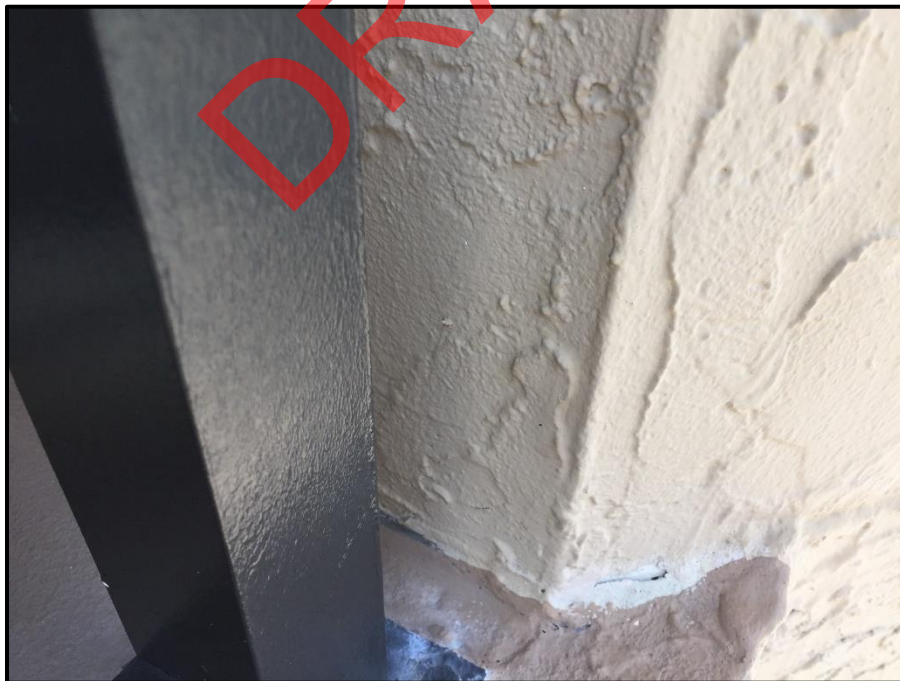
Photograph 44: Unit #401, Sealant failure at unit wall.
