CONSTRUCTION SOLUTIONS, INC
ENGINEERING • TESTING • PROJECT MANAGEMENT
www.constructionsolutions.cc

August 8, 2017

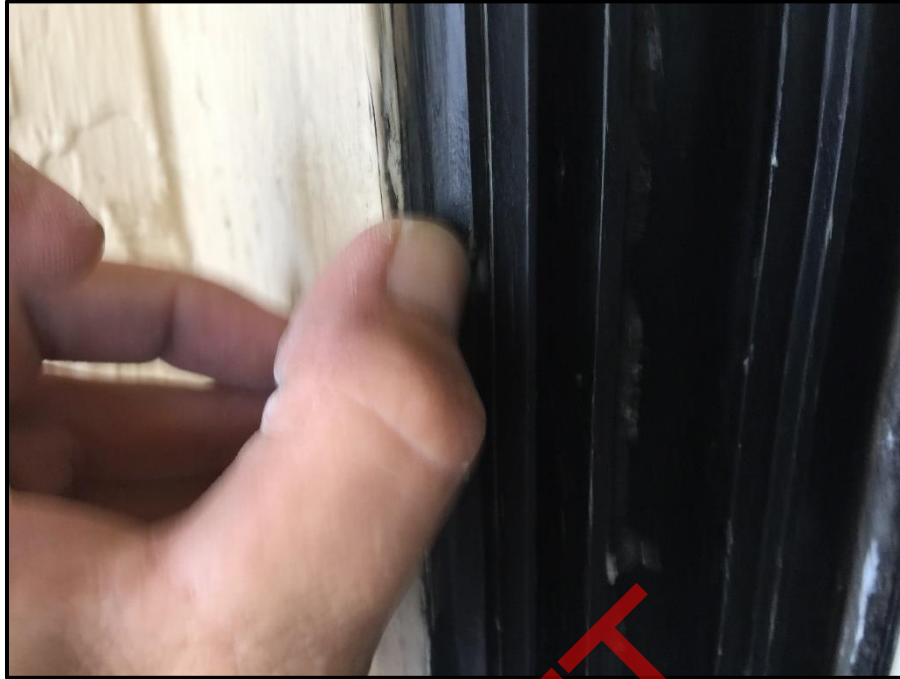
Photograph 45: Unit #401, Failed sealant at sliding glass door.

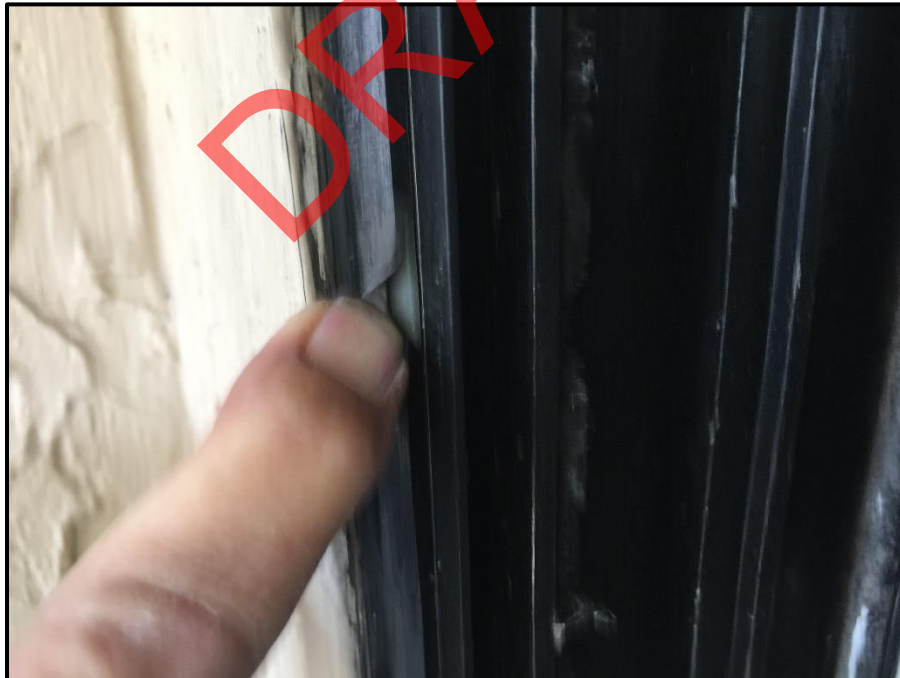
Photograph 46: Unit #401, Failed sealant at sliding glass door.

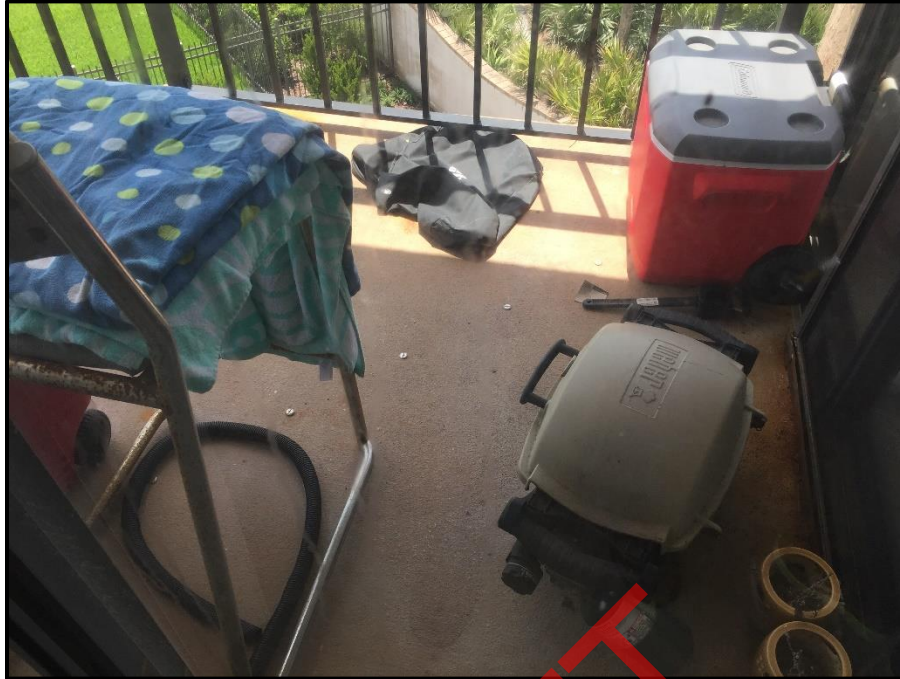
Photograph 47: Unit #404, Perspective view of balcony.

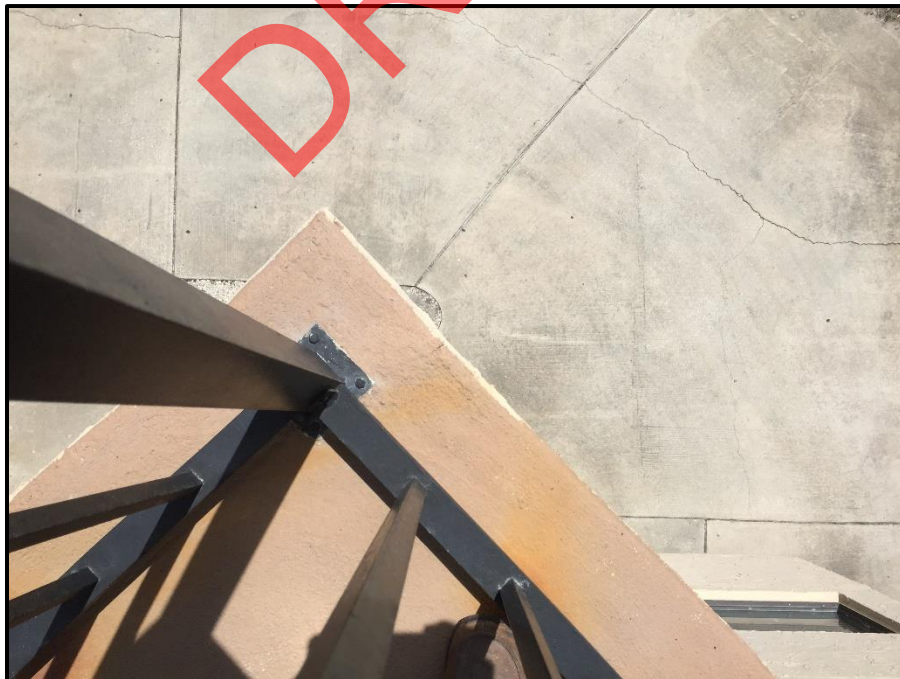
Photograph 48: Unit #404, Leading edge of balcony cracked.

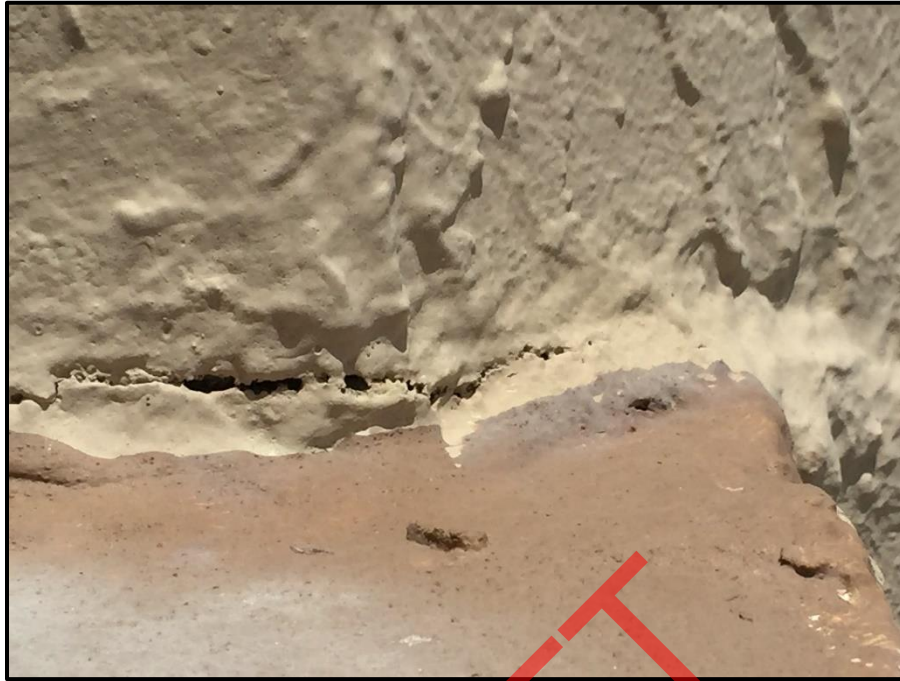
Photograph 49: Unit #404, Sealant failure at unit wall.

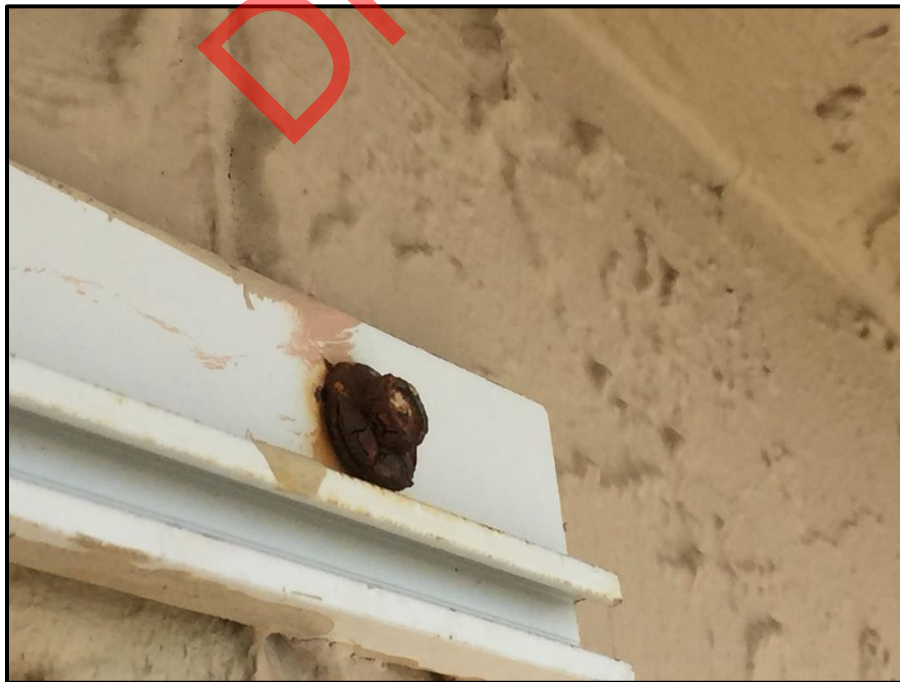
Photograph 50: Unit #404, Heavily corroded fastener at storm shutter bracket.

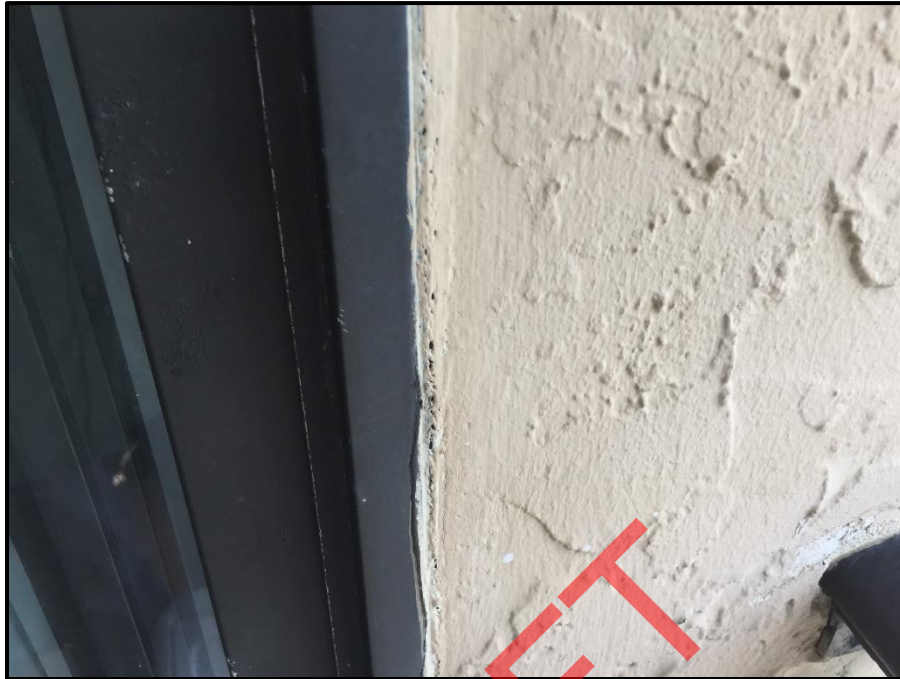
Photograph 51: Unit #404, Sealant failure at sliding glass door.

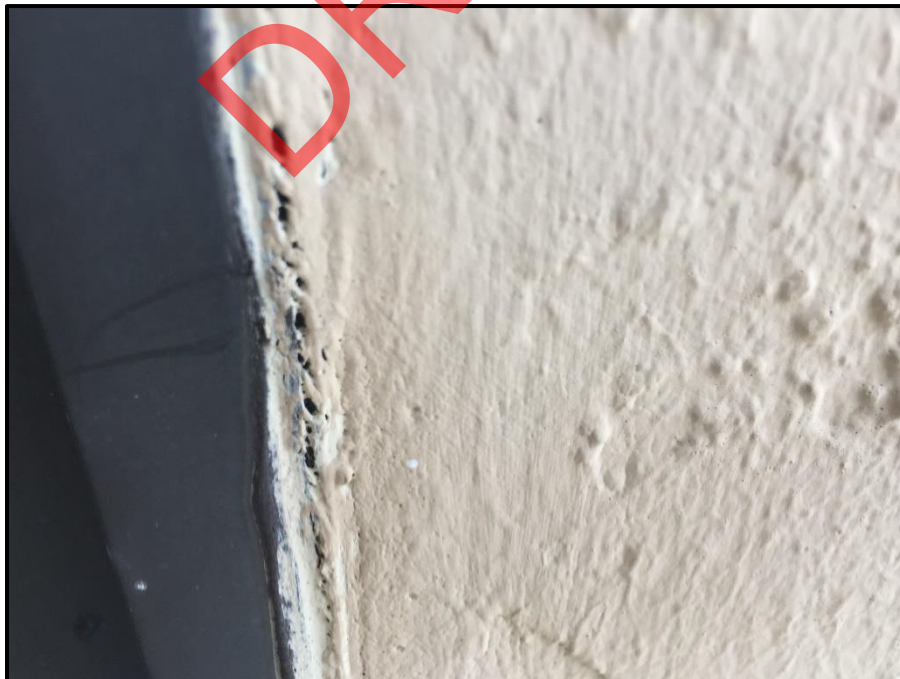
Photograph 52: Unit #404, Close of previous photo.

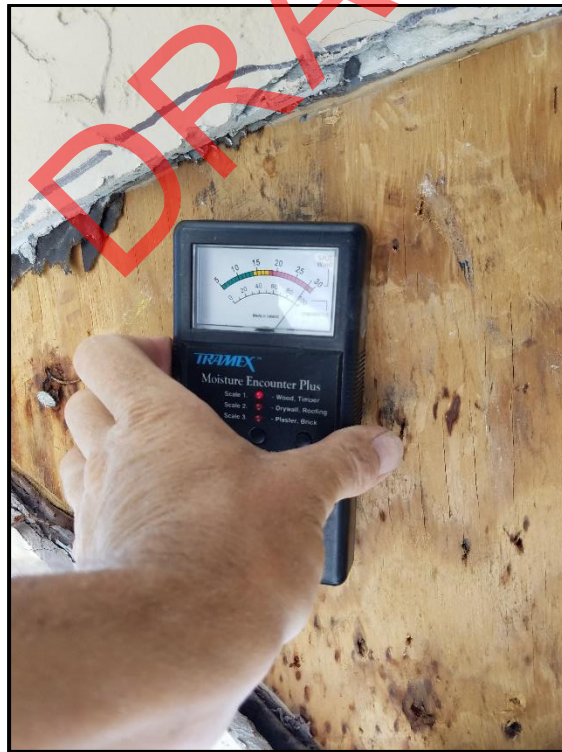
Photograph 54: Unit #202, Readings taken indicate high level of moisture contained in plywood sheathing.

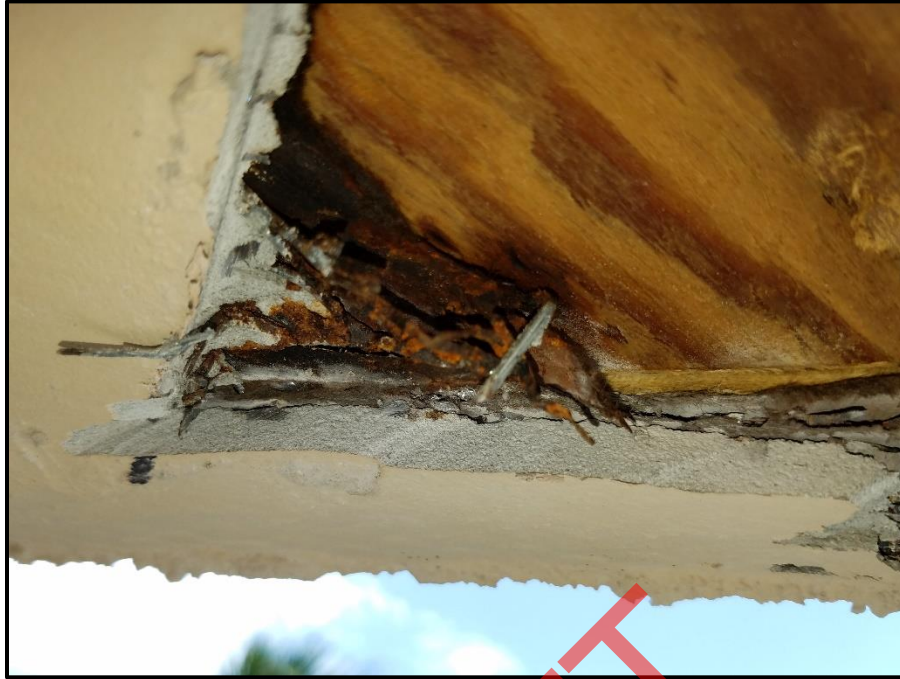
Photograph 55: Unit #202, Heavily corroded stucco lath observed.

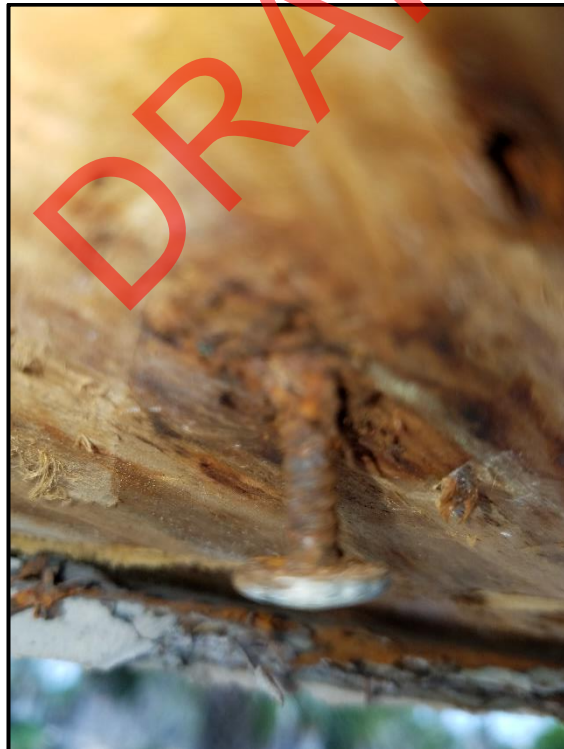
Photograph 56: Unit #202, Heavily corroded fasteners observed.

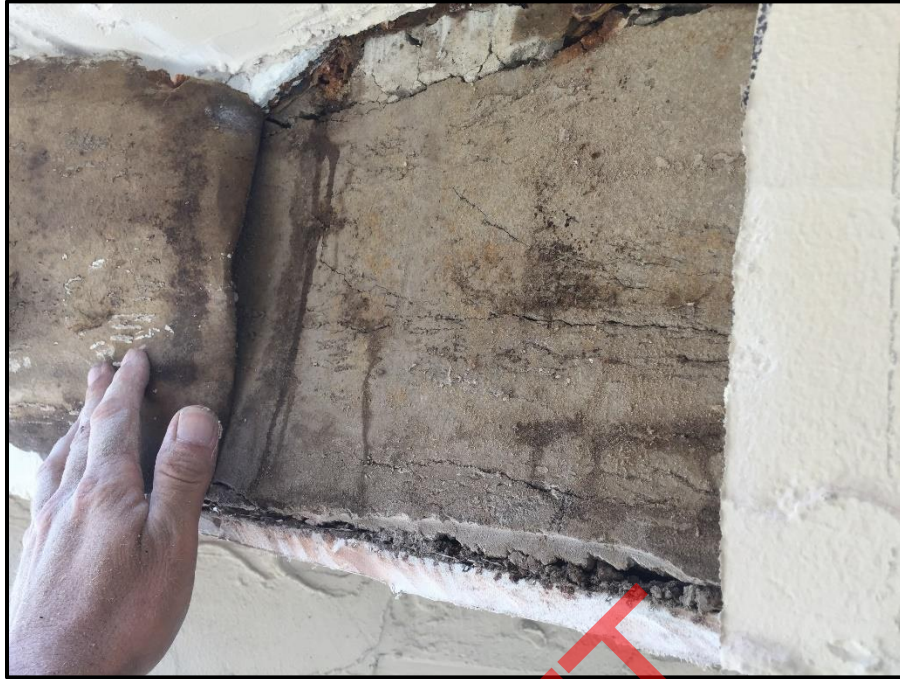
Photograph 57: Unit #202, Gyp board installed upon original construction saturated due to long term water intrusion.

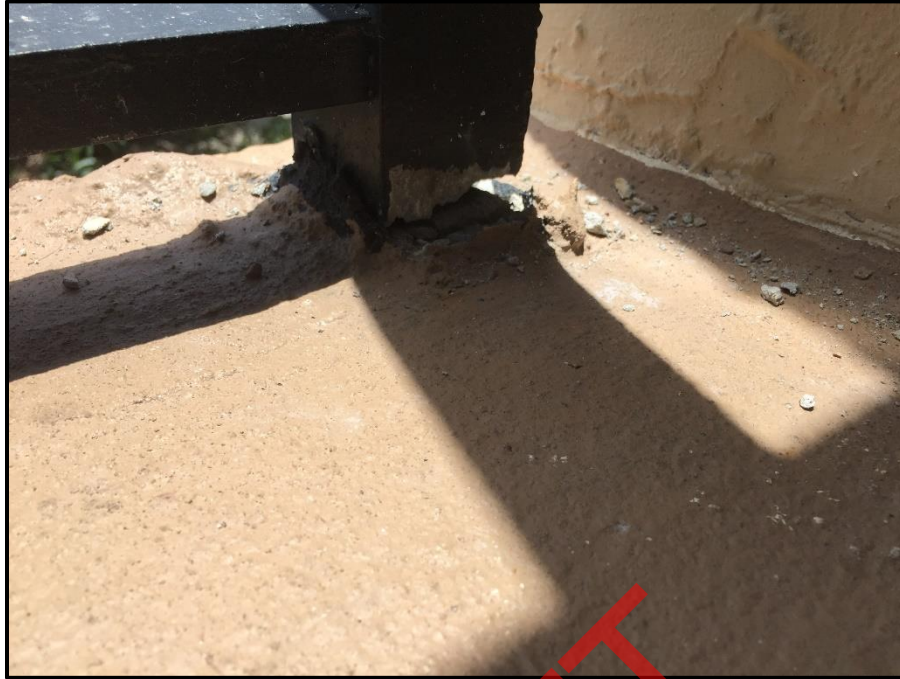
Photograph 59: Unit #202, Guardrail post completely deteriorated due to water intrusion and oxidation.

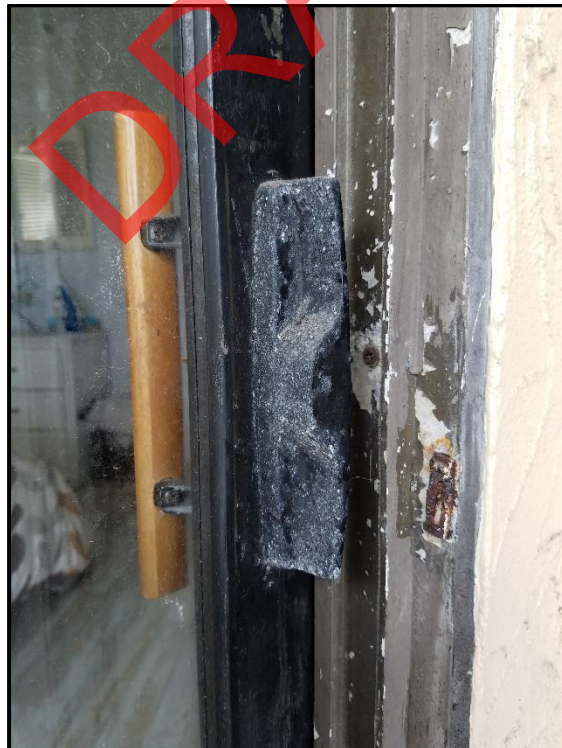
Photograph 60: Unit #202, Sliding glass door components heavily corroded.

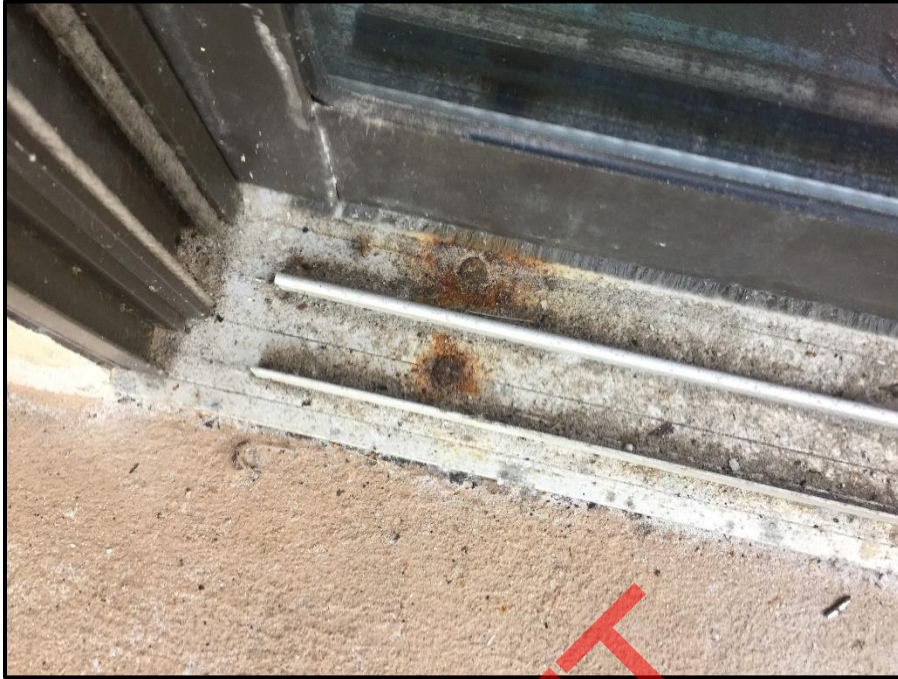
Photograph 61: Unit #202, Sliding glass door fasteners heavily corroded and potential source of water intrusion.

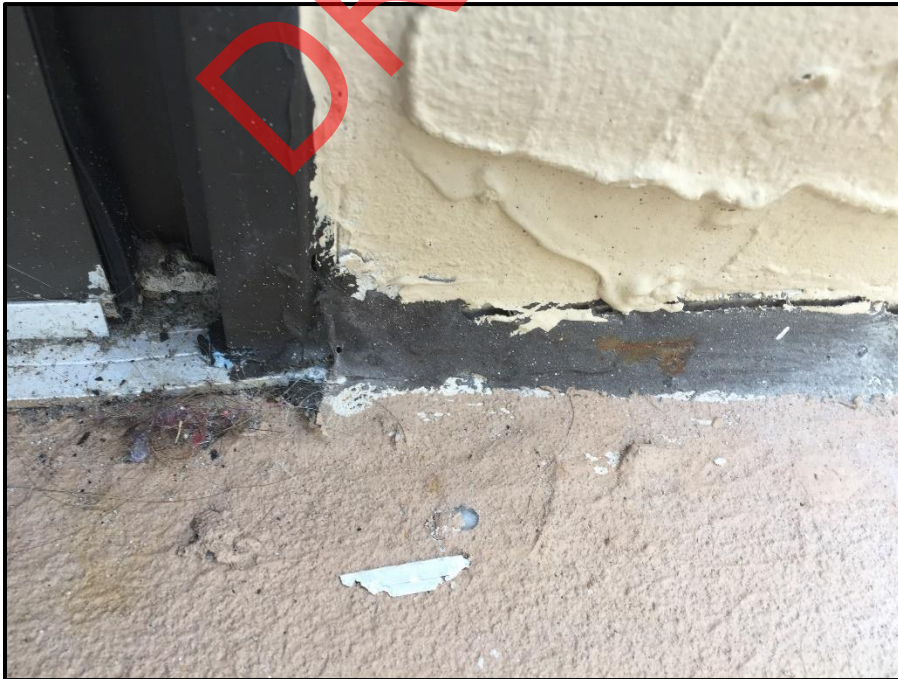
Photograph 62: Unit #202, Sealant failure at unit wall perimeter.

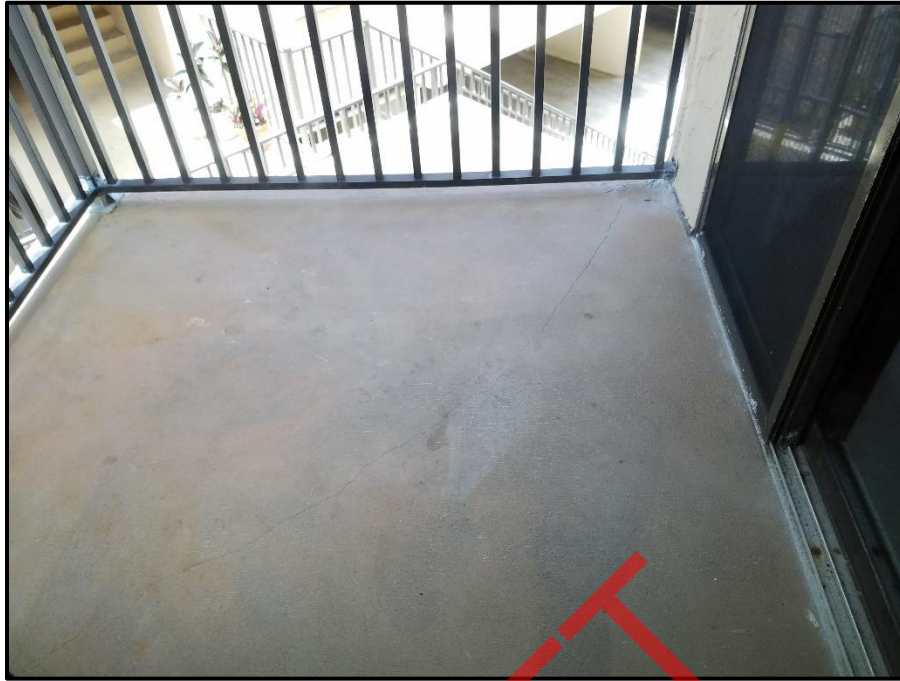
Photograph 63: Unit #301, Balcony topping slab cracked down the middle.

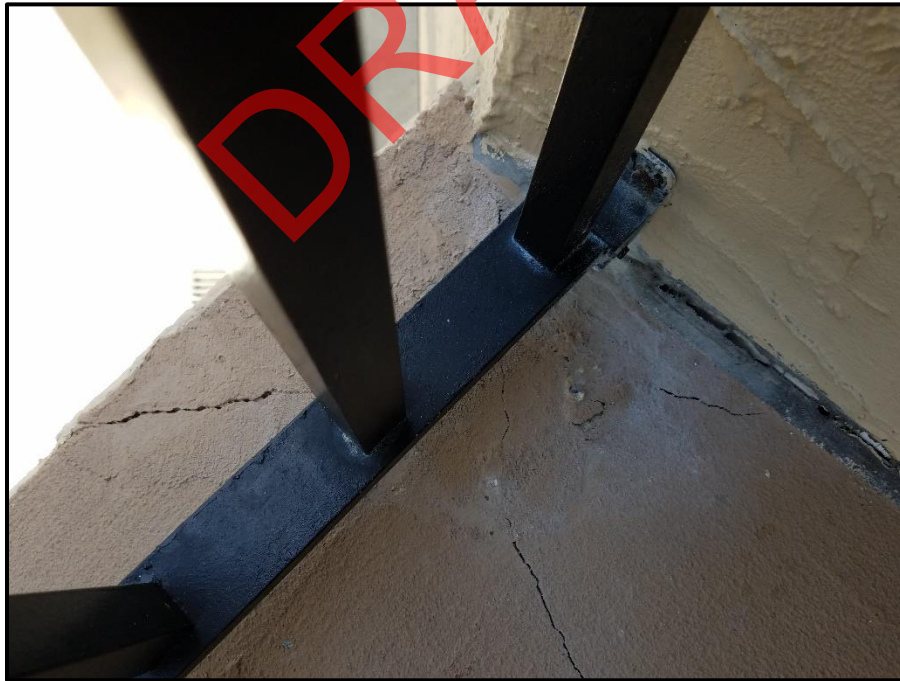
Photograph 64: Unit #301, Balcony topping slab severely cracked at unit wall and leading edge.

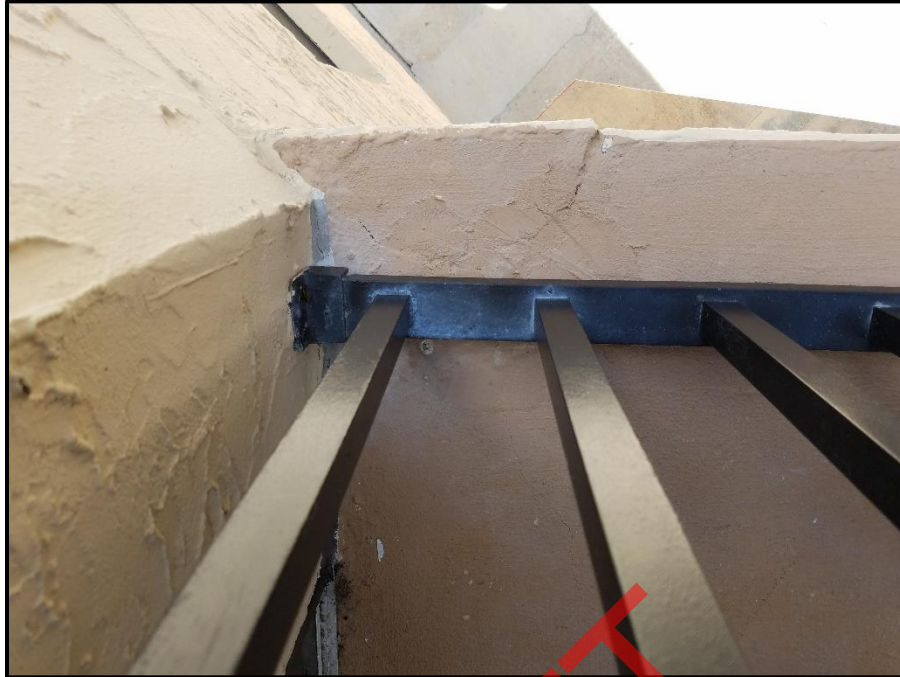
Photograph 65: Unit #301, Balcony cracked and spalling at leading edge and unit wall.

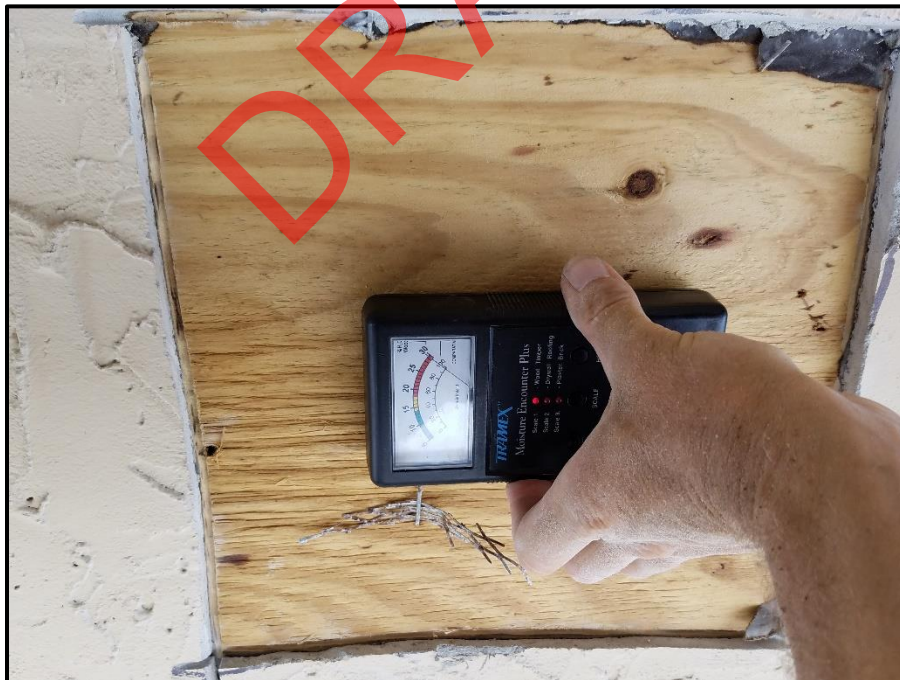
Photograph 66: Unit #301, Observation hole cut in stucco ceiling, high levels of moisture indicated at plywood sheathing.

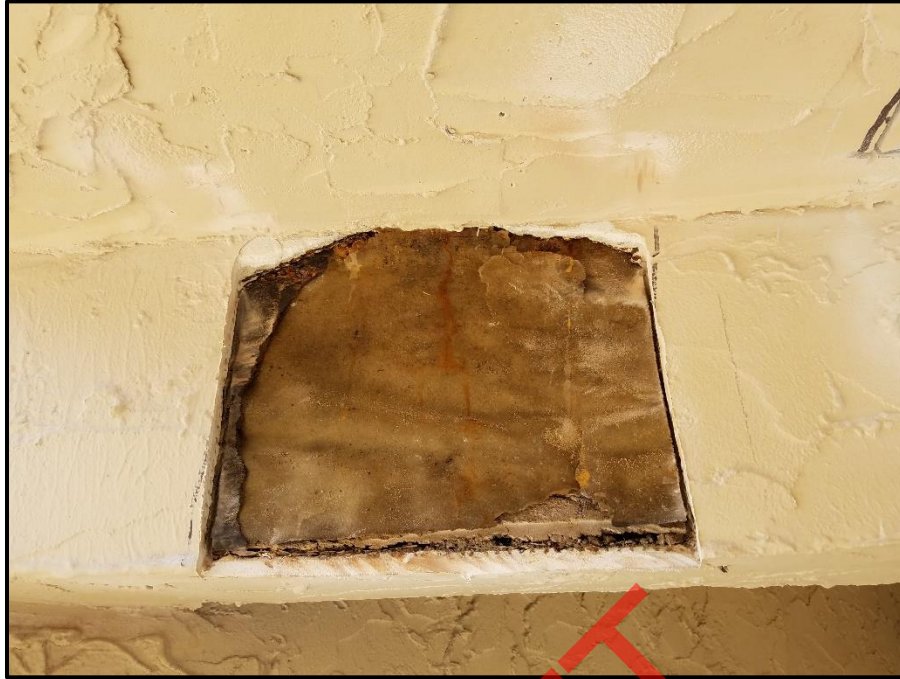
Photograph 67: Unit #301 Observation hole cut in stucco at Structural I beam.

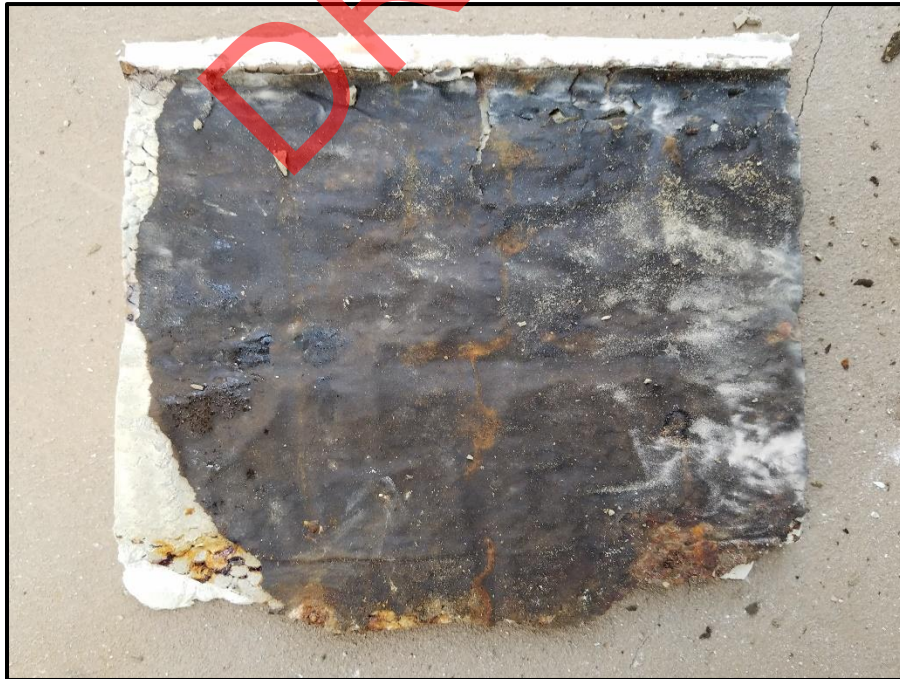
Photograph 68: Unit #301, Felt paper at back side of stucco sample stained with rust due to long term water intrusion.

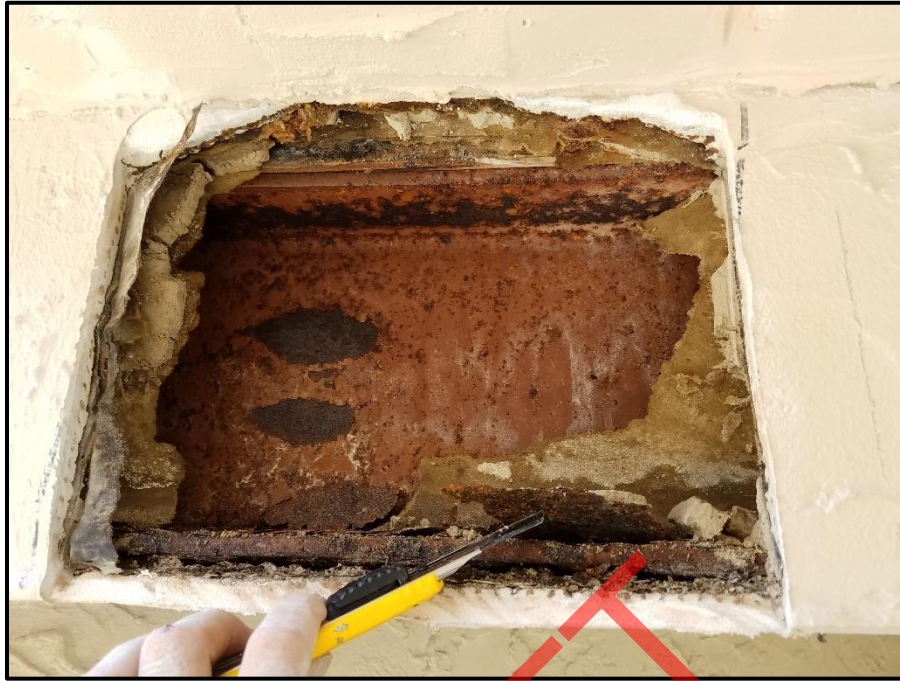
Photograph 69: Unit #301, I-beam corrosion observed.

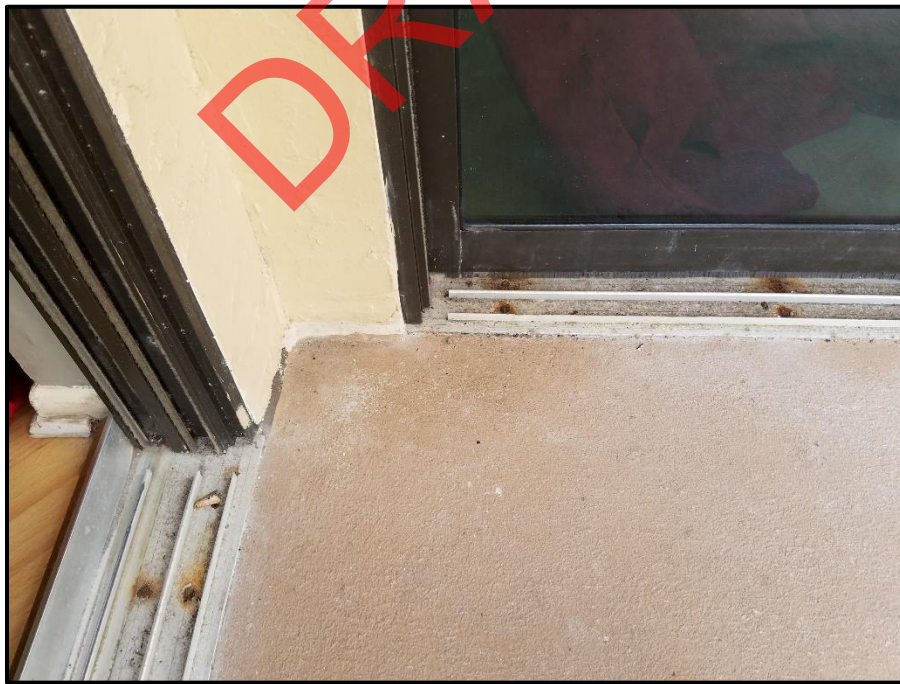
Photograph 70: Unit #301, Corroded fasteners at sliding glass door thresholds observed.

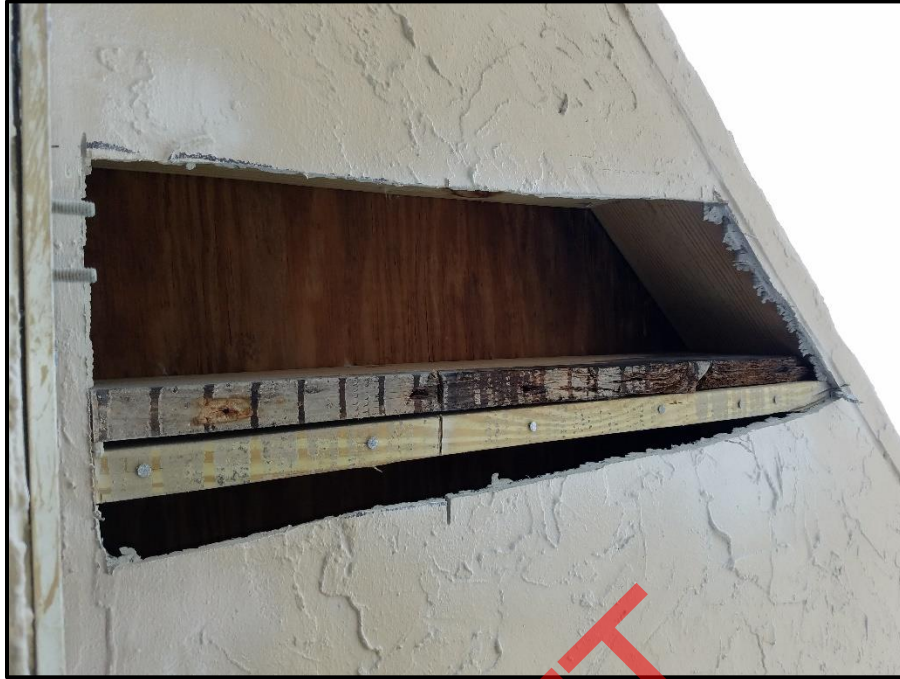
Photograph 71: Unit #303, Observation hole cut at ceiling.

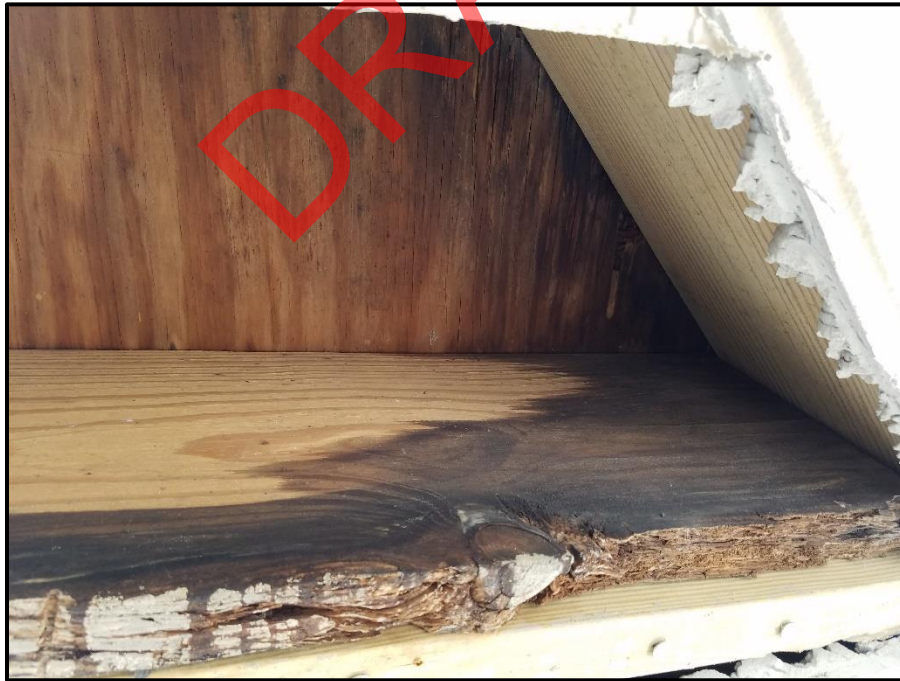
Photograph 72: Unit #303, New joist attached to old joist indicating previous repair attempt.

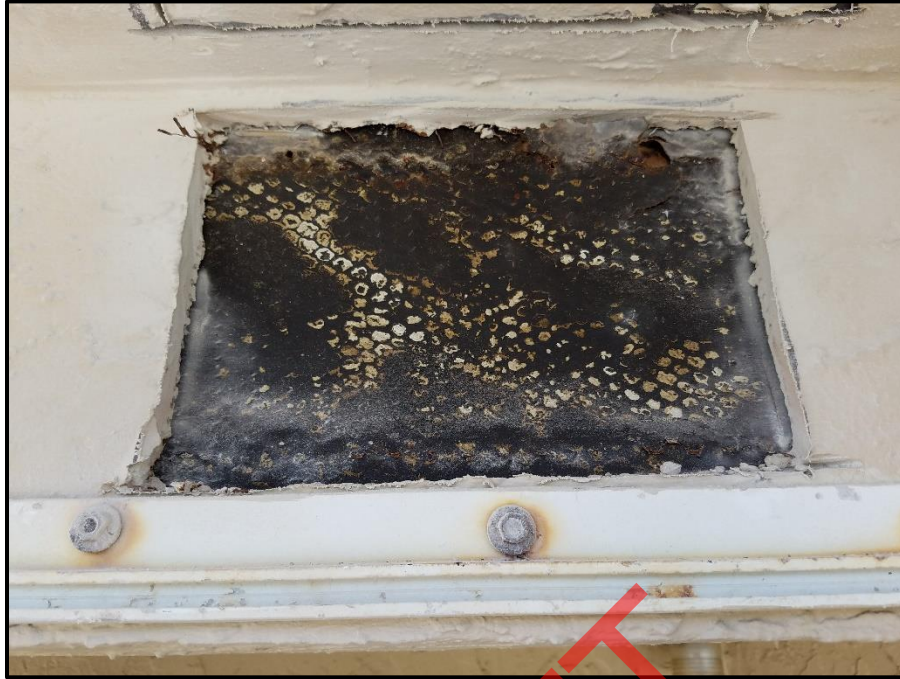
Photograph 73: Unit #303, Observation hole cut in stucco at I-beam location. Felt paper stained due to long term water intrusion.

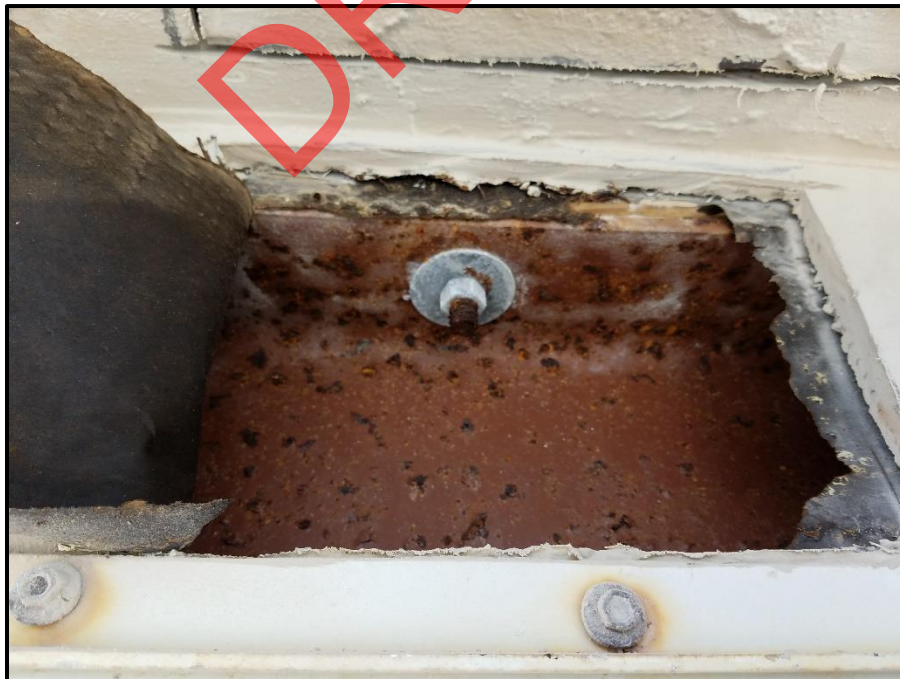
Photograph 74: Unit #303, I-beam and fasteners beginning to corrode.

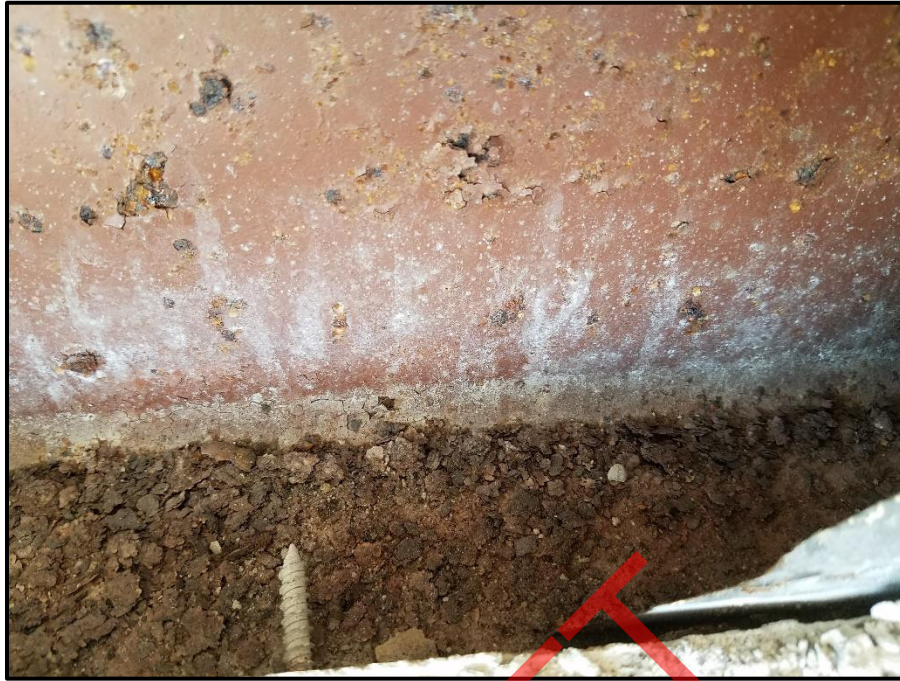
Photograph 75: Unit #303, I-beam corrosion close photo.

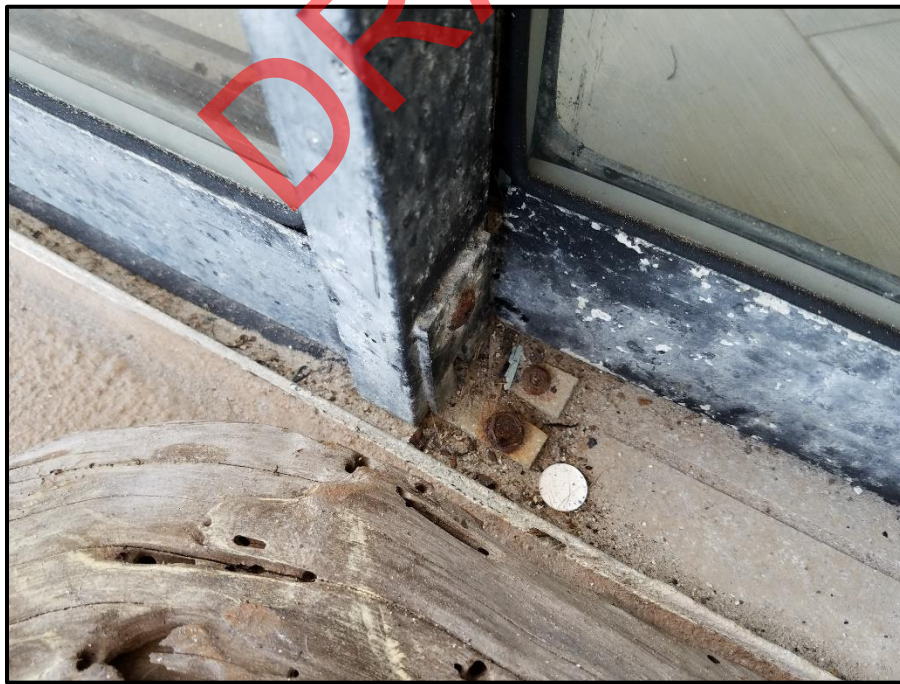
Photograph 76: Unit #303, Sliding glass door fasteners heavily corroded.

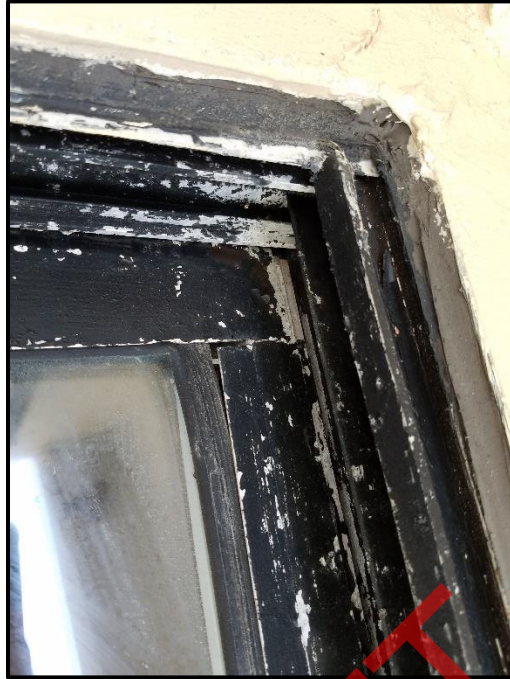
Photograph 77: Unit #303, Sealant failure at sliding glass door.

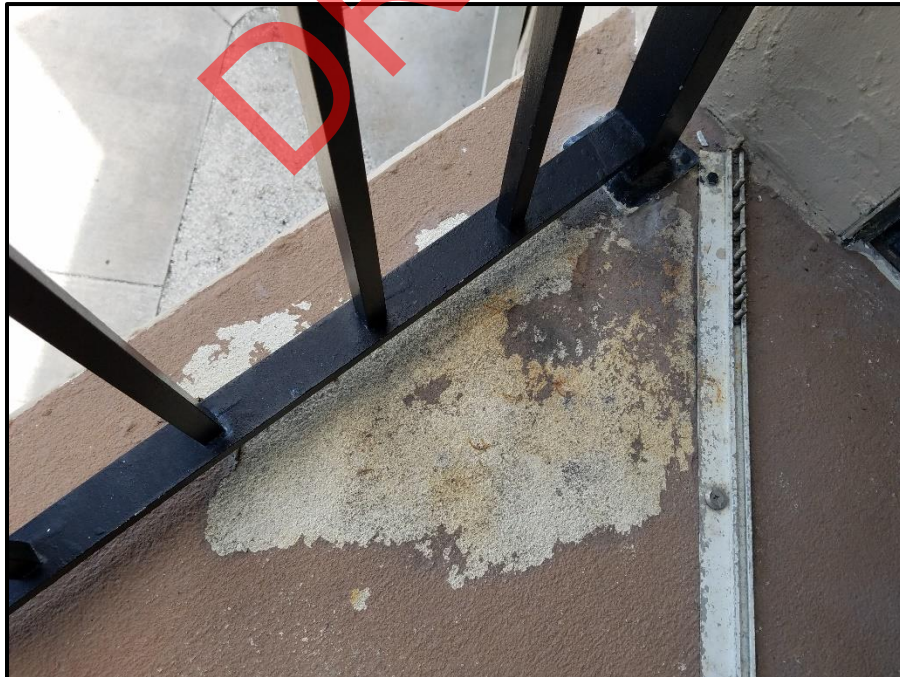
Photograph 78: Unit #303, Acrylic coating failure observed.

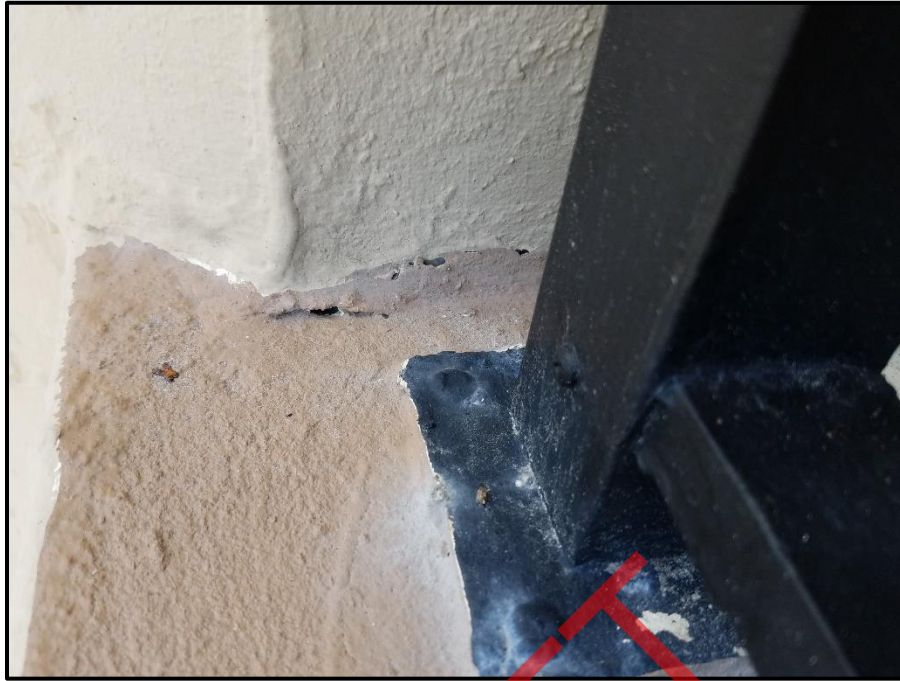
Photograph 79: Unit #303, Sealant failure at unit wall.

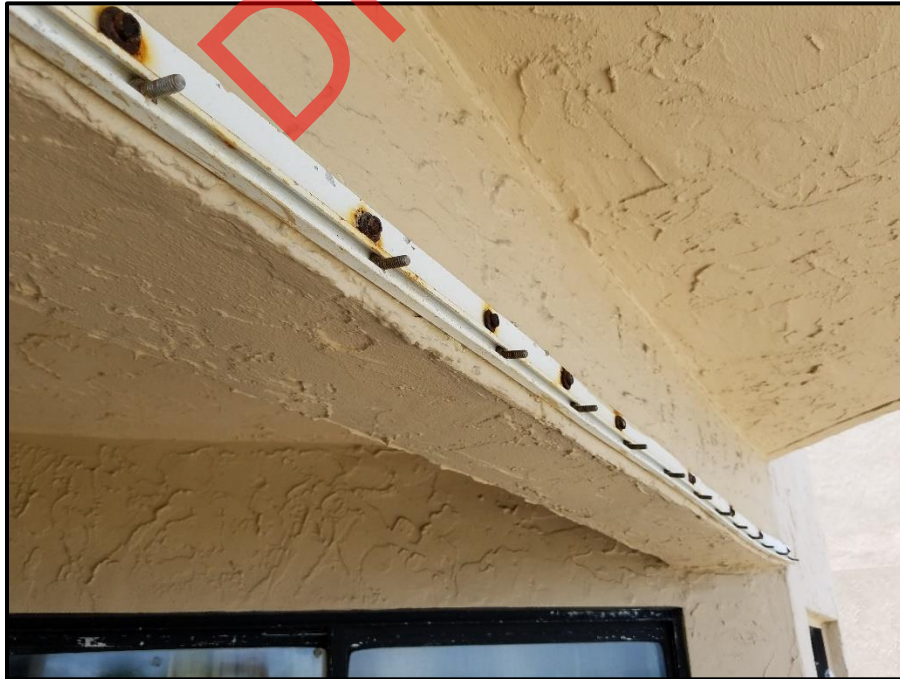
Photograph 80: Unit #303, Storm shutter fasteners heavily corroded and potential source of water intrusion.

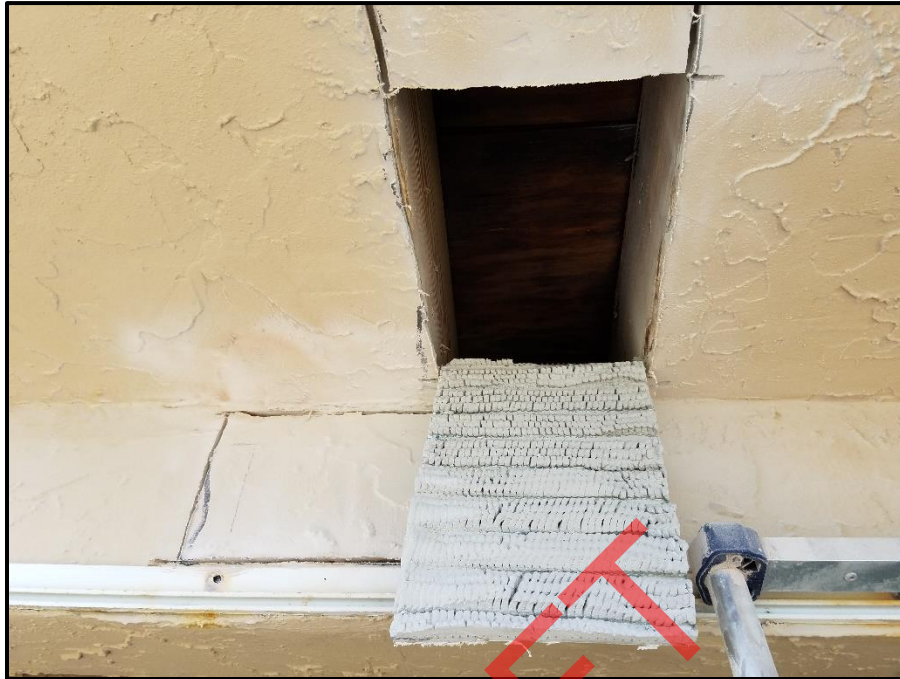
Photograph 81: Unit #304, Observation hole cut at ceiling and I-beam location.

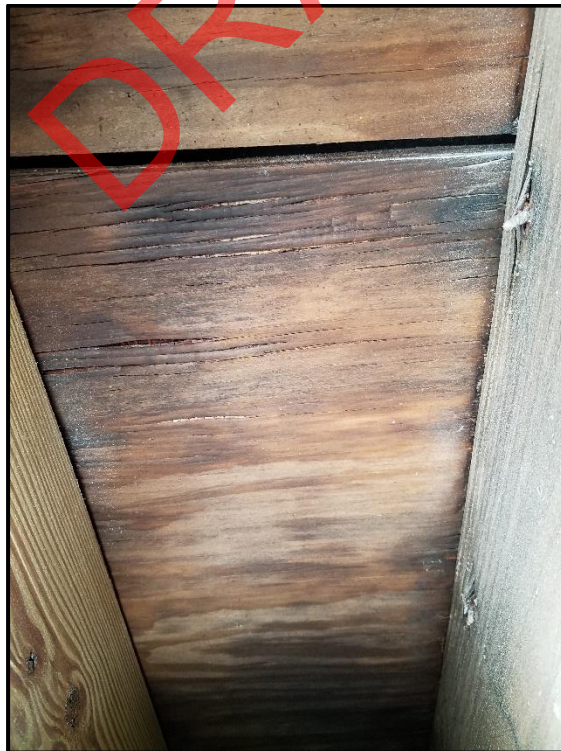
Photograph 82: Unit #304, Underside of deck sheathing stained and saturated due to water intrusion.

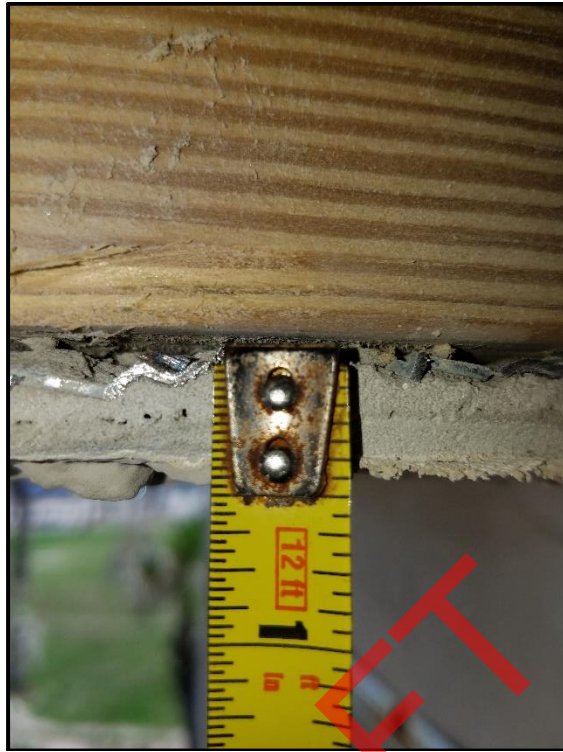
Photograph 83: Unit #304, The stucco in this previously repaired location was approximately 1/2 inch thick.

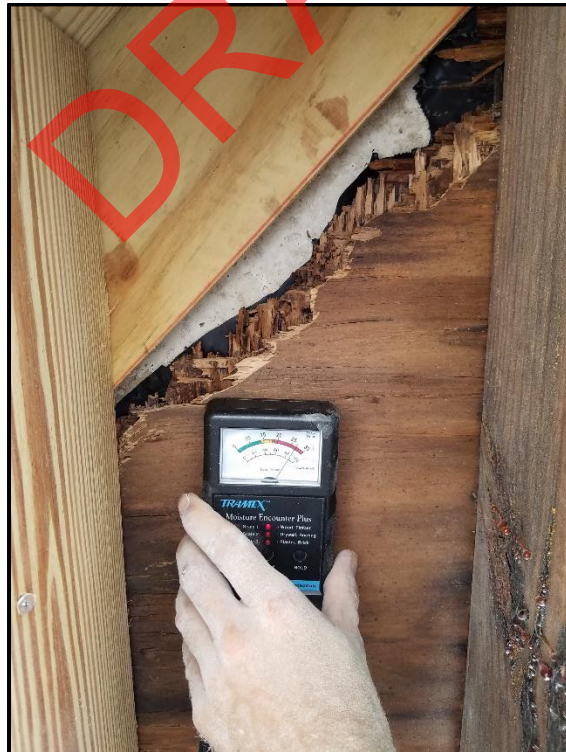
Photograph 84: Unit #304, Readings taken at the underside of the deck sheathing indicate high moisture levels.

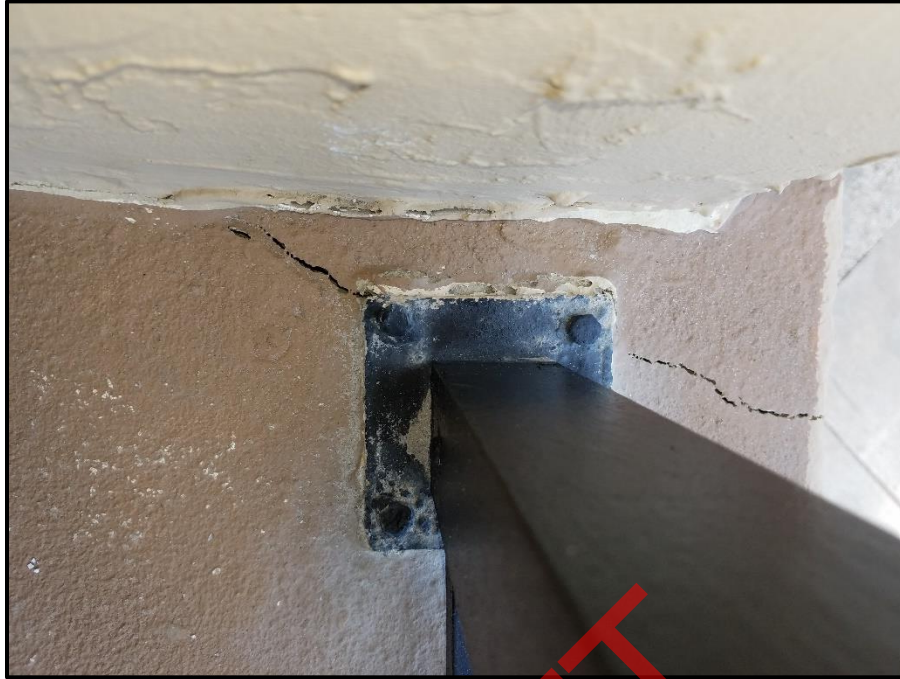
Photograph 85: Unit #304, Crack in topping slab at unit wall.
