CONSTRUCTION SOLUTIONS, INC
ENGINEERING • TESTING • PROJECT MANAGEMENT
www.constructionsolutions.cc

August 8, 2017

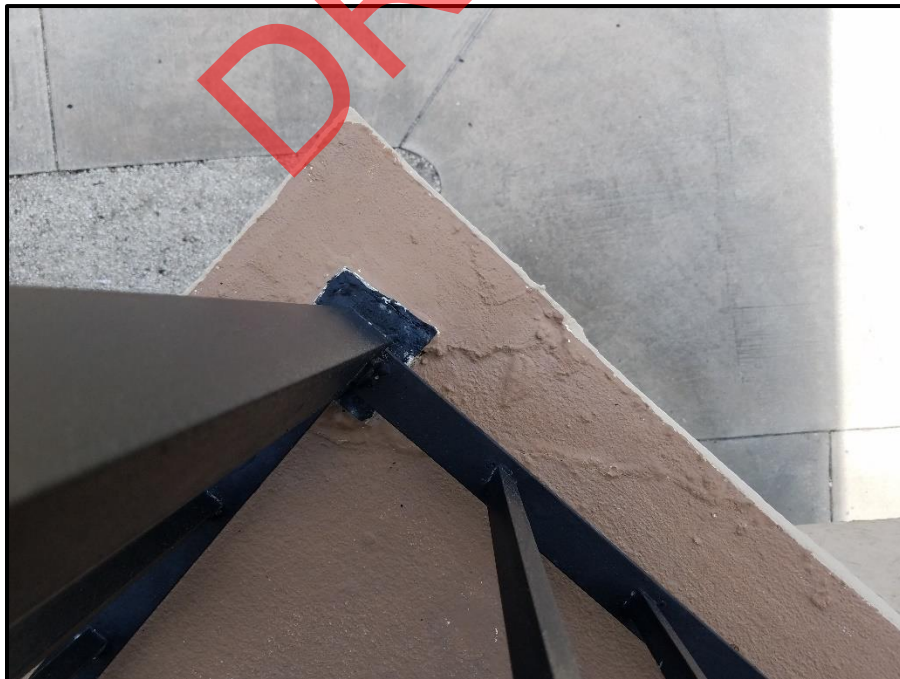
Photograph 86: Unit #304, Crack at leading balcony edge.

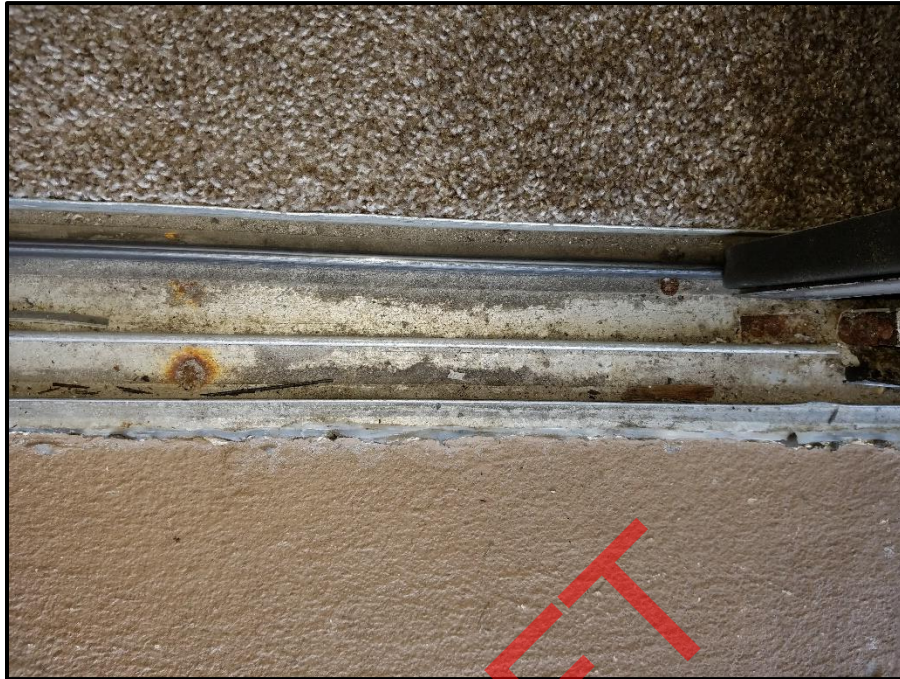
Photograph 87: Unit #304, Rusted fasteners at sliding glass door threshold.

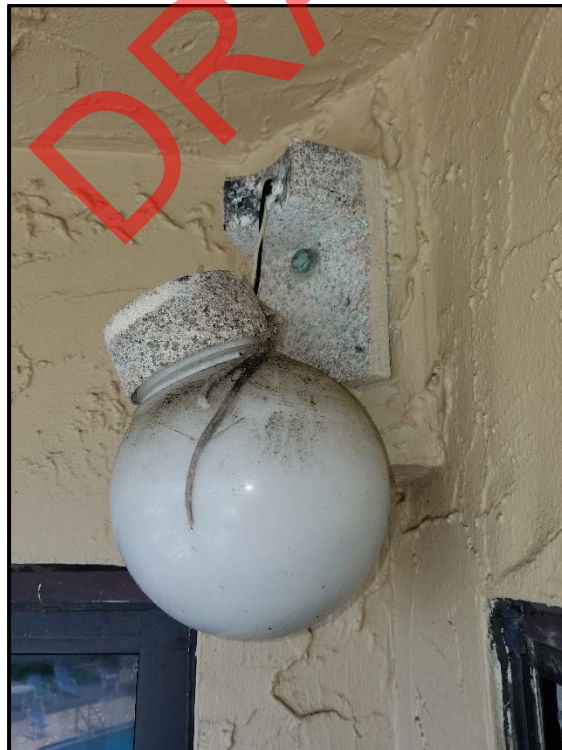
Photograph 88: Unit #304, Balcony light broken and not sealed to unit wall.

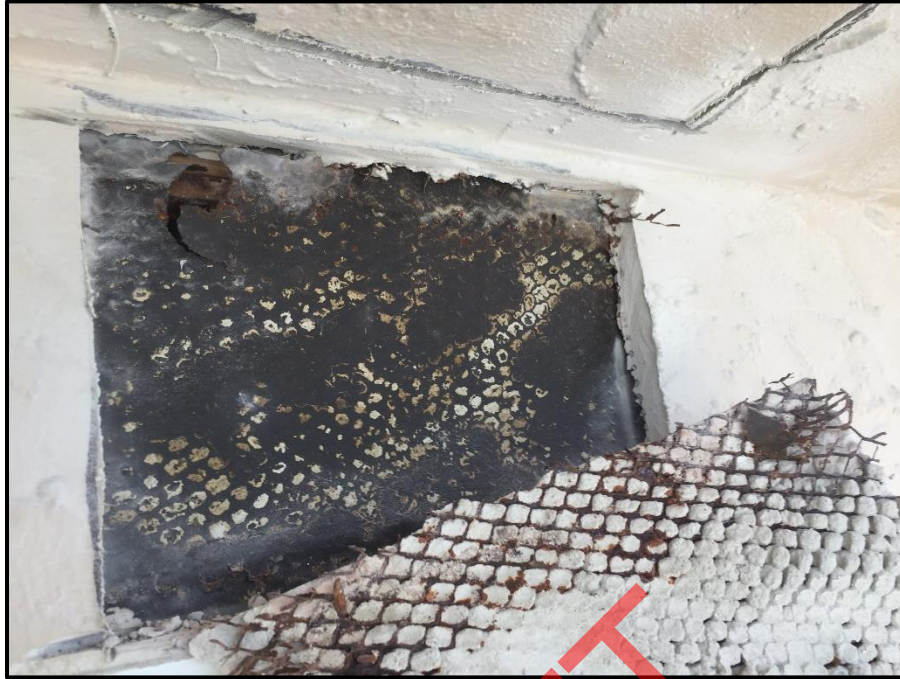
Photograph 89: Unit #304, Observation hole cut at I-beam location, corrosion and staining due to long term water intrusion.

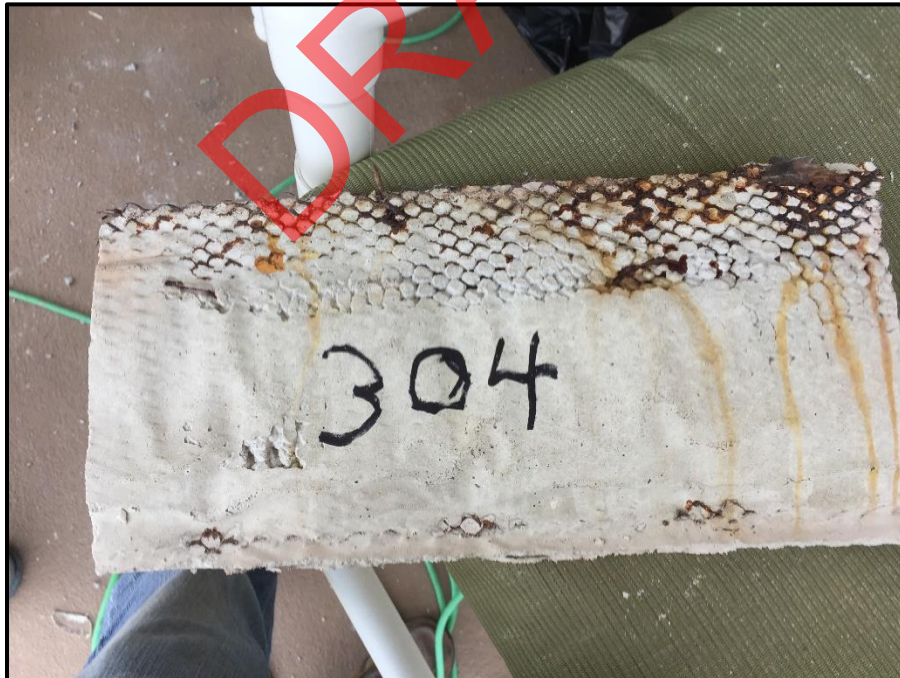
Photograph 90: Unit #304, Stucco lath and fasteners heavily corroded.
