# **Structural Integrity Reserve Study Ocean Terrace Condominium Jacksonville Beach, Florida**

**Prepared for FY 2025  
Report Date: November 16, 2024**

Re: Reserve Study Report for Ocean Terrace Condominium

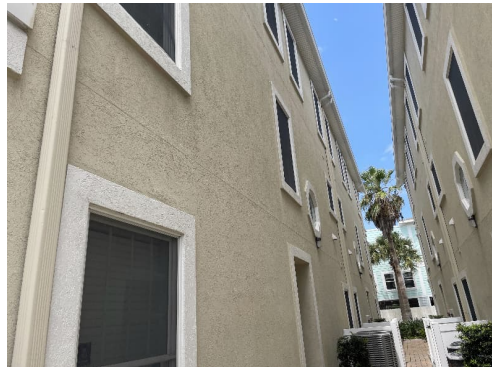
No issues observed or reported by Management.

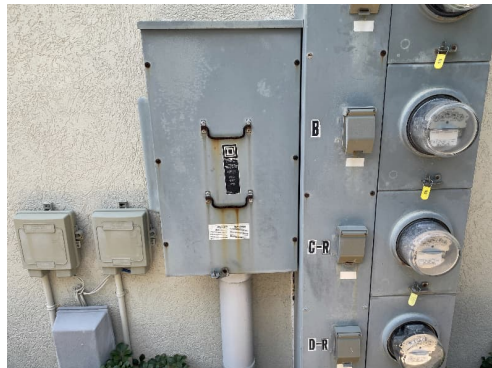
Located on exterior of buildings exposed to salt air typically have a life of 25-30 years

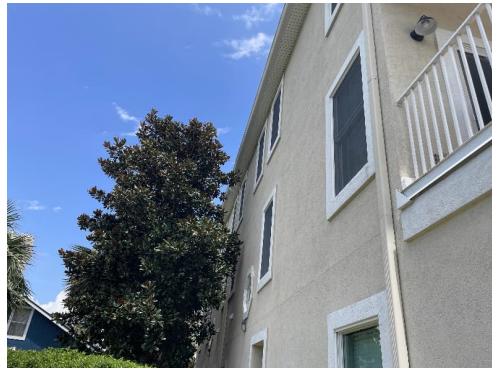
### Ext Repair/Painting - 2027

Association has requested painting be included on a 10 year cycle.
