# **Reserve Study Update RiverPlace at Summer Beach HOA Fernandina Beach, Florida**

**Prepared for FY 2025  
Report Date: September 9, 2024**

Re: RiverPlace at Summer Beach HOA

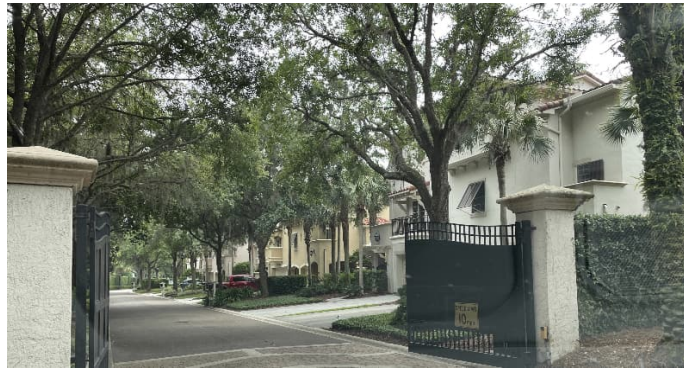
Refurbishment planned in 2035 will bring gates and equipment to almost new condition therefore extending life by 20 years.

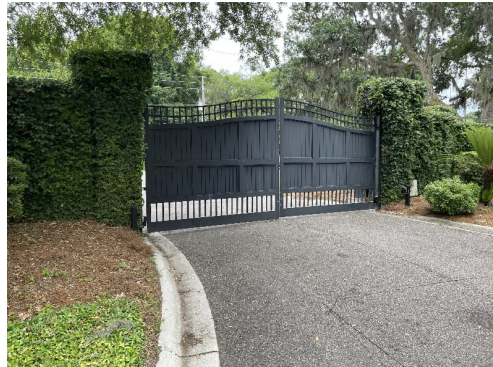
*Vehicle Gates - Exit continued...*

Refurbishment planned in 2035 will bring gates and equipment to almost new condition therefore extending life by 20 years.
