THE SEASONS  
AT MILL COVE

ELIM SERVICES, INC

GUTTER REPORT

SEPTEMBER 2022

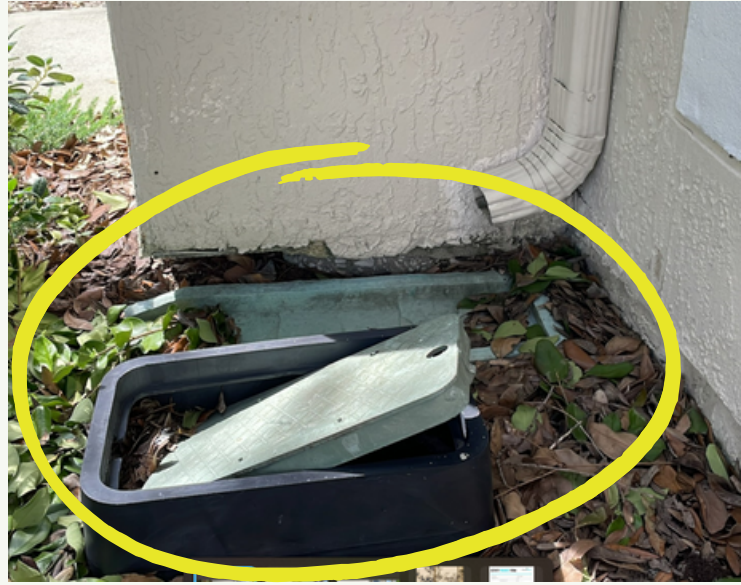
Elbow with flex pipe to get 5-foot clearance from the building. Current placement causes building damage and erosion. Residents need to keep splash blocks under the drain to prevent damage.

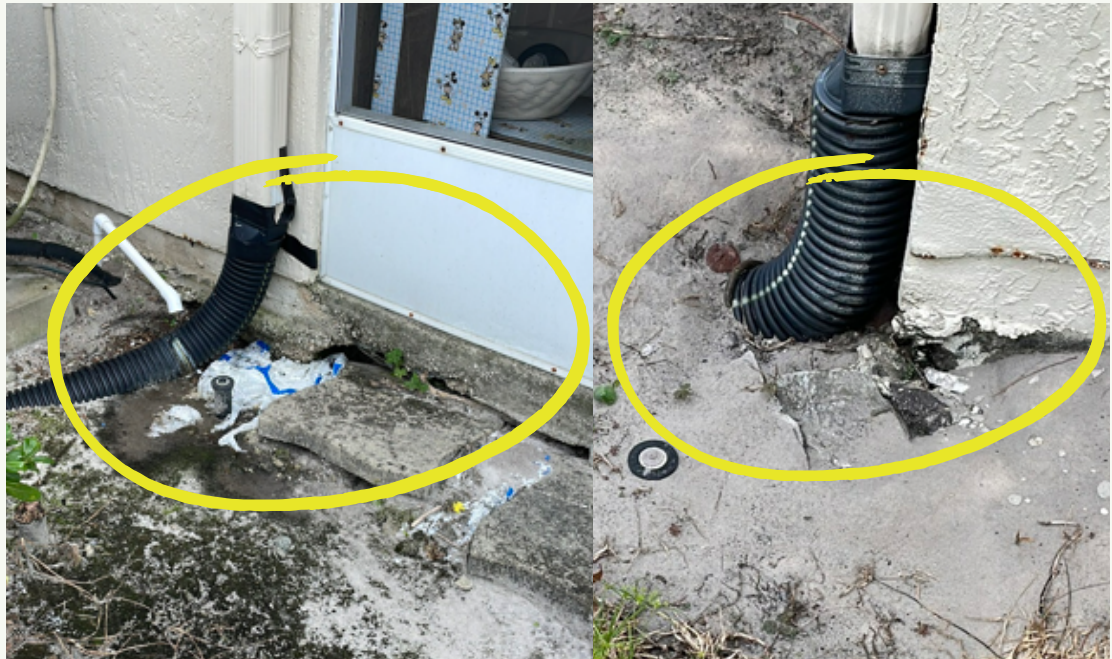
Underground drains need to be cleared or re-routed with plastic. All underdrains observed appear to be clogged causing gutters to overflow resulting erosion.

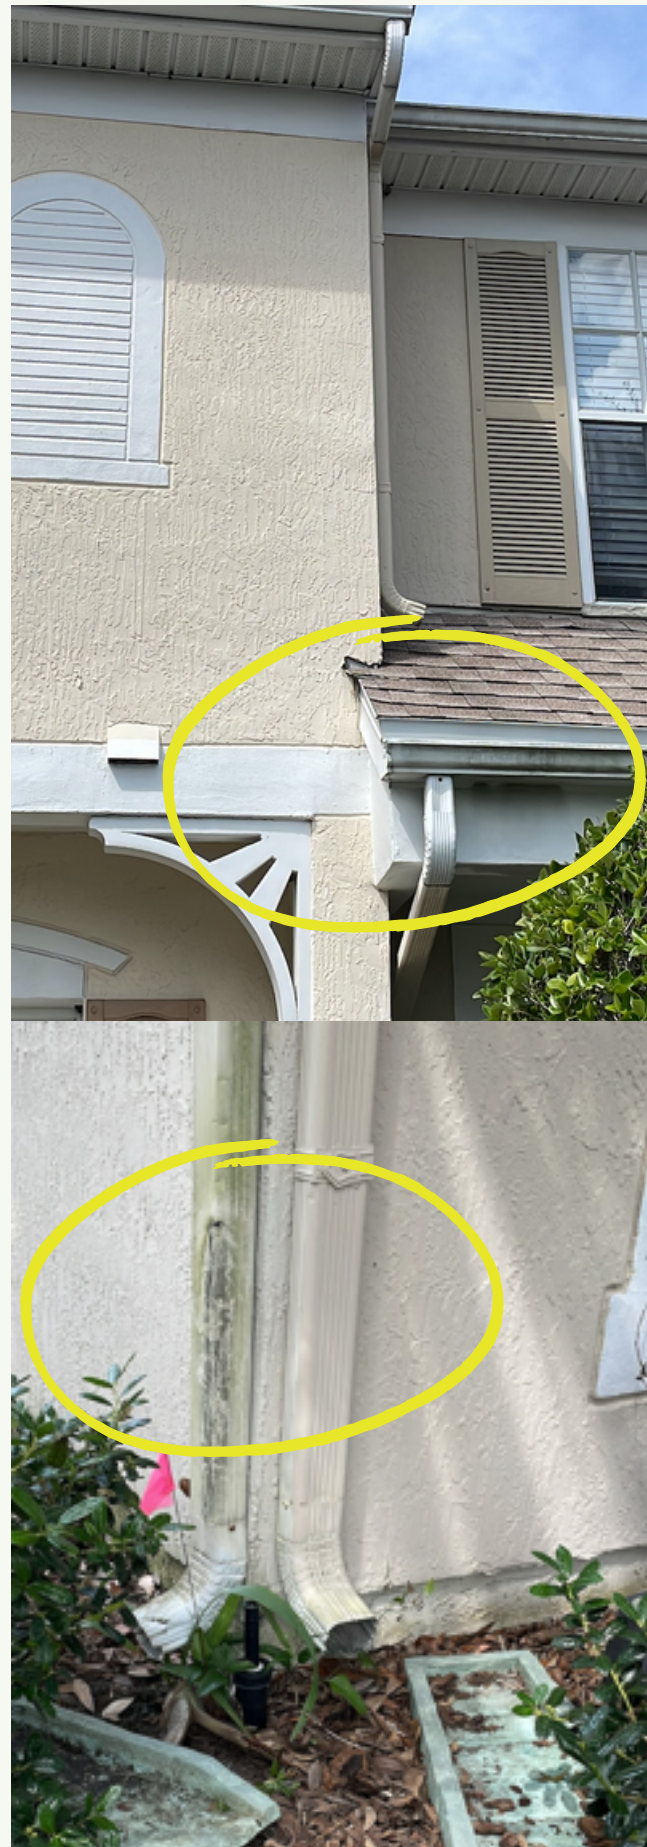
Unit 106

Visible water damage from  
failing gutters.

The gutter has a hole in it.

This isn't a major concern at  
the moment and can wait.

replacing busted gutter with  
6inch gutter.

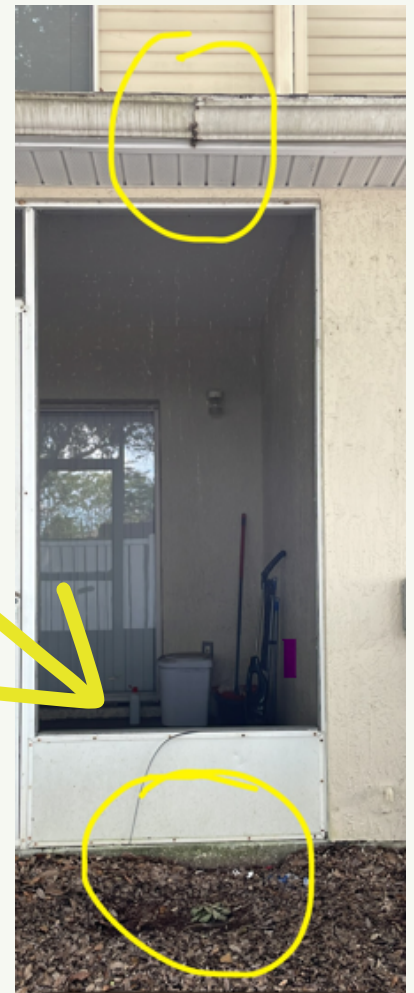
## **BUILDING 100 REAR**

Back of building 1 gutter clogged.  
1 bad seam behind building 1  
causing erosion.

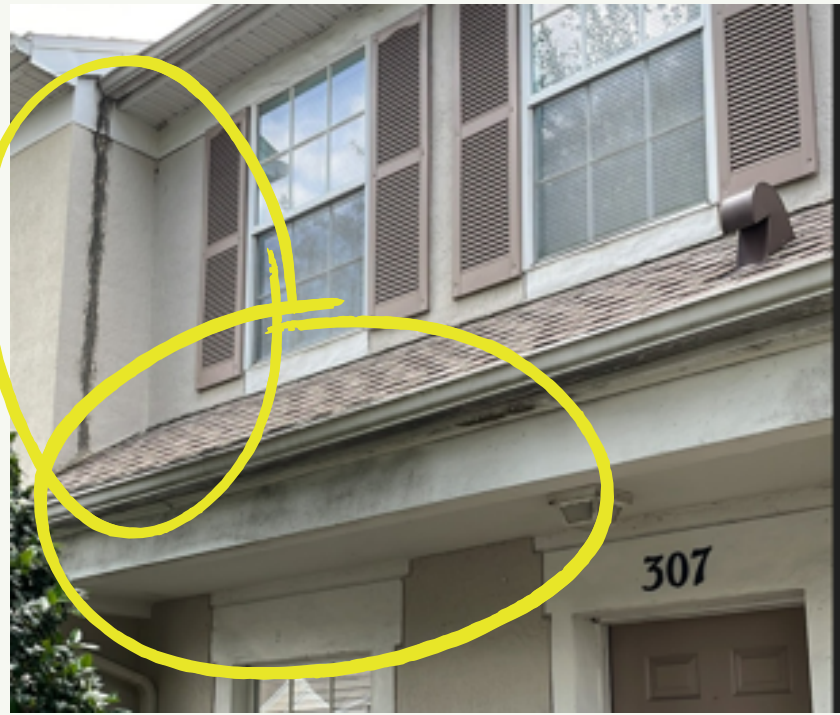
Building 3

Gutter repair needed.

Rear needs to be cleaned and add gutter cover.

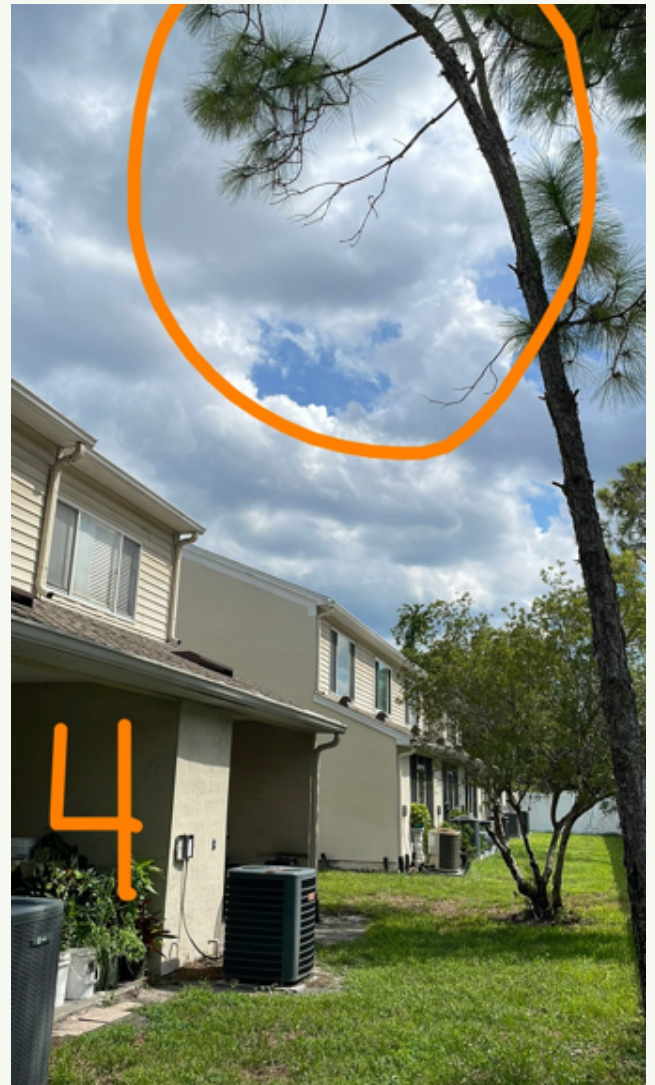
## **BUILDING 400 FRONT/REAR**

The rear has damaged gutter covers damaged.

Recommended removing pine tree, which would leave no tree line and no need for gutter cover.

The area behind building 4 attempt to reseal.
