# Via Mare Condominium Association, Inc.

June 19, 2024 • Atlantic Beach, FL

**STRUCTURAL INTEGRITY  
RESERVE STUDY**

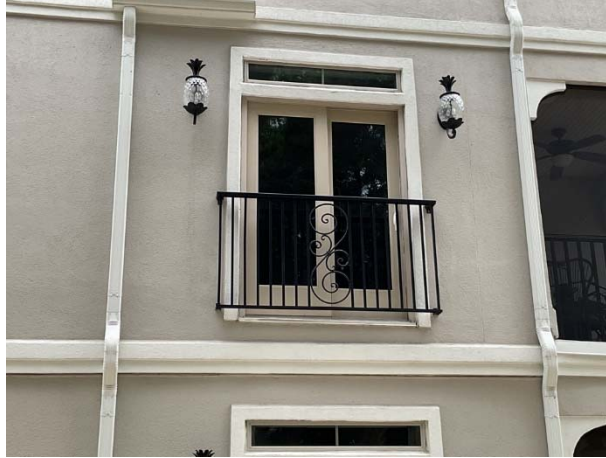
**Decorative railings at Juliet balconies**

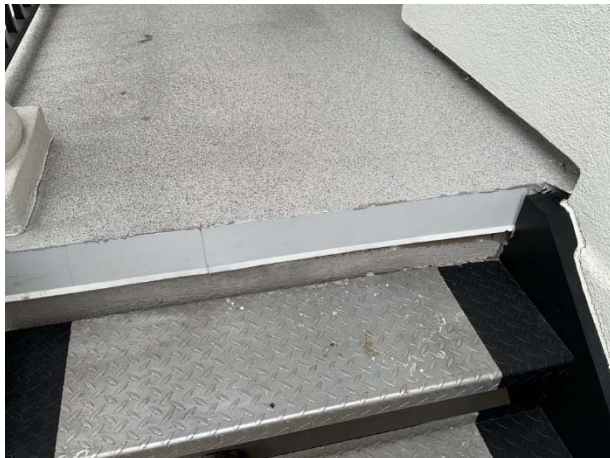
**Flashing at breezeway perimeter**

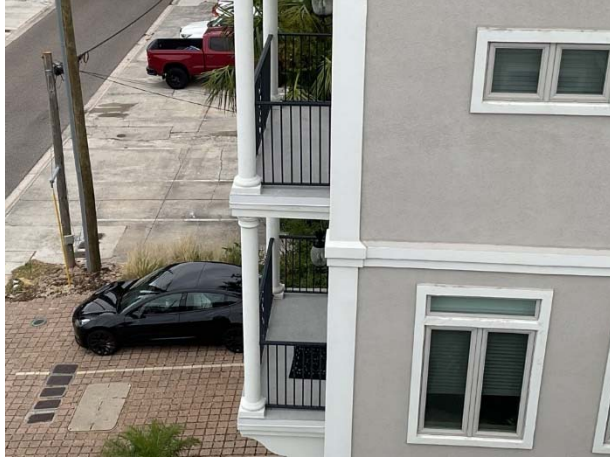
**Wood frame balconies with concrete surfaces overview**

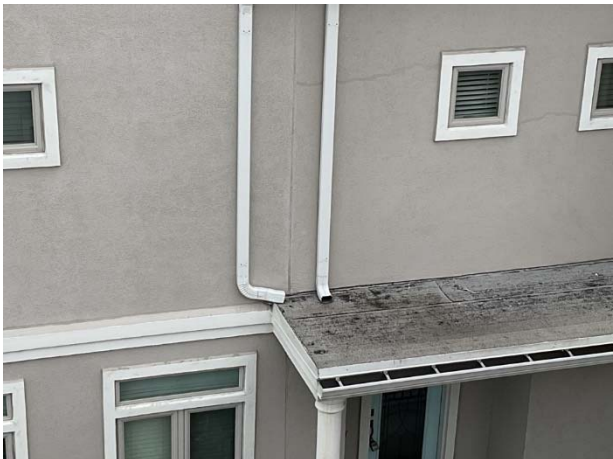
**Downspouts discharging onto lower roof section**

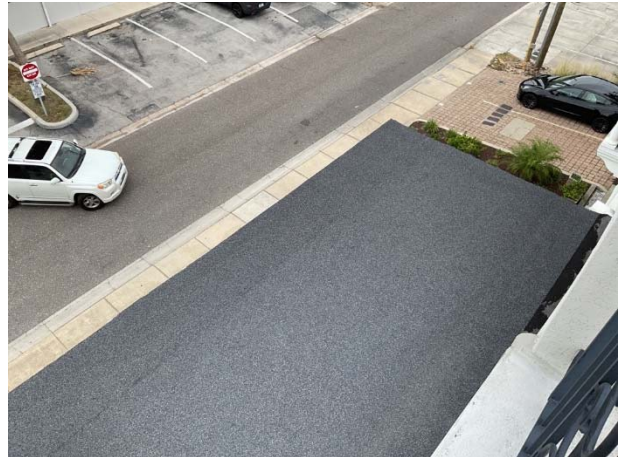
Modified bitumen roof at front elevation balconies

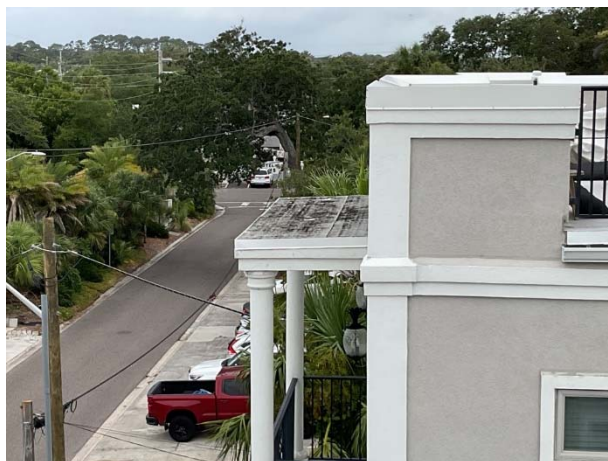
Modified bitumen roof section with evidence of standing water

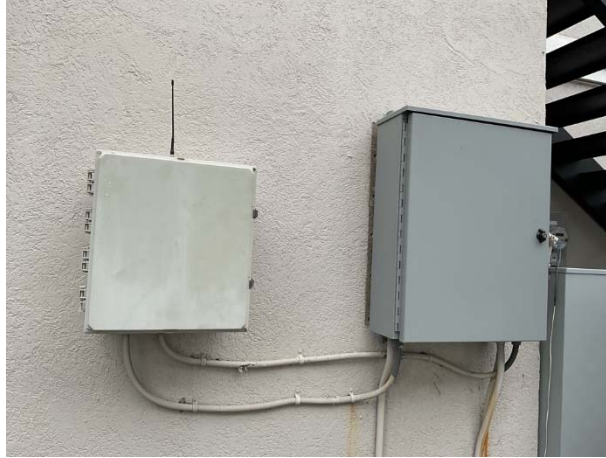
**Control panel enclosures**

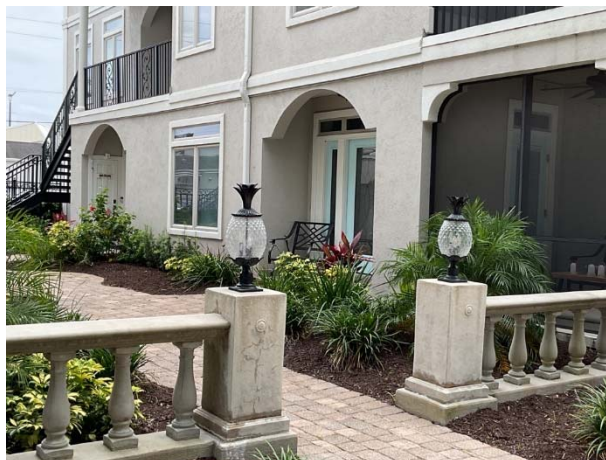
Light fixtures at courtyards

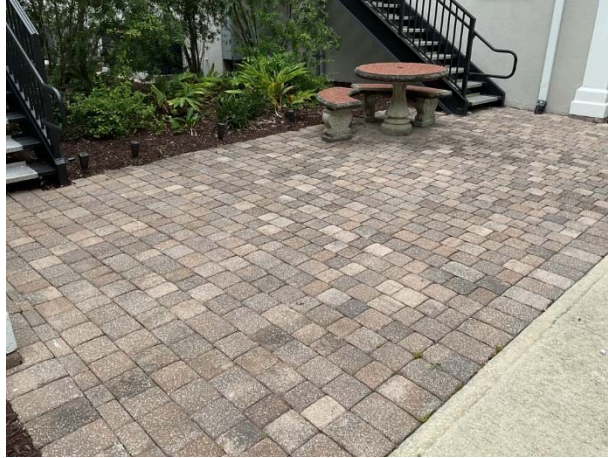
**Pavers at staircase landing**
