# Via Mare Condominium Association, Inc.

June 19, 2024 • Atlantic Beach, FL

**STRUCTURAL INTEGRITY  
RESERVE STUDY**

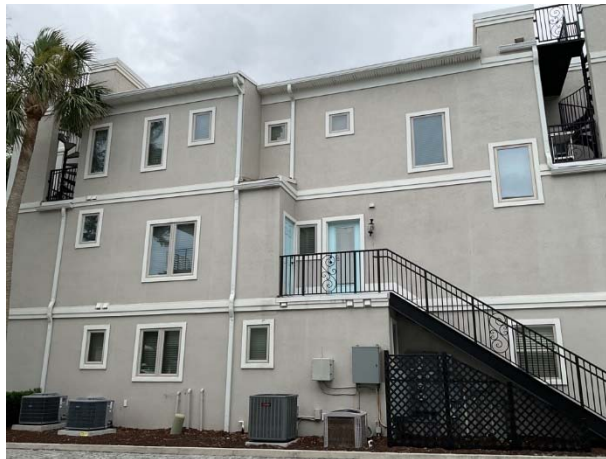
Building side elevation

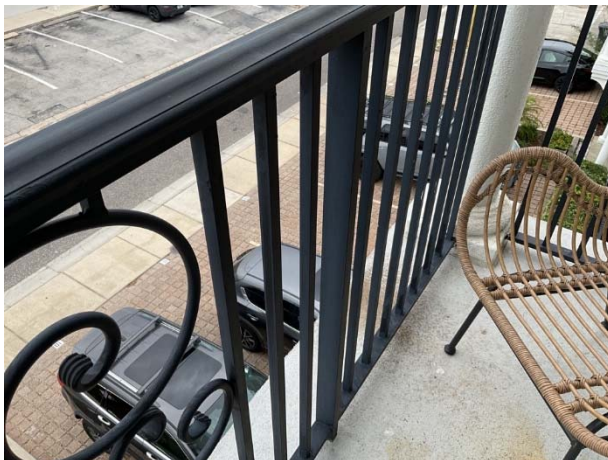
Aluminum railings

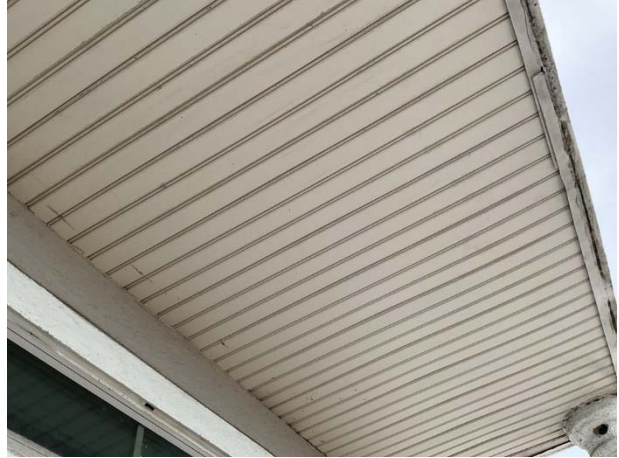
**Balcony underside**

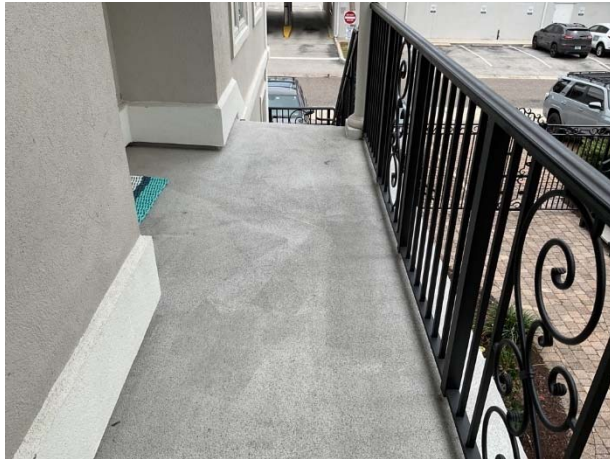
**Breezeway landing overview**

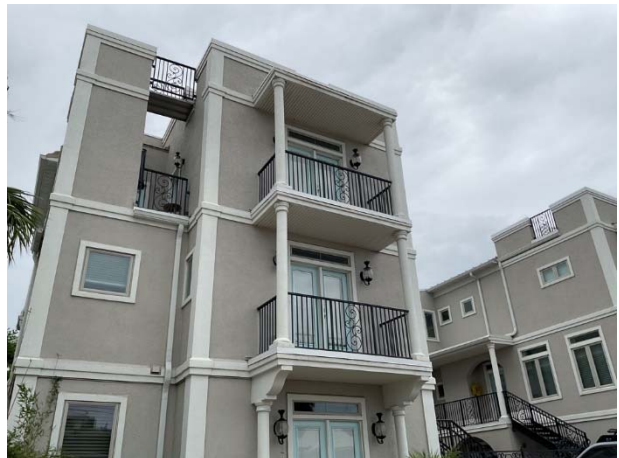
**Front elevation balconies**

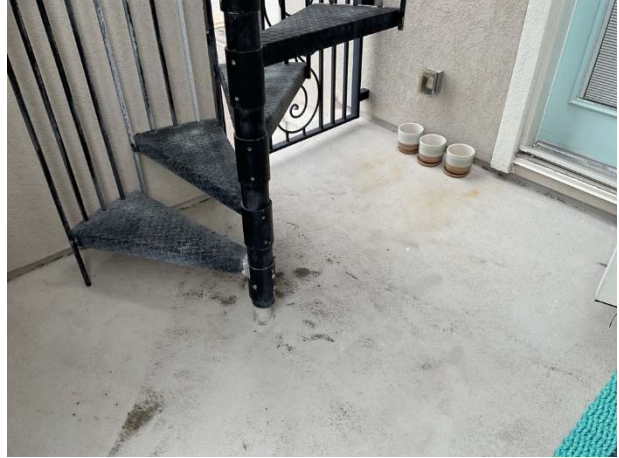
**Wood frame balcony with concrete surface**

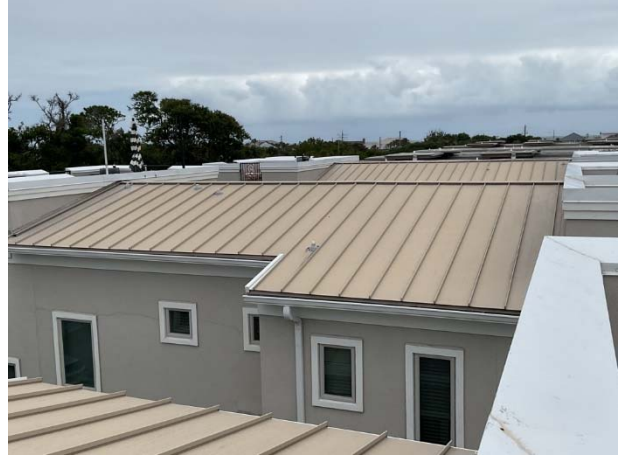
**Metal roofs overview**

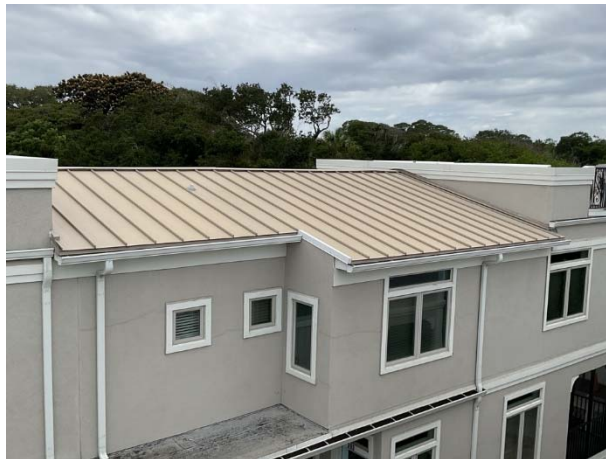
**Metal roof**

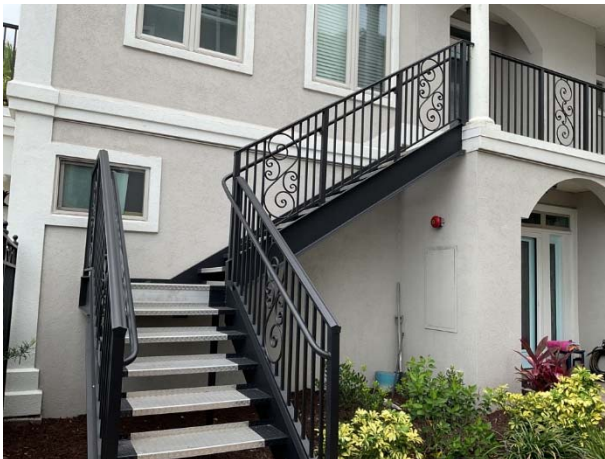
**Staircase overview**

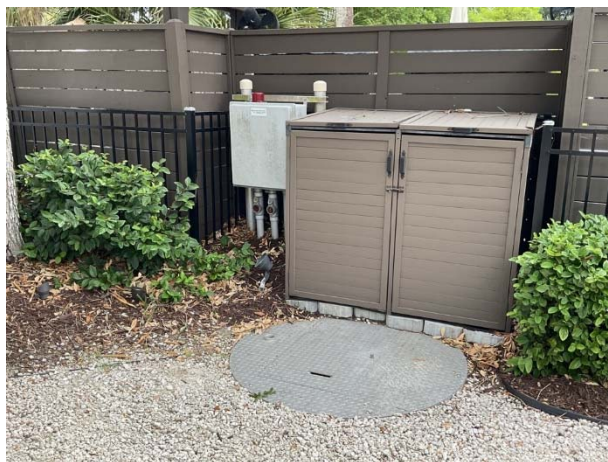
Lift station

- General - Replacement of vehicular pavers at the front elevation parking area due to noted deterioration
- General - Replacement of lift station pumps to prevent service interruptions

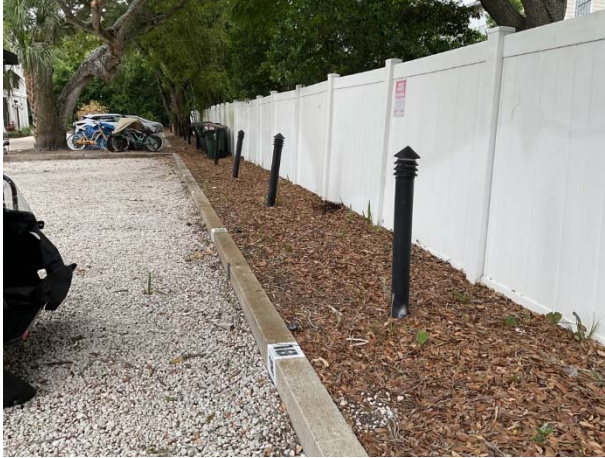
**Leaning fixtures**

- General - Replacement of bollard light poles and fixtures due to noted damage
- General - Replacement of vinyl fencing at the north perimeter due to noted damage and to maintain the security of the property
